Appendix G: Photo Record

North Dam As-Built Report		
		Overview of Dam Construction Activities		
Job No: 1CH008.058.430 Filename: Figure 1_Overview_1CH008.058.pptx	Hope Bay Mining Limited	Date: May 2012	Approved: JBK	Figure: 1

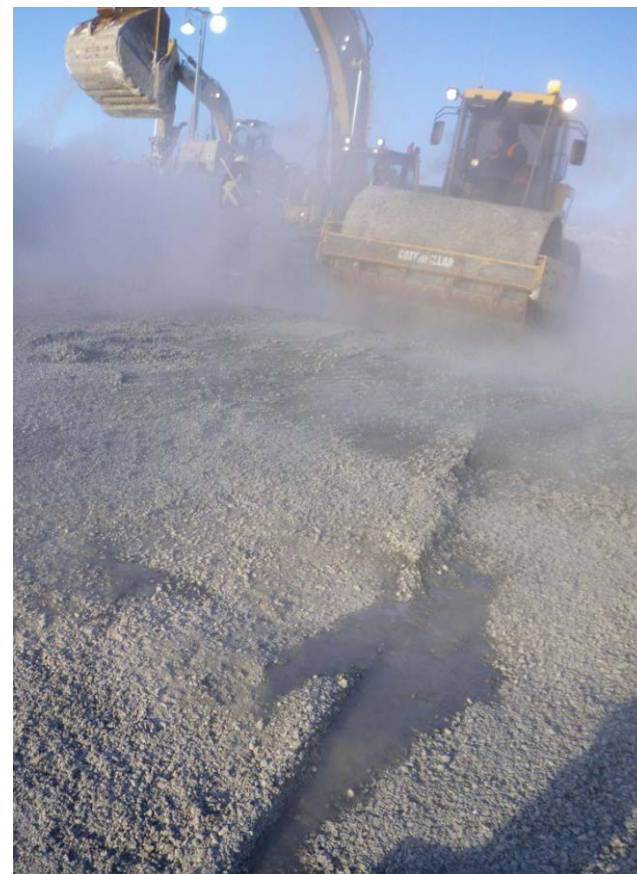
Excessive bleed water was noted during levelling course placement with the original (20 mm minus) core material. Photo taken March 3, 2011

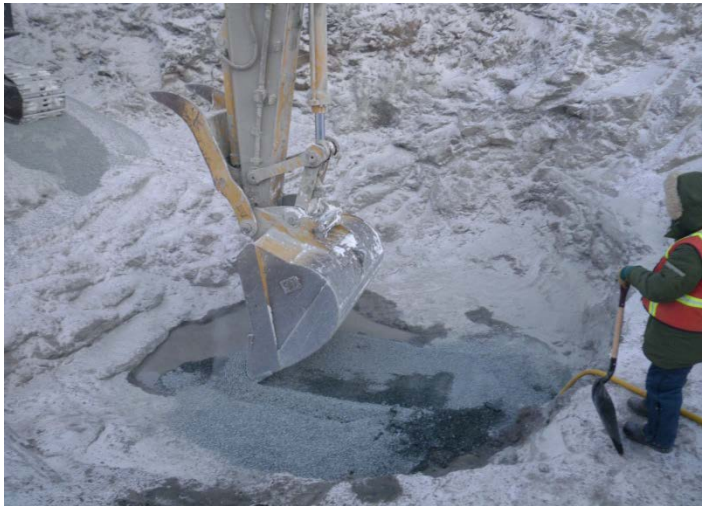
Failed first attempt at mixing-in-place core placement in Peat Zone excavation, February 24, 2011

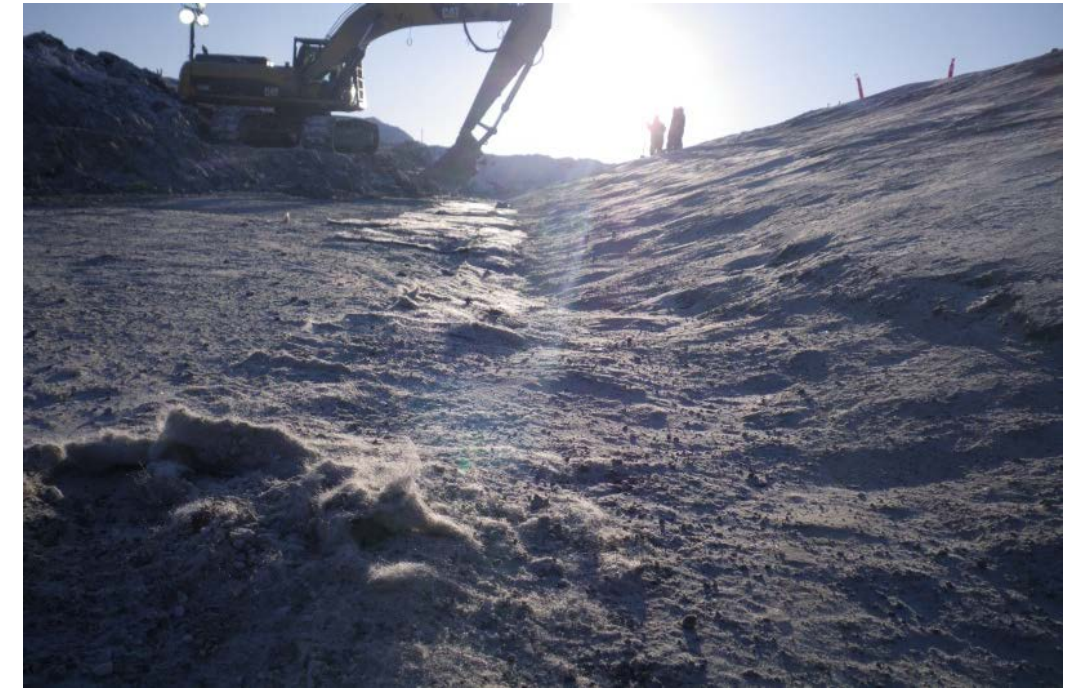
Damage to lower GCL due to the removal of thermal cover material, March 23, 2012

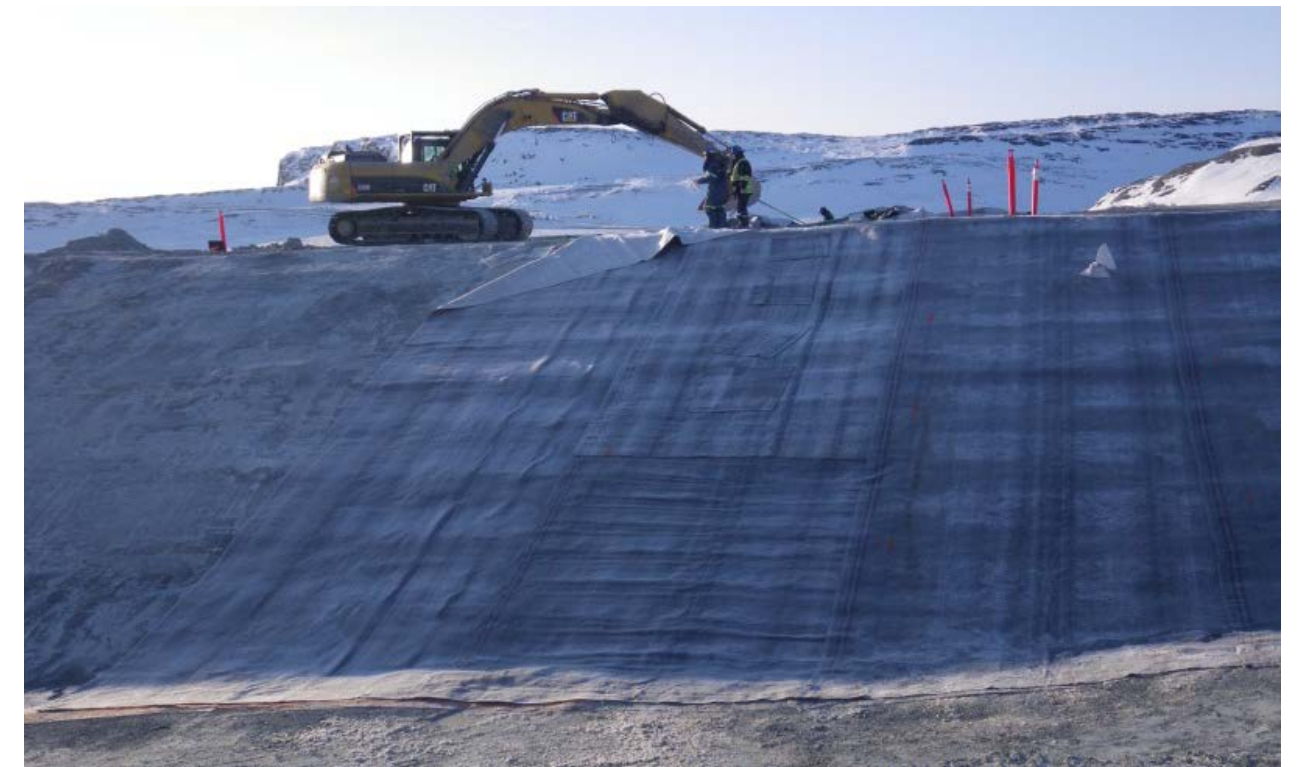
GCL placed on the upstream slope of the frozen core, March 23, 2012. Note the horizontal seam on the slope. Horizontal seams on slopes were avoided when possible, only apparent in a few areas

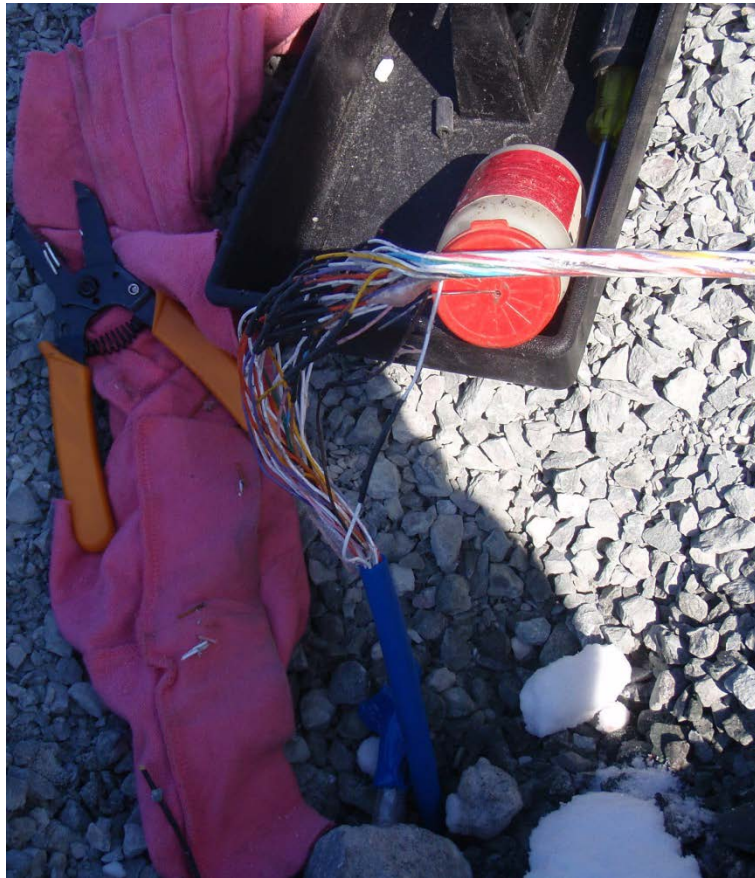
Splicing damaged GTC, April 29, 2011
