**Re: December 2012 – Monthly Monitoring Report for Water Licence 2AM-DOH0713 - Updated**

The Doris Site was opportunistically inspected on December 23, 2012, directly after the ice between Victoria Island and the mainland became passable by snow machine.

<b>2012-2013 Hope Bay - Doris Care &amp; Maintenance Inspection</b>		 	
Inspected By: (Please Print)	1 <u>ALEX BUCHAN</u> 3	Date(s) of Inspection (dd/mm/yy):	23 / 12 / 12		
	2 <u>ALEXA BUCHAN</u> 4				
Area 1: KBL Waste Management - Office					
1 ) Signs of entry (forced or wildlife)	Yes	<u>No</u>	 		
2 ) Signs of damage to exterior	Yes	<u>No</u>			
Area 2: KBL Waste Management - Incinerator					
1 ) Signs of entry (forced or wildlife)	Yes	<u>No</u>	 		
2 ) Signs of damage to exterior	Yes	<u>No</u>			
Area 3: Kingland Ford Tent					
1 ) Signs of entry (forced or wildlife)	Yes	<u>No</u>	 		
2 ) Signs of damage to exterior	Yes	<u>No</u>			
Area 4: 5 Million Litre Tank / Containers (Robert's Bay)

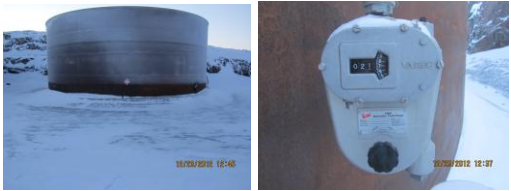
<p>Roberts Bay Laydown</p>	<p>Roberts Bay Tank Farm Tank #4</p>

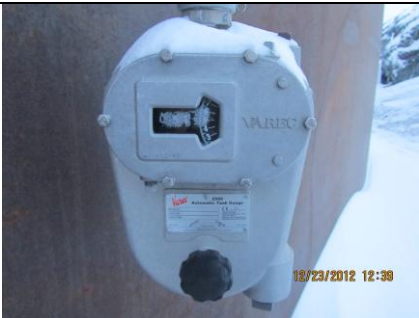
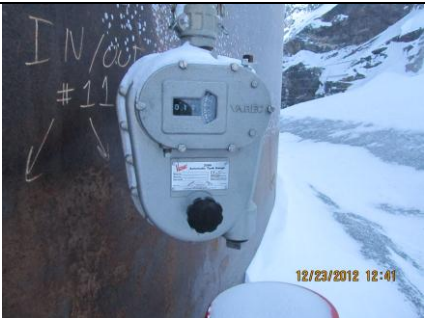
<p>Roberts Bay Tank Farm Tank #3</p>	<p>Roberts Bay Tank Farm Tank #2</p>

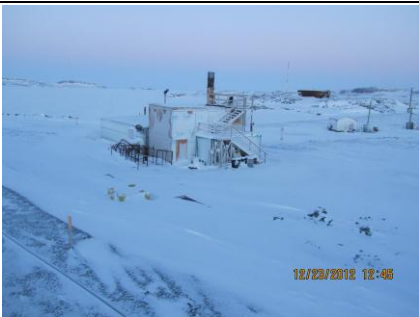
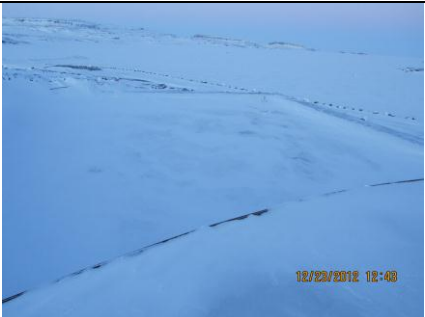
<p>Roberts Bay Waste Management Area</p>	<p>Roberts Bay Tank Farm Berm</p>

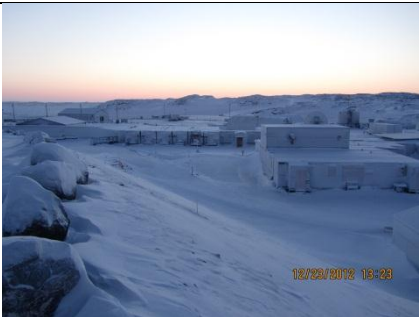
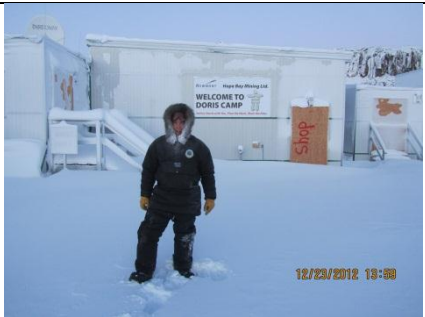
<p>Doris Camp</p>	<p>Doris Camp Main Entry</p>
