Re: August 2017 – Monthly Monitoring Report for Water Licence 2AM-DOH1323

This report is comprised of monitoring requirements as set out in Part J and Schedule J of water licence 2AM-DOH1323 Amendment 1, and additional requirements from INAC.

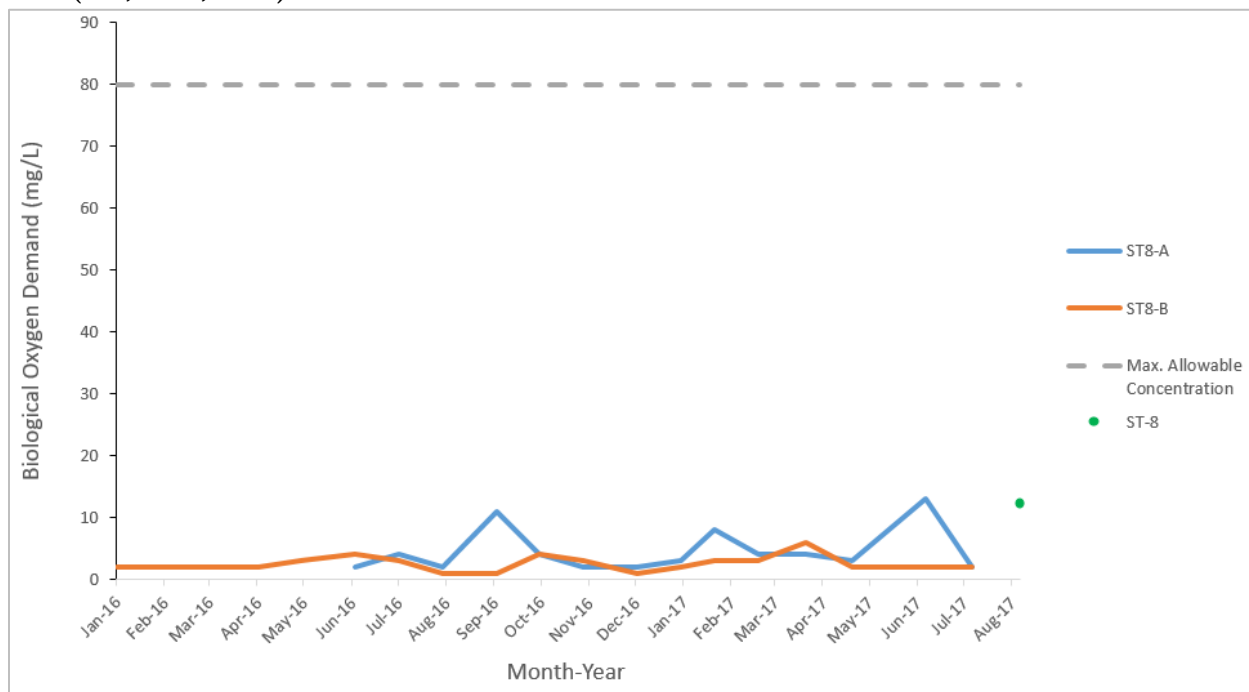
Figure 1. Biological Oxygen Demand Results Consistently Below Discharge Criteria for Wastewater Treatment Plant (ST8, ST8A, ST8B)

Note: Maximum Average Concentration as per Part G Item 4(b).

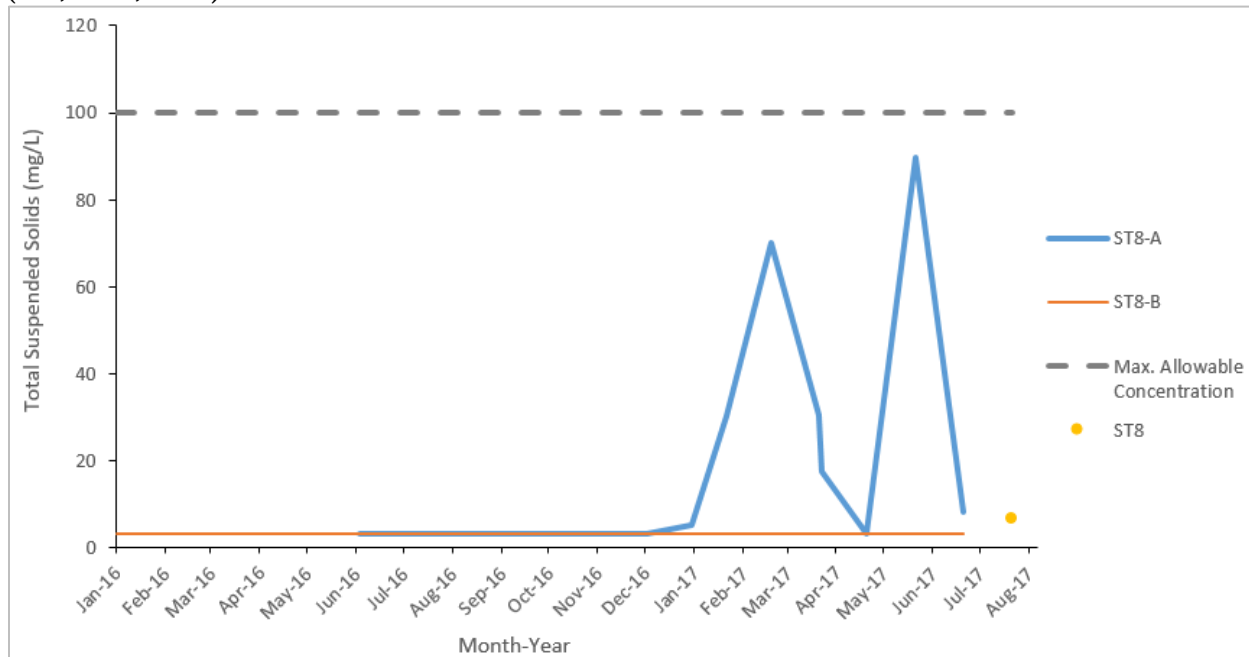
Figure 2. Total Suspended Solids Results Consistently Below Discharge Criteria for Wastewater Treatment Plant (ST8, ST8A, ST8B)

Note: Maximum Average Concentration as per Part G Item 4(b).
