Re: January 2018 – Monthly Monitoring Report for Water Licence 2AM-DOH1323

This report is comprised of monitoring requirements as set out in Part J and Schedule J of water licence 2AM-DOH1323 Amendment 1, and additional requirements from INAC.

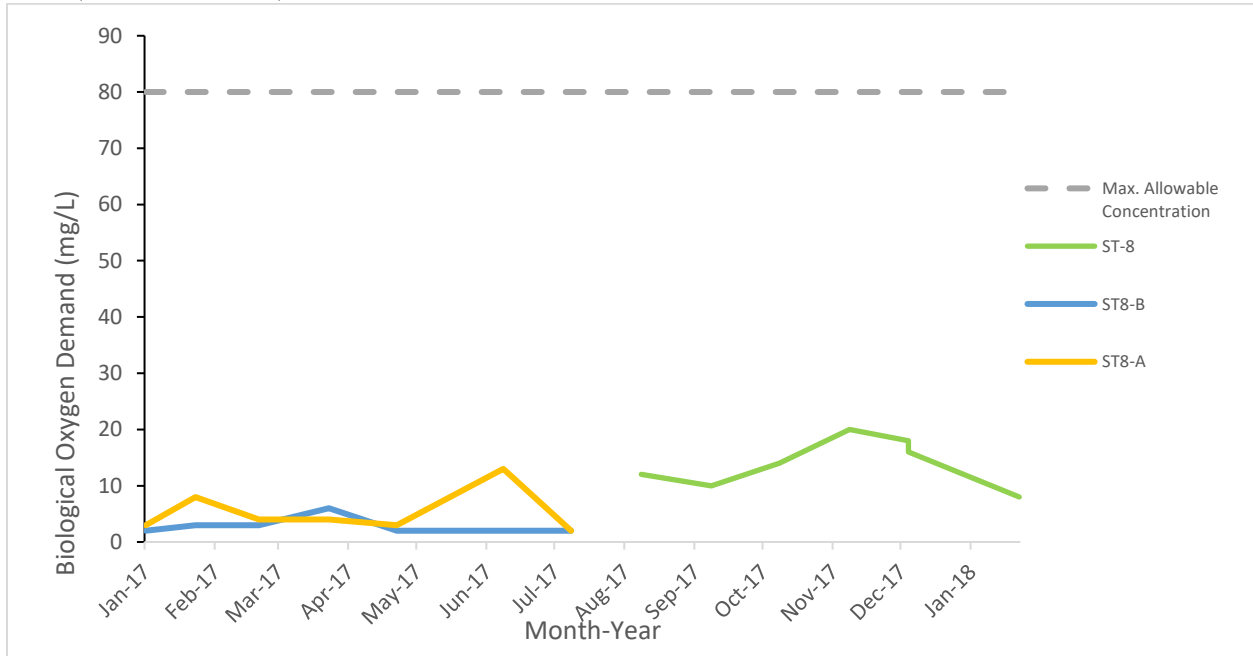
Repairs conducted by the wastewater treatment operator in December resulted in a subsequent improvement of results for Biological Oxygen Demand (BOD) and Total Suspended Solids (TSS) at monitoring station ST8 in January. Results for these parameters remain below the effluent quality limits outlined in Part G of the licence. As part of TMAC's adaptive management strategy, additional monitoring was continued on the wastewater treatment plant by the wastewater treatment operator throughout January. The elevations observed in December were attributed to degraded treatment performance in one of the two treatment units due to regular wear and tear on the filter membrane cassettes. The malfunctioning cassette was isolated and new cassettes have been sourced through the manufacturer for replacement.

Figure 1. Biological Oxygen Demand Results Consistently Below Discharge Criteria for Wastewater Treatment Plant (ST8, ST8A, ST8B)

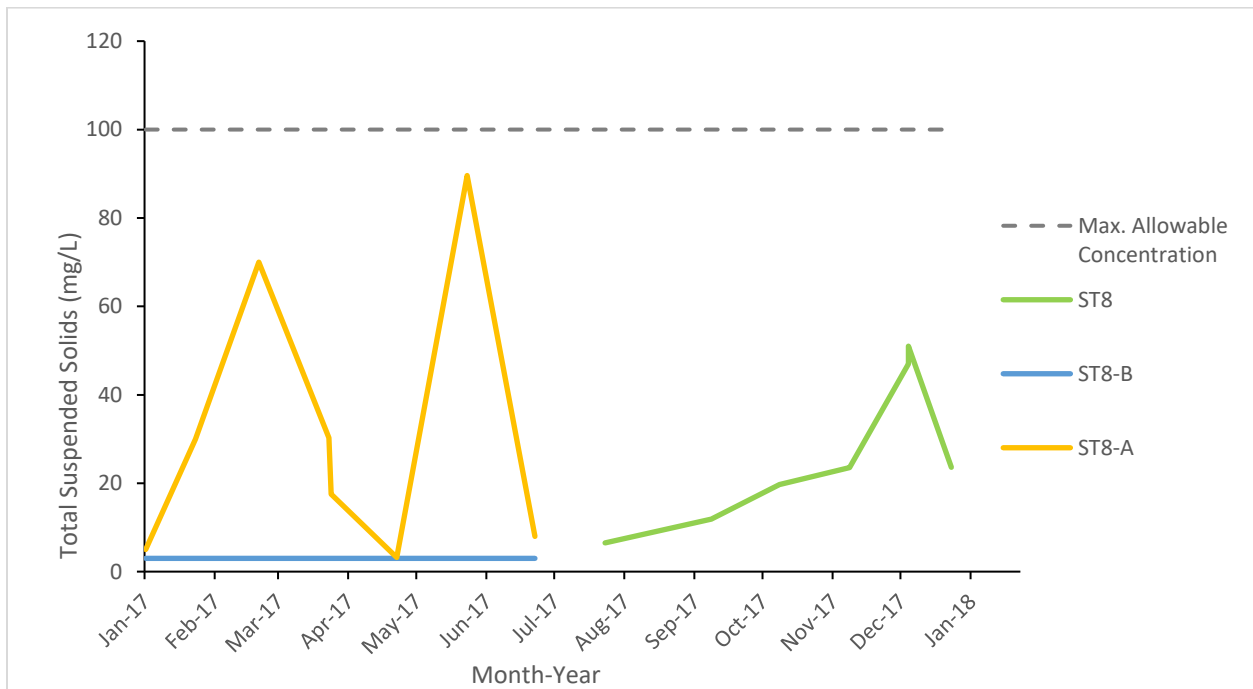
Figure 2. Total Suspended Solids Results Consistently Below Discharge Criteria for Wastewater Treatment Plant (ST8, ST8A, ST8B)
