June 29, 2018

Re: May 2018 – Monthly Monitoring Report for Water Licence 2AM-DOH1323

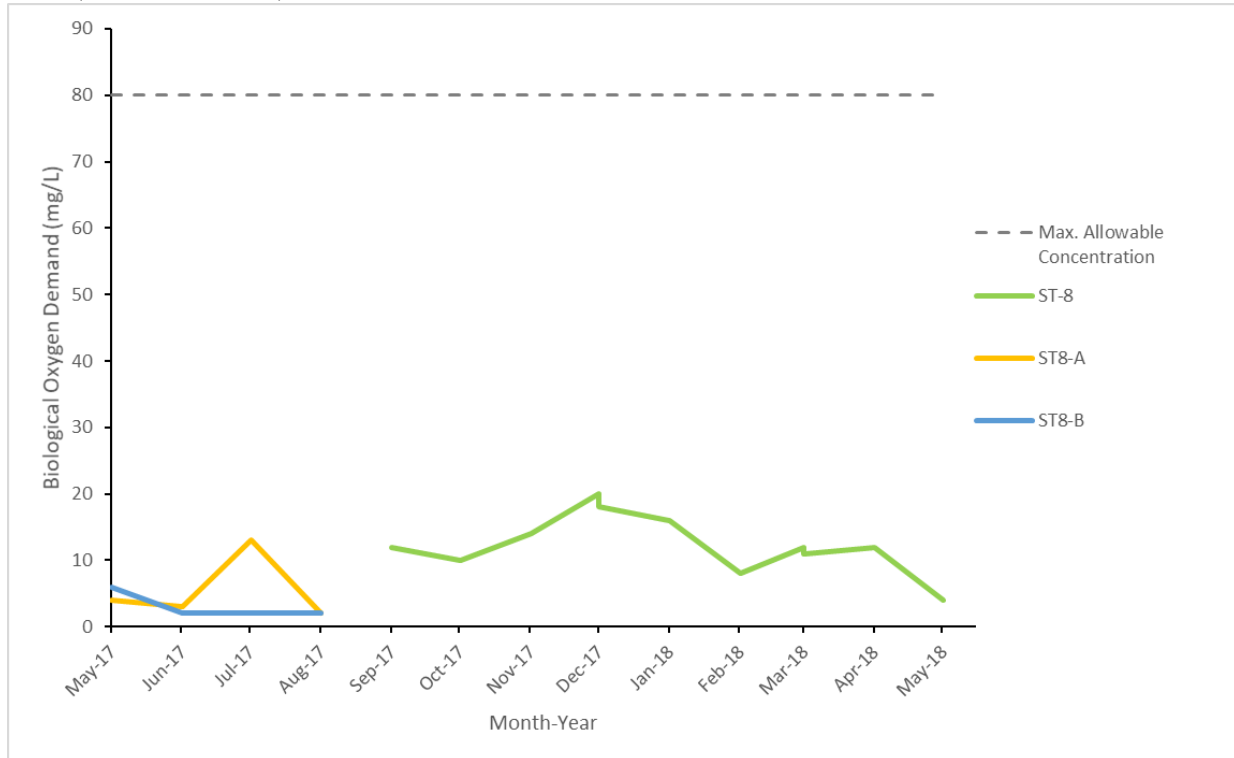
Figure 1. Biological Oxygen Demand Results Consistently Below Discharge Criteria for Wastewater Treatment Plant (ST8, ST8A, ST8B)

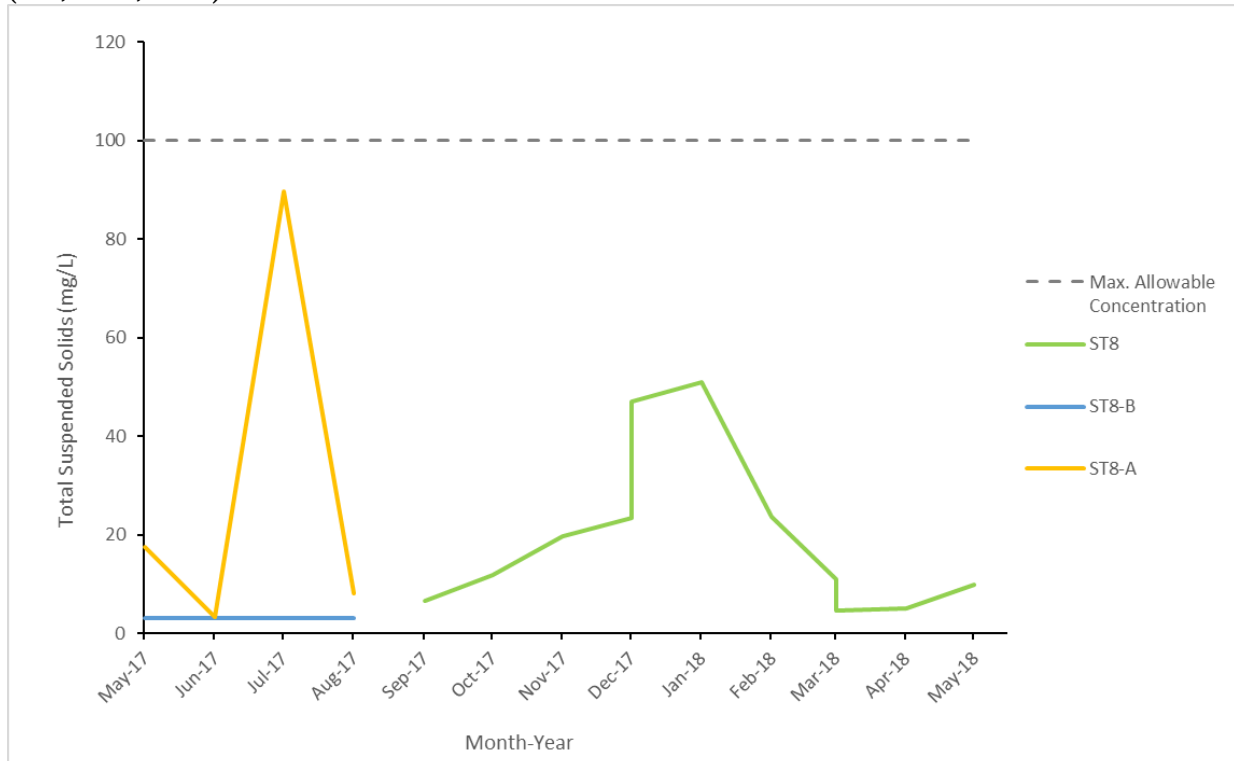
Figure 2. Total Suspended Solids Results Consistently Below Discharge Criteria for Wastewater Treatment Plant (ST8, ST8A, ST8B)

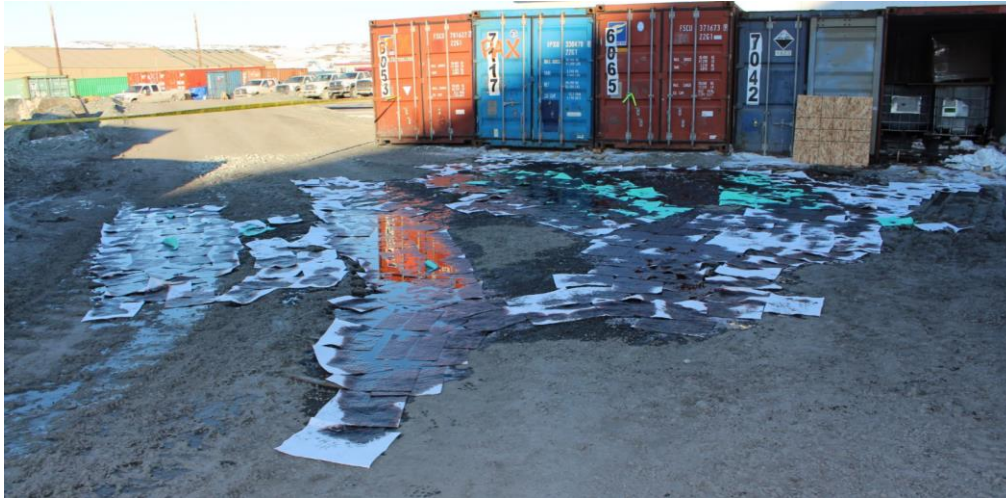
Spill #18-205 - On May 31, 2018 a spill of 900L of DanaFloat 245 product occurred on the south side of the process plant building when an operator using a telehandler attempted to remove a 1000L tote of the product from a storage sea-can. The floor of the sea-can had a buildup of snow and ice, which caused the right fork to raise up and puncture the tote as the operator moved the telehandler forward. The DanaFloat 245 spilled from the tote into the sea-can and out the door onto the crush rock pad surrounding the sea-can. Contaminated crush was excavated from the camp pad surface; this included removing the storage sea-can of the punctured tote and adjacent sea-cans to excavate contaminated crush from product that had migrated beneath the sea-cans. All contaminated crush was removed and placed in the Tailings Impoundment Area for disposal. Photos of the spill and completed clean-up are provided in Figure 3 below.

- A spotter was not used to guide the operator when attempting to remove the tote
- Some lights on the telehandler were not operational at the time of the incident. The work lights may have provided adequate illumination within the sea-can to identify that the forks were not lined up in the correct location.
- The sea-can from the vendor contained totes of other product, creating a need to move and handle totes multiple times to remove the required product.

Figure 3. Extent of DanaFloat 245 migration outside storage sea-can and placement of spill absorbent pads.

- Conduct site-wide safety presentations, department safety toolbox talks, and stop/corrects to emphasize to all departments the requirements of using a spotter when loading or unloading product from storage sea-cans.

- Instruct all Supervisors and Superintendents to conduct spot checks and/or stop and corrects for deficiencies on pre-op check sheets and ensure the optimal working condition of all equipment used in their scope of work.

- Discuss, form and implement a plan for the efficient layout of sea-cans to reduce congestion on the process plant laydown and allows for an effective delivery system of reagents, parts and materials.

- Review the possibility of raising sea-cans above grade to facilitate easier clean up of drifting snow during winter months, and allow for closing and positive seal of all doorways to prevent snow buildup within sea-cans.

- Inquire into the possibility of single product loads of reagents into sea-cans by vendors to eliminate the need to handle multiple containers to access the required ones and reduce the risk of a similar event from re-occurring. An alternative plan to be implemented during the summer weather to rearrange sea-cans currently on-site which contain multiple products.

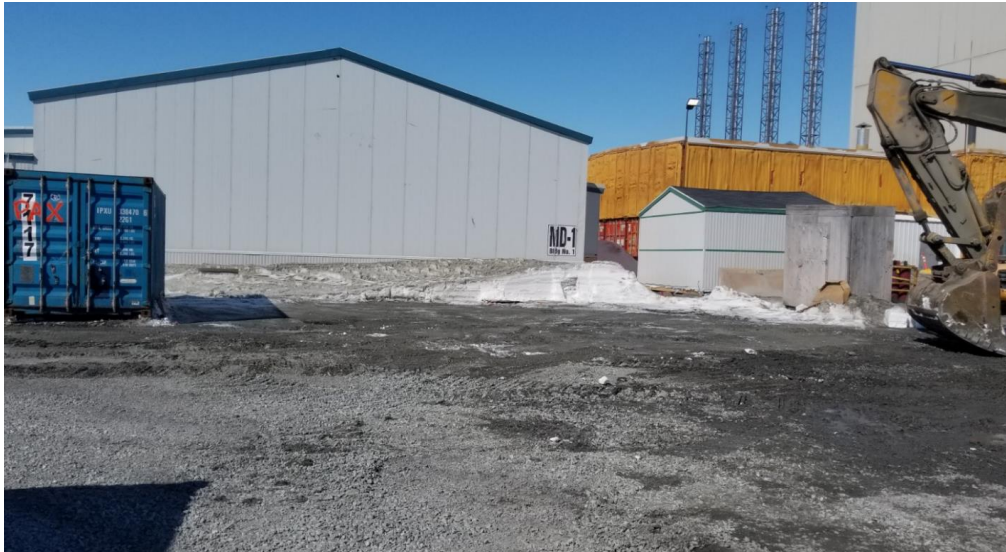
Figure 4. Completed clean-up of contaminated crush.
