Re: June 2018 – Monthly Monitoring Report for Water Licence 2AM-DOH1323

This report is comprised of monitoring requirements as set out in Part J and Schedule J of water licence 2AM-DOH1323 Amendment 1, and additional requirements from CIRNAC.

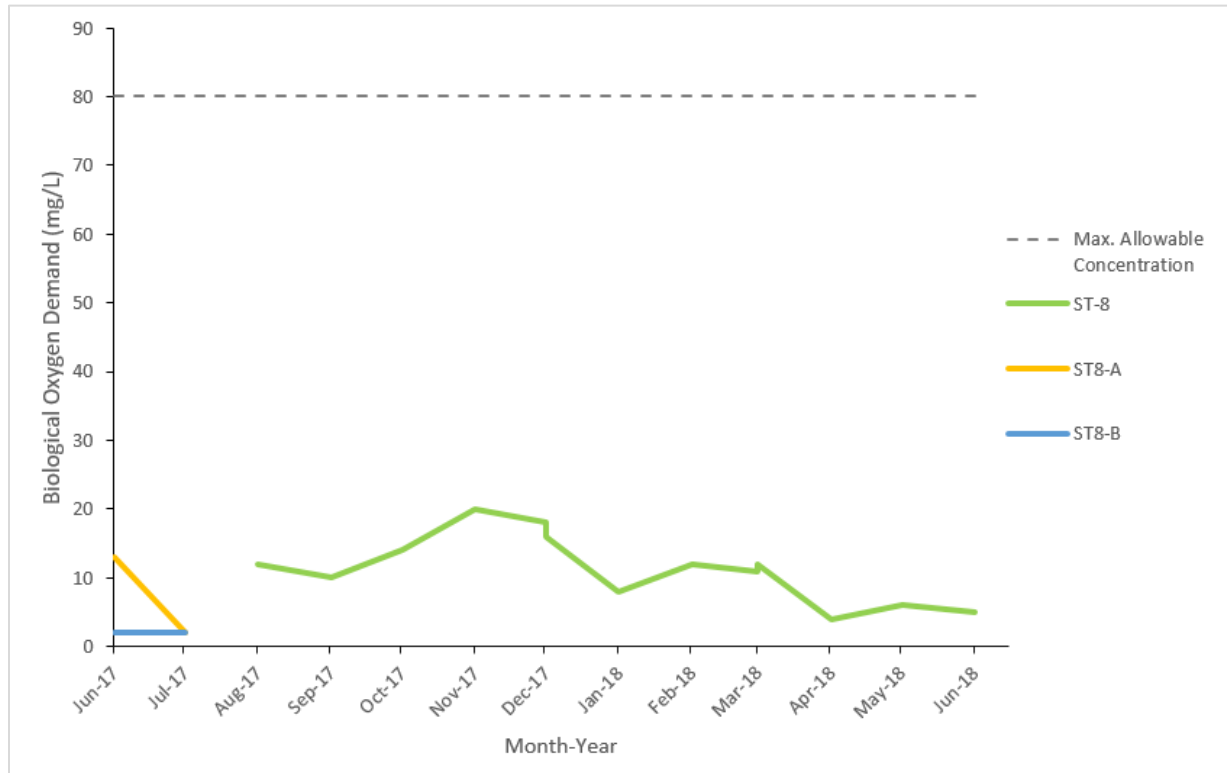
Figure 1. Biological Oxygen Demand Results Consistently Below Discharge Criteria for Wastewater Treatment Plant (ST8, ST8A, ST8B)

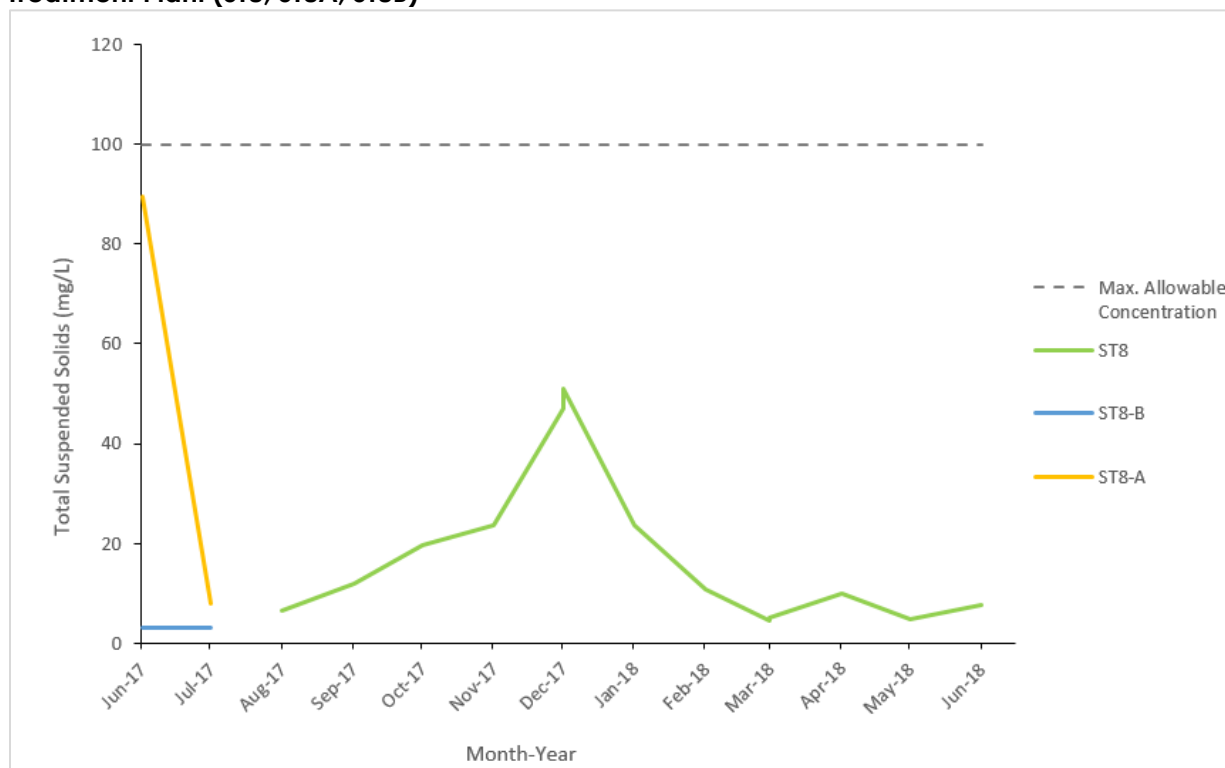
Figure 2. Total Suspended Solids Results Consistently Below Discharge Criteria for Wastewater Treatment Plant (ST8, ST8A, ST8B)

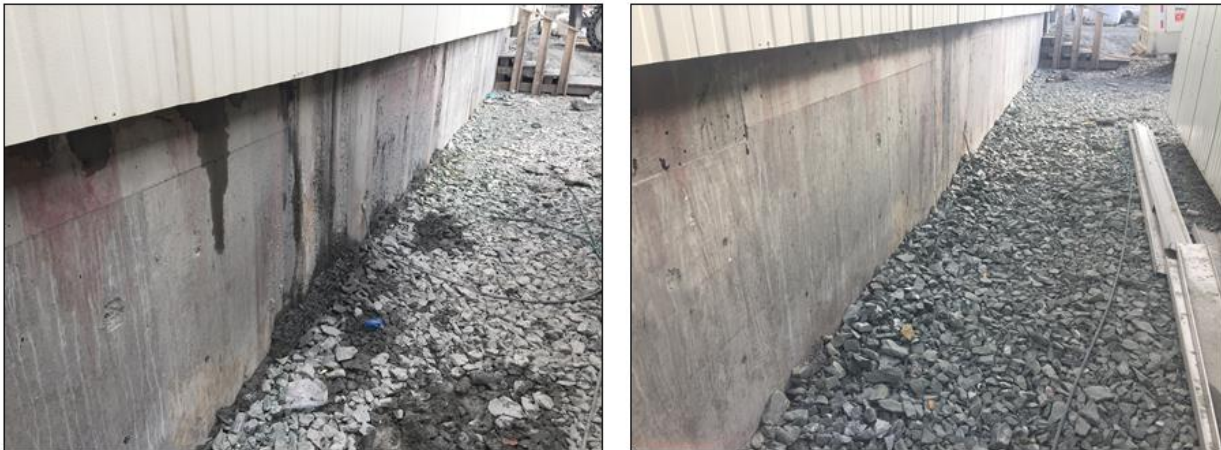
Spill #18-234 – On June 15, 2018 an estimated 50L of leached slurry containing approximately 37.5 grams of cyanide in solution was released to the camp pad surface outside the mill building. A leach filter feed pump had leaked slurry due to the failure of the gland seal and pump sleeve. The slurry sprayed onto the adjacent wall, which lacked an adequate seal between the concrete retaining wall and the exterior cladding to prevent the material from escaping the mill. As a result, some of the material spilled out onto the camp pad.

- Failure of gland seal and pump sleeve

Figure 3. Spill location prior to (left) and post cleanup (right).

- A barrier has been placed between the pump and the exterior cladding as a temporary measure;
- The gland seal and pump sleeve were replaced and the preventative maintenance schedule modified to match wear time for both parts;
- Mechanical seals will be investigated as a better application for the environment the pump is located in; and
- The gap between the concrete retaining wall and the exterior cladding will be sealed to prevent another spill occurrence.
