**Re: August 2018 – Monthly Monitoring Report for Water Licence 2AM-DOH1323**

This report is comprised of monitoring requirements as set out in Part J and Schedule J of water licence 2AM-DOH1323 Amendment 1, and additional requirements from CIRNAC.

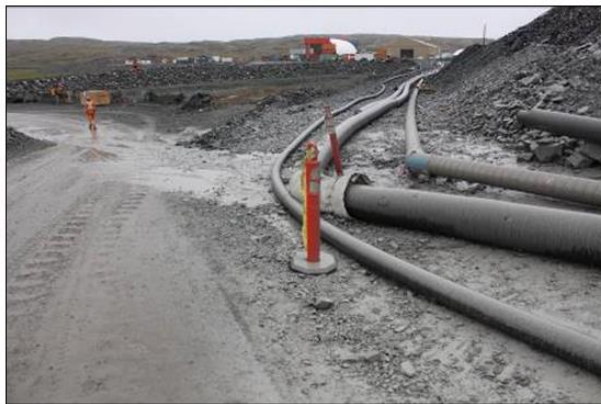
Spill #18-310 – On August 4, 2018 an estimated 10m<sup>3</sup> of flotation tailings was released to the engineered mine pad surface from the tailings distribution line running from the Doris North mill facility to the Tailings Impoundment Area (TIA). The flotation tailings spill was comprised of 1.6 m<sup>3</sup> of solids and 8.4 m<sup>3</sup> of solution. The mill operations were immediately suspended and the tailings pump shut down. Heavy equipment operators were called to the scene in order to recover the spilled and contaminated materials. A berm was initially constructed with clean crush rock material to minimize the spread of the spill. An excavator was used to excavate the tailings and contaminated materials from the mine pad surface, and a haul truck was used to transport contaminated materials to the TIA for disposal. Photos are provided in Figure 3 below.

- Small hole had worn through an elbow joint on the steel tailings line from the inside. The line had not been punctured from the outside.
- A spigot change had occurred earlier that morning that may have caused a temporary increase in line pressure. This may have also contributed to the rupture

Spill location.

- A ¼" thick halfpipe was welded overtop of the hole in order to prevent another spill occurrence;
- Routine ultrasonic thickness testing at elbows to confirm pipe thickness;
- The steel section of the tailings line was in the process of being replaced with an HDPE line that has a significantly reduced wear rate (now complete); and
- A Leak Detection System (LDS) is being investigated and may be installed on the tailings line to improve leak detection capability and decrease response time in the event of a spill.

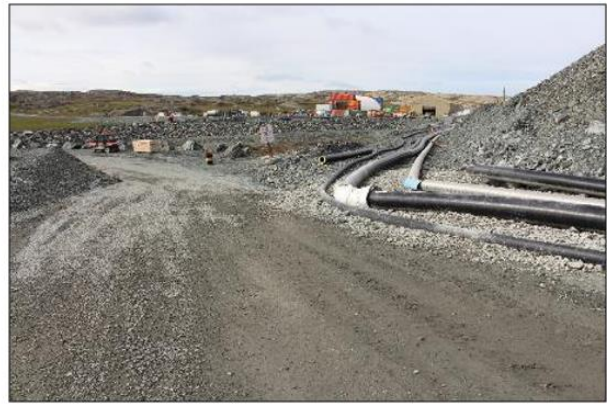
Spill reclamation.

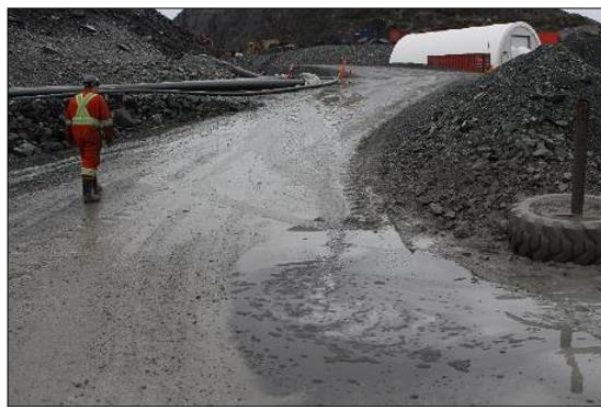
Spill location.

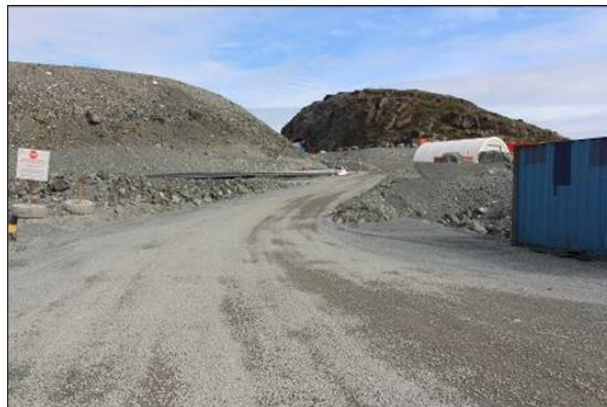
Spill reclamation.

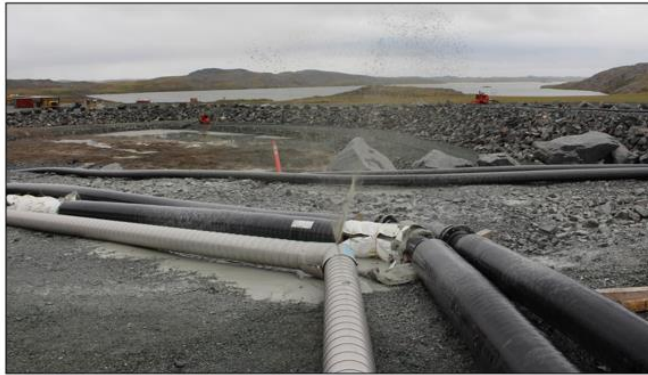
Spill #18-335 – On August 20, 2018 a spill of flotation tailings slurry was discovered emanating from the inspection port on an elbow of the steel tailings distribution. A contractor working in the area identified the spill immediately and contacted the mill control room operator. The tailings pump was shut down to reduce pressure in the line and minimize the volume of material released. An estimated 150L of tailings slurry was released to the crush pad at the north-west corner of the Pollution Control Pond. Contaminated crush was excavated from the area and disposed of in the Tailings Impoundment Area. Photos are provided in Figure 4 below.

Spill location and extent of contaminated material.

- Repairs were completed to the inspection port threads and the cap replaced;
- The steel section of the tailings line has since been replaced with a fuse welded HDPE line which does not require the same inspection port installation;

- An additional flowmeter will be installed on the tailings distribution line prior to discharge into the Tailings Impoundment Area. This flowmeter will be linked to the mill control room and monitor for potential loss of flow within the line. A loss of flow could indicate an issue or leak with the tailings line and would trigger additional inspections of the tailings line; and,
- A Leak Detection System (LDS) is being investigated and may be installed on the new HDPE tailings line to improve leak detection capability and decrease response time in the event of a spill.

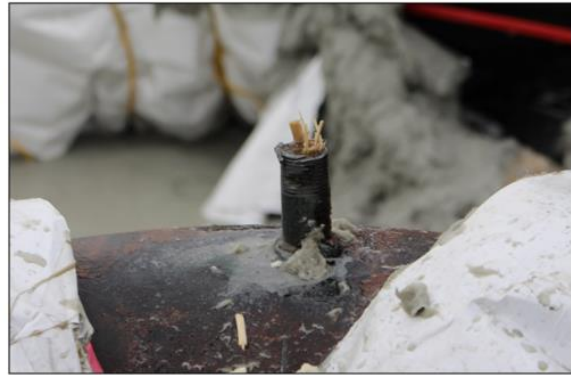
- Thread on the inspection port was worn resulting in failure of the cap on the inspection port located on the elbow of the steel tailings line.

Worn threads on plugged inspection port prior to repair.

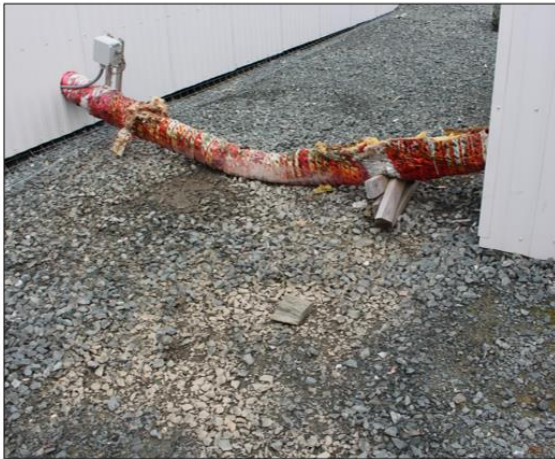
Spill #18-351 – On August 29, 2018 an employee conducting inspections of the various sewage lift stations at Doris Camp observed evidence of a leak emanating from a deformed sewage distribution pipeline. It is not known when the leak began and therefore, the spill volume released cannot be estimated. Repairs to the line were completed immediately and contaminated soils were excavated and disposed of on the overburden stockpile. Photos are provided in Figure 5 below.

- Large, heavy piece of rubber liner being used as a temporary roof cover had blown off during a storm and landed on the pipeline below. The cribbing used to support the pipe was insufficient to support this additional weight and caused the pipeline to sag over time resulting in the leak.

Spill location showing damaged pipeline and cribbing.

- A inspection of all service pipes was conducted to ensure all pipelines are adequately supported, insulated and protected from potential falling objects; and
- Inspections of all service pipelines will be conducted on a routine basis to evaluate pipeline integrity and identify any potential issues requiring maintenance.

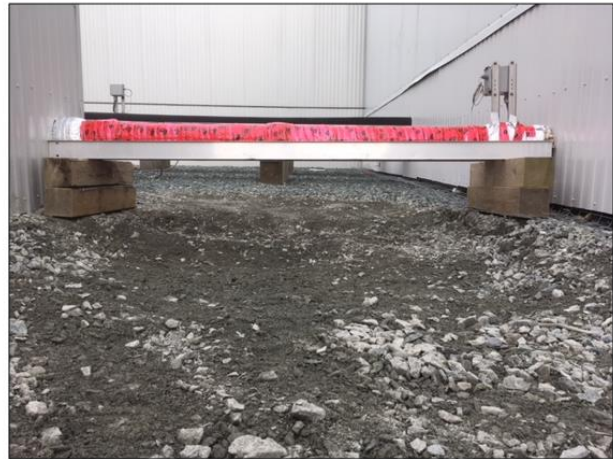
Spill location post-cleanup. Pipeline now fully supported.
