Re: September 2018 – Monthly Monitoring Report for Water Licence 2AM-DOH1323

This report is comprised of monitoring requirements as set out in Part J and Schedule J of water licence 2AM-DOH1323 Amendment 1, and additional requirements from CIRNAC.

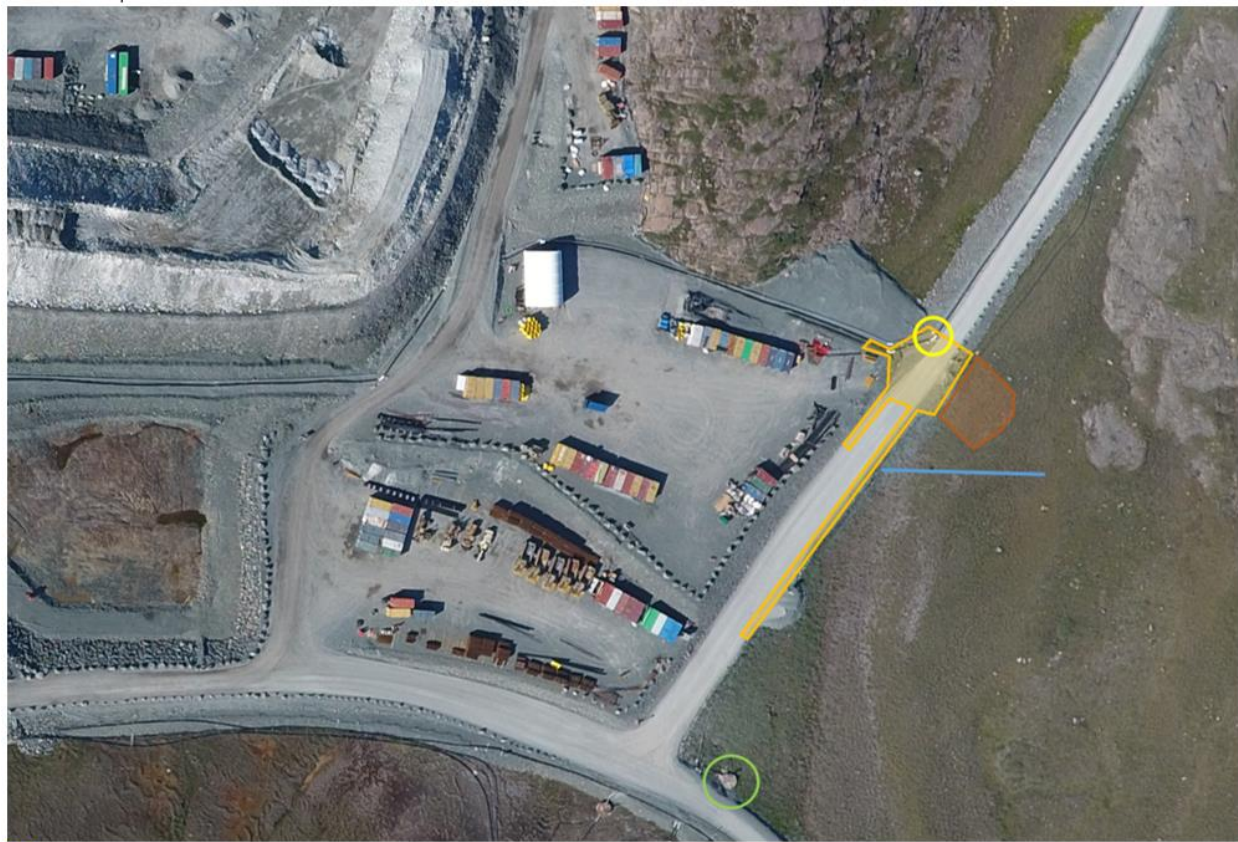
Figure 3. Spill #18-371 Overview of spill location

Spill #18-371 – On September 11, 2018 an estimated 30 m³ of flotation tailings was released to the engineered mine pad surface approximately 200m west of Doris Lake from a flange on the newly commissioned tailings distribution line running from the Doris North mill facility to the Tailings Impoundment Area (TIA). The flotation tailings spill was comprised of approximately 10.5 m³ of solids and 19.5 m³ of solution.

- Flange gasket had failed. The gasket and flange were removed from the line and found to have sustained damage due to wear from the tailings solids under high pressure.

- Gaskets were not properly sized for this particular application and were not installed as per the manufacturer's recommendation. A specific torqueing progression is recommended by the flange manufacturer during installation in order to maintain a minimum residual bolt torque. The high initial torque provides seating stress to ensure a no-leak path while the residual bolt torque provides the long-term sealing stress. These flange installations can be used with or without a gasket, however if a gasket is installed it will undergo some compression that will decrease the bolt torque. A 4-hour re-torque is required to achieve the final target torque value when a gasket is used with the installation. Based on the investigation results, the recommendation to complete a 4-hour re-torque was overlooked during the flange and gasket installation, which is believed to be the root cause of the gasket failure and leaking flange.

- Leaking Flange
- Primary Spill Area
- Secondary Spill Area (Wind dispersed)
- Silt Fence Installation
- Contact Water Management Sump

Heavy equipment operators were called to the scene to recover the spilled and contaminated materials. A berm was constructed with crushed quarry rock to contain the spill. An excavator was used to excavate the tailings and contaminated materials from the mine pad surface, and a haul truck was used to transport the contaminated materials to the TIA for disposal. Snow and ice on the roadway provided a barrier to the spread of the tailings material and prevented much of the tailings solution from spreading beyond the surface of the road. Tailings and contaminated materials that were not accessible by equipment were hand excavated and disposed of within the TIA.

- All gaskets were removed from flange installations on the tailings distribution line;
- A preventative maintenance program has been established to confirm target residual bolt torque is maintained and re-torque occurs as required;
- Installation of protective flange boxes are on going. These will allow for easy access during winter months and if a flange failure were to occur, may aid in containing the spill to a smaller footprint in the event of high winds;
- Various Leak Detection Systems (LDS) are being investigated and may be installed on the tailings line to improve leak detection capability and decrease response time in the event of a spill.

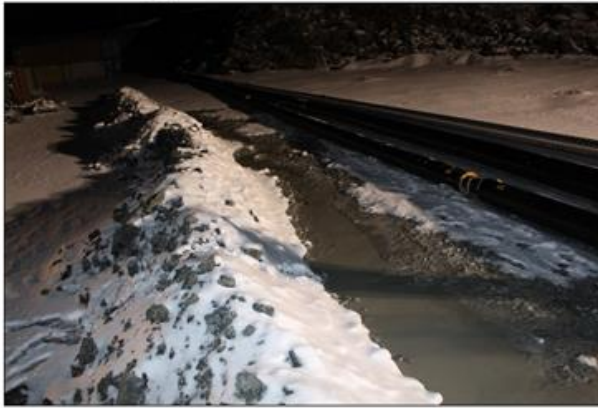
Figure 4. Spill #18-371 Completed spill cleanup

Primary spill location.

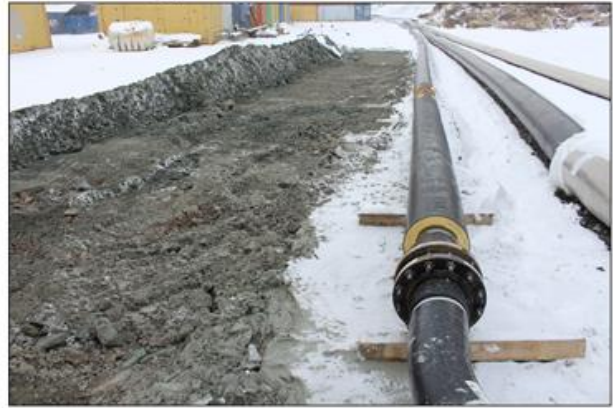
Primary spill location reclamation.

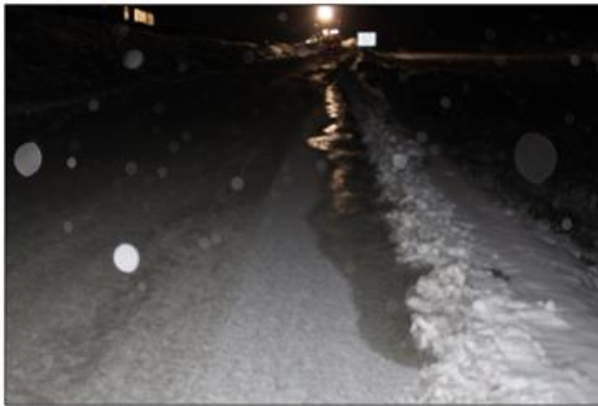
Primary spill location.

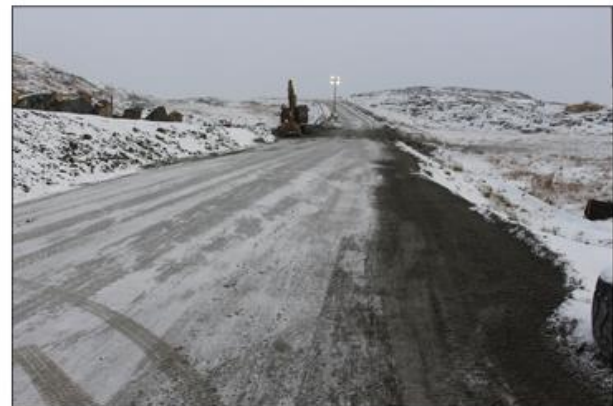
Primary spill location reclamation.

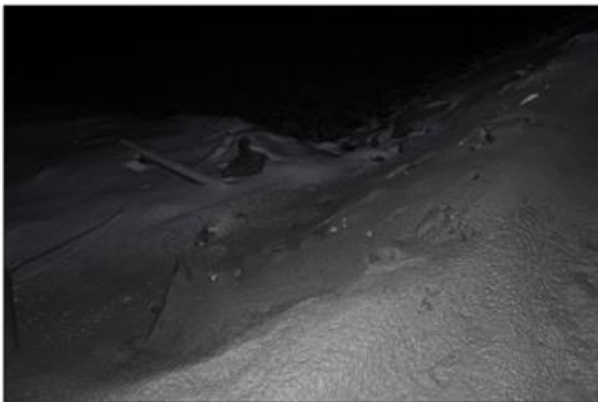
Primary spill location.

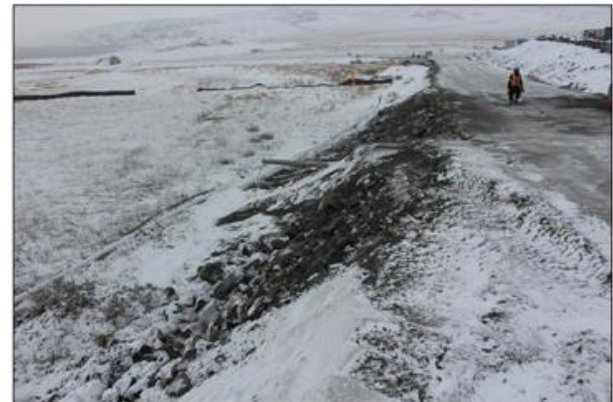
Primary spill location reclamation.

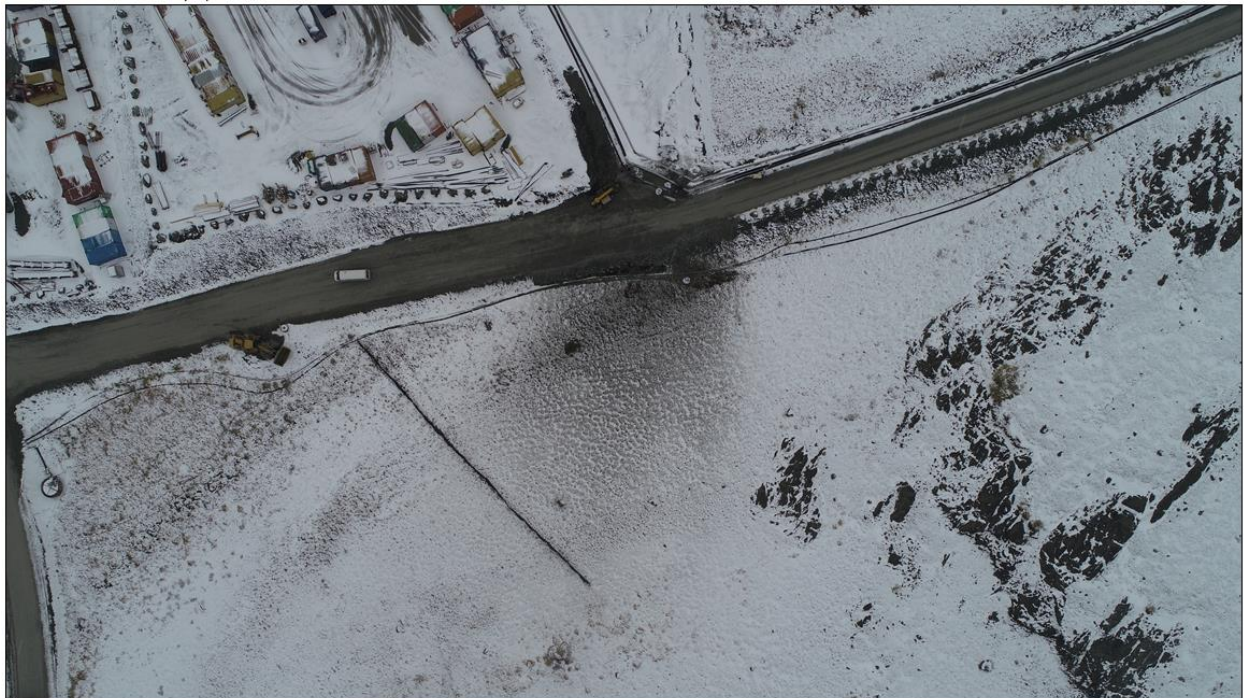
High winds during the spill event resulted in some windblown tailings being deposited on nearby tundra east of the spill area. The tundra (active layer) was not yet frozen at the time of the spill, which prohibited the use of heavy equipment to recover contaminated snow. This area is within the footprint of the permitted Waste Rock Storage Pad U that is planned for construction during the winter of 2019. Once the tundra has frozen sufficiently to support heavy equipment and prior to construction of this pad, TMAC will scrape the area and dispose of the contaminated materials within the TIA. In the interim, a silt fence was installed downstream of the impacted area to direct any melt water to a water management sump prior to freeze-up.

Figure 5. Spill #18-371 Secondary spill location with silt fence installation
