**Re: October 2018 – Monthly Monitoring Report for Water Licence 2AM-DOH1323**

This report is comprised of monitoring requirements as set out in Part J and Schedule J of water licence 2AM-DOH1323 Amendment 1, and additional requirements from CIRNAC.

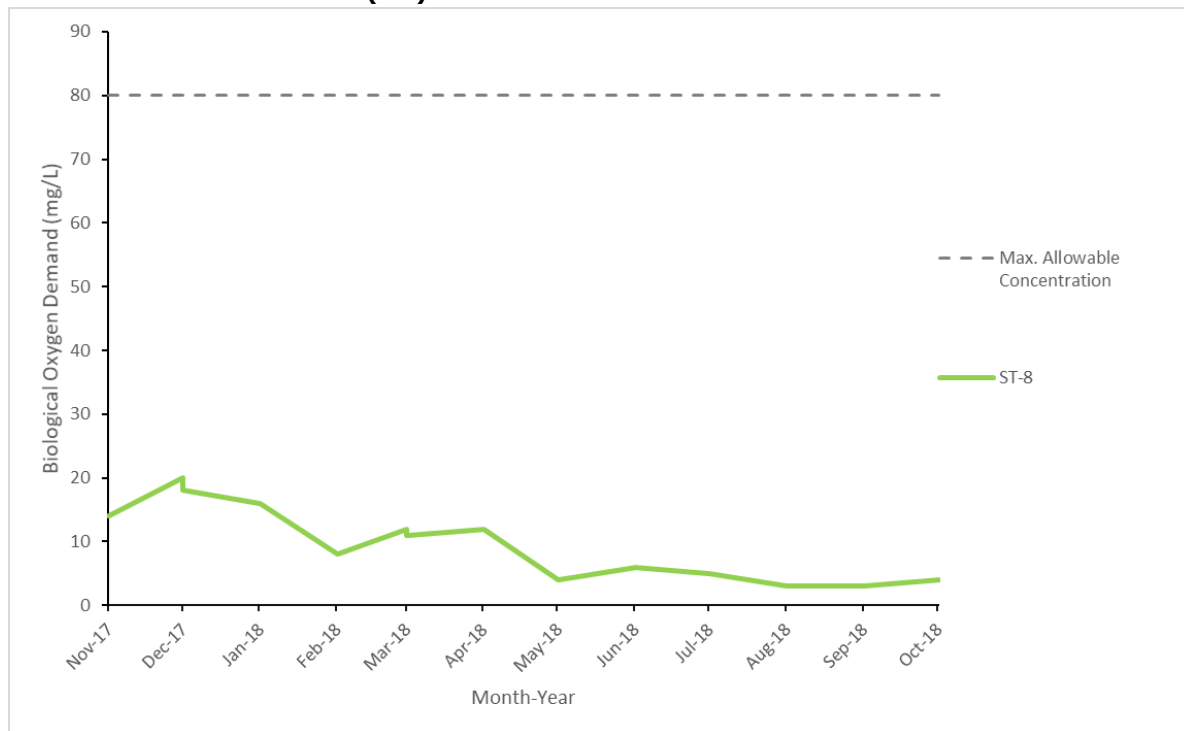
**Figure 1. Biological Oxygen Demand Results Consistently Below Discharge Criteria for Wastewater Treatment Plant (ST8)**

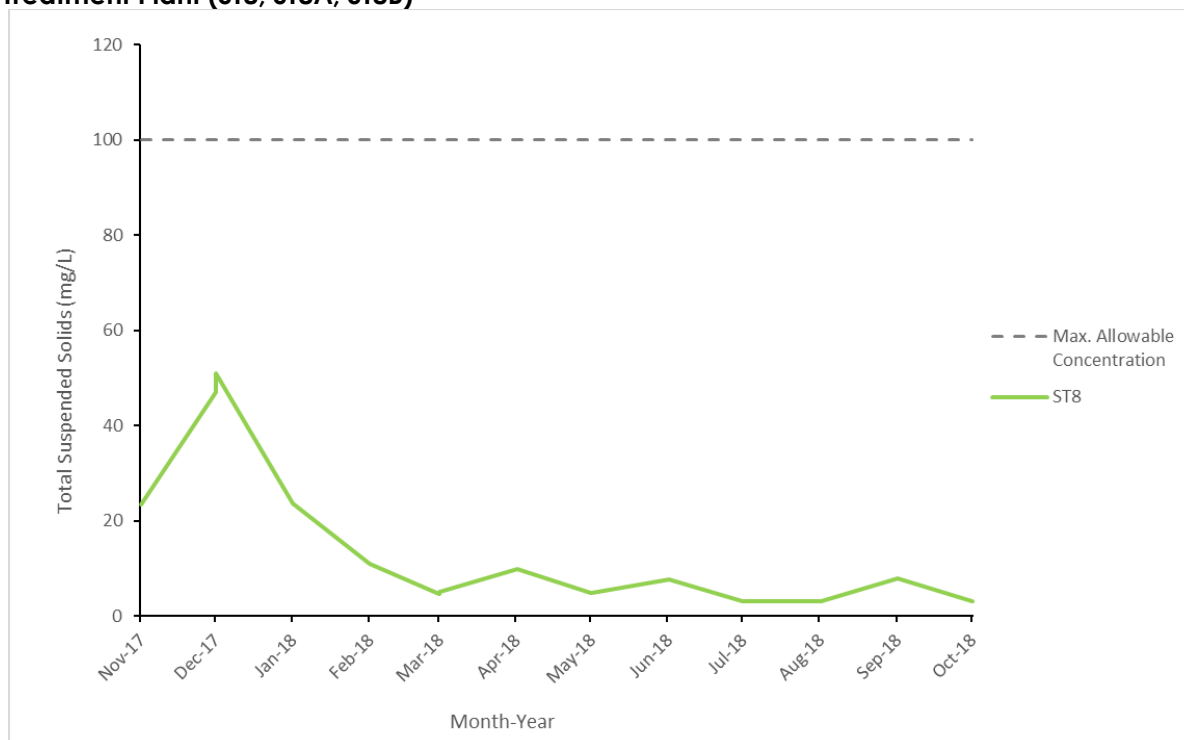
**Figure 2. Total Suspended Solids Results Consistently Below Discharge Criteria for Wastewater Treatment Plant (ST8, ST8A, ST8B)**

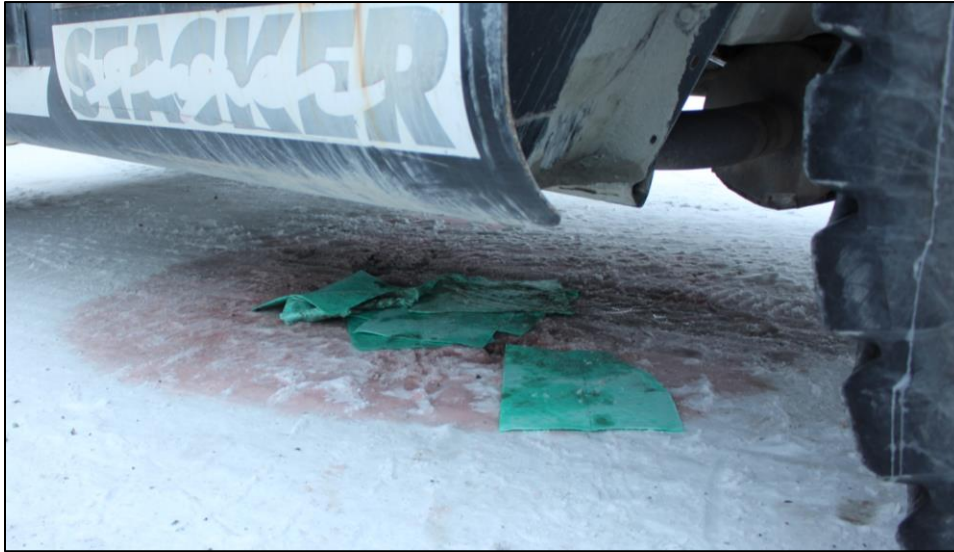
Spill #18-430 – On October 19, 2018 an operator was preparing to use a reach stacker to move a sea-can container from the upper laydown area to the main camp pad. During the pre-operational check of the equipment, the operator identified a pinhole leak in the coolant hose line. The operator contacted the mechanical shop to notify of the leak and a work order was generated to complete the repairs on the hose line.

The operator continued to use the reach stacker to complete the sea-can move and was then going to take the reach stacker to the mechanical shop when a larger hole formed in the hose line. A spill of 8L of ethylene glycol 60-40 coolant was released to the snow covered road surface.

Further investigation by the mechanics determined the hole in the hose line was a result of normal wear and tear on the equipment. Preventative maintenance is conducted on the reach stacker after every 500 operating hours and includes checks of all hose lines and hose clamps. Worn hose lines are replaced if integrity issues are identified. The preventative maintenance had been conducted within the recommended schedule for this equipment at the time of the spill.

**Figure 3. Spill #18-430 contamination area**

Spill pads were placed beneath the leak to reduce the amount of spill contacting the ground surface. Mechanics were called to the scene of the spill and patched the coolant line to stop the leak. The reach stacker was then taken to the mechanical shop to replace the hose line. Contaminated materials were removed from the surface of the road (spill pads, snow and crush) and taken to the waste management facility to be stored for offsite disposal. Please refer to photos 1 through 4 showing the damaged hose line, and the spill location prior to and after clean-up.

TMAC internally reviewed the incident and identified the following corrective actions in order to reduce the likelihood of a reoccurrence:

- Continue performing pre-operational checks on all equipment prior to use to

identify potential issues prior to using the equipment;

- If an issue is identified during the pre-operational check, use alternative equipment if available to conduct tasks until repairs can be completed; and
- Continue performing preventative maintenance programs on all equipment at the recommended interval (every 500 operating hours for the reach stacker).

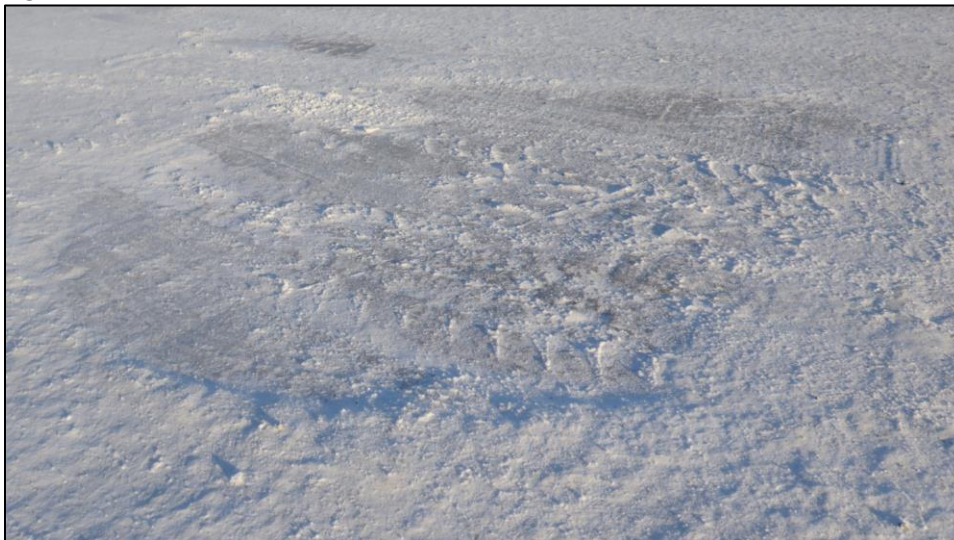
**Figure 4. Spill #18-430 Completed spill cleanup**
