Re: December 2018 – Monthly Monitoring Report for Water Licence 2AM-DOH1323

This report is comprised of monitoring requirements as set out in Part J and Schedule J of water licence 2AM-DOH1323 Amendment 1, and additional requirements from CIRNAC.

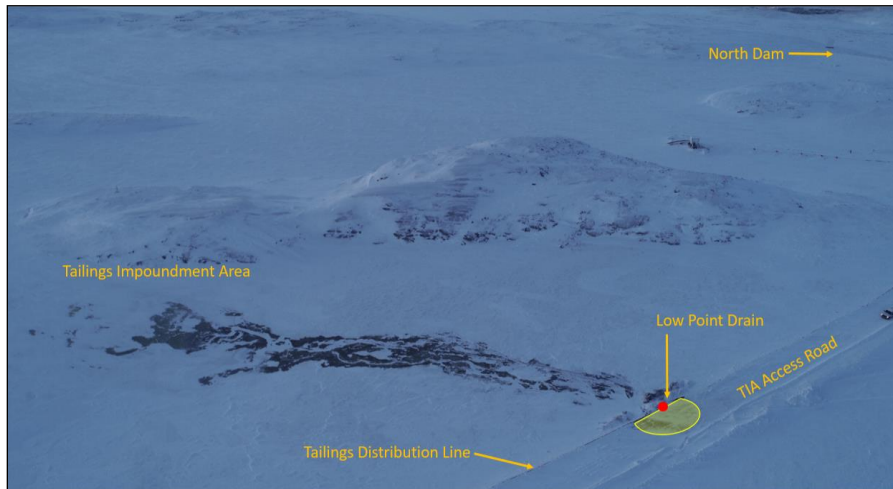
Spill #18-475 – On December 9, 2018 a grader operator was clearing snow on the Tailings Impoundment Area (TIA) access road when he discovered a spill of flotation tailings onto the roadway and into the TIA from the tailings distribution pipeline. An estimated 6m³ of flotation tailings was released to the access roadway and an unknown volume of tailings was spilled into the TIA downstream of this location.

The spill investigation determined that a small hole had worn through a steel flange located on a low point drain of the HDPE tailings distribution pipeline allowing release of tailings from the flange. TMAC internally reviewed the incident and identified the following corrective actions in order to reduce the likelihood of a reoccurrence:

Figure 3. Spill #18-475 spill location and area of contamination (post-cleanup)

- The worn steel flange was replaced;
- Routine ultrasonic thickness testing of drains/spigot points to confirm thickness integrity; and

- Options to install a Leak Detection System (LDS) have been investigated and TMAC is in the process of evaluating operational effectiveness of these options in order to determine which system will be most suitable given the tailings pipeline alignment and operation in arctic conditions.

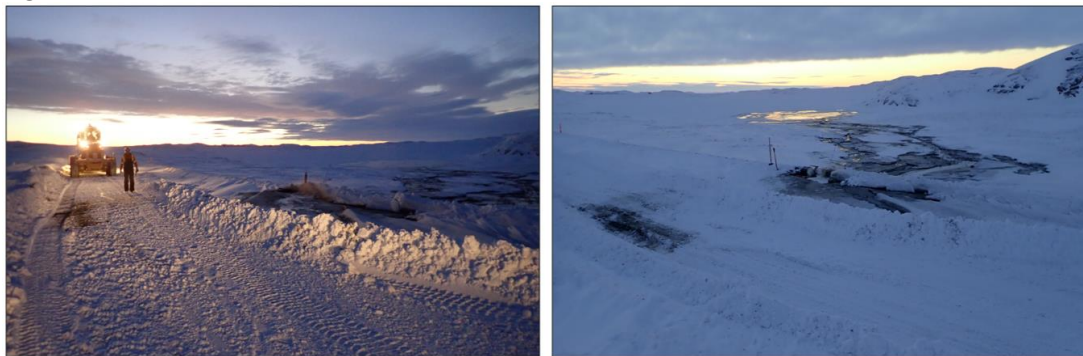
The mill operations were promptly suspended and the tailings pump shutdown. Snow banks on the roadway had prevented tailings from migrating off the road to the tundra east of the Tailings Impoundment Area and all spilled tailings were contained to the roadway and the TIA. The grader operator immediately constructed a berm with snow on the roadway upon discovery of the spill to minimize the spread of the spill. An excavator was used to excavate the tailings and contaminated crush from the road surface and dispose of this material into the Tailings Impoundment Area.

Figure 4. Spill #18-475 spill location prior to cleanup

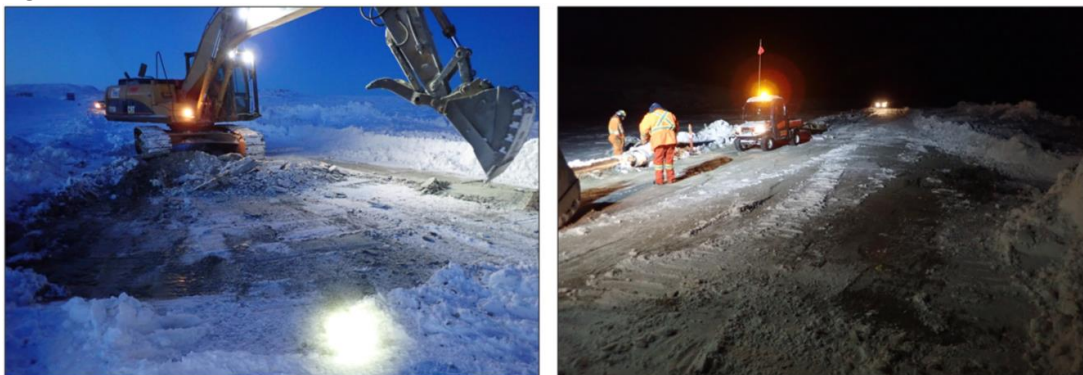
Figure 5. Spill #18-475 excavation of contaminated materials

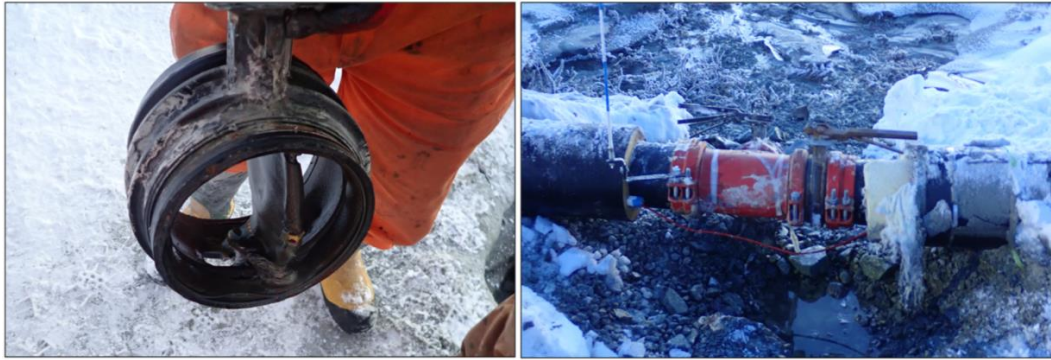
Figure 6. Spill #18-475 worn flange (left) and repaired pipeline (right)

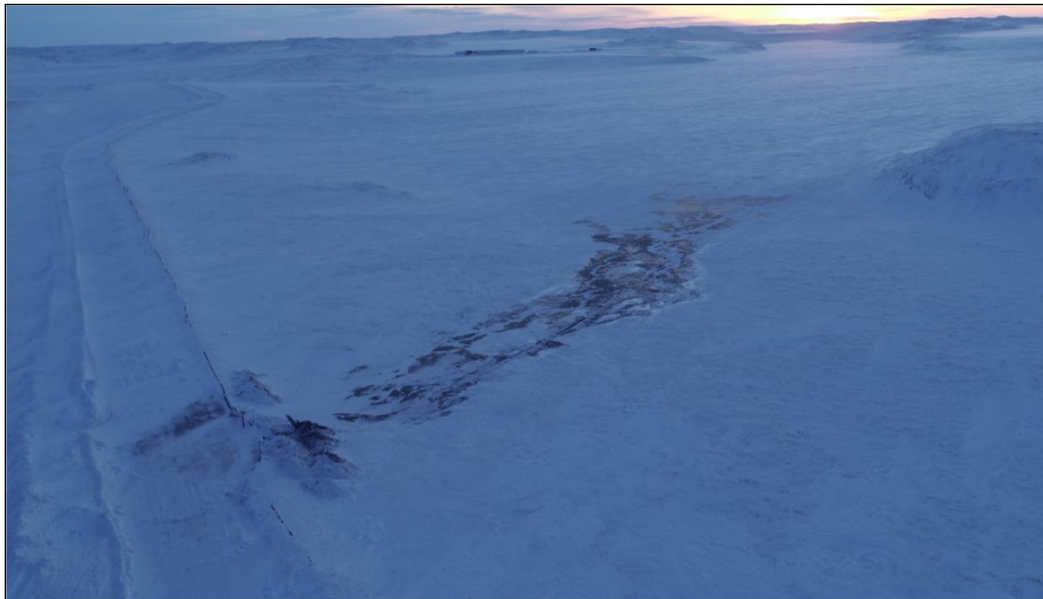
Figure 7. Spill #18-475 post-cleanup activities

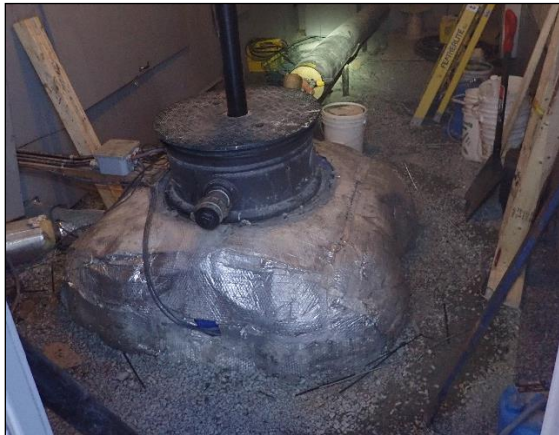
Spill #18-487 – On December 28, 2018, the sewage treatment operator noted lower than normal overnight input into the Sewage Treatment Plant by approximately 4 m³. At approximately 5:45am, during a daily inspection of the main Doris Camp lift station, the sump was found to be overflowing and weeping on to the gravel floor of the building. On December 27th at 17:00, the sump pump was replaced in the same lift station. Multiple tests were completed to ensure proper function of the pump and the sump was closed up for the night. Upon investigation, the root cause was found to be excess wire from the new pump installation had broken its mooring and fallen, trapping the floats in the down or off position. The pump did not turn on as needed and the sump over flowed.

Figure 8. Area of contamination.

The sump pump was immediately switched to manual mode to pump the water level down and determine the problem. The excess wire was secured to an area away from the float with additional strapping. Additionally, the float connection point was also relocated to ensure free movement and no chance of obstruction.

The spill area surrounding the sump was hand excavated to the extent practicable and contaminated soil was removed from the area. Lime was also placed on the impacted areas to prevent the development of odors or pathogens during the warmer months.

- An upgraded inspection schedule will be made after repairs on key systems to monitor the first few hours or as deemed necessary to ensure correct function.

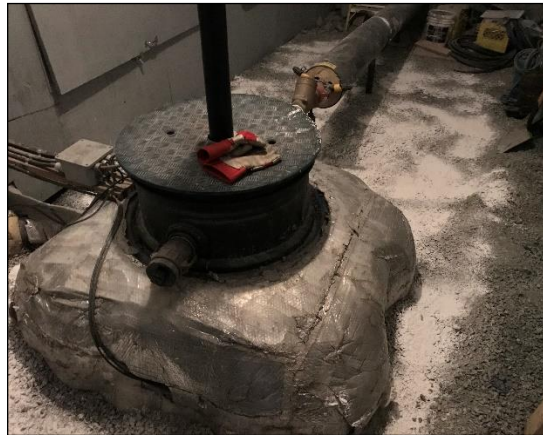
Figure 9. Area of contamination post cleanup.
