**Re: March 2019 – Monthly Monitoring Report for Water Licence 2AM-DOH1335**

This report is comprised of monitoring requirements as set out in Part I and Schedule I of water licence 2AM-DOH1335 Amendment 2, and additional requirements from CIRNAC.

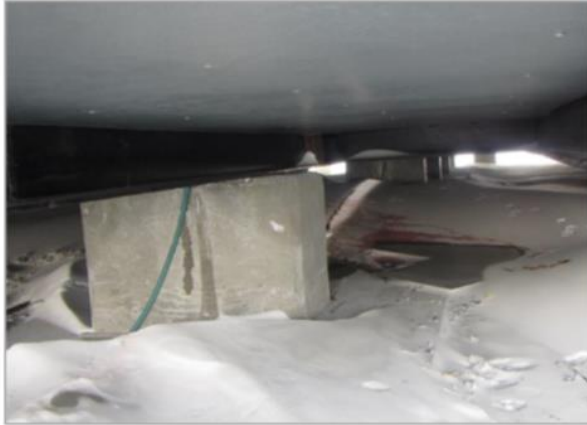
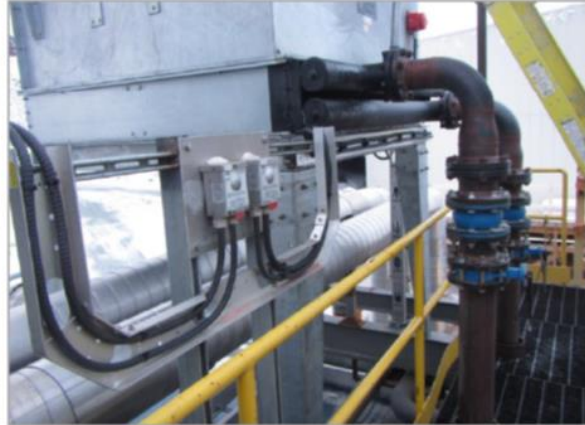
Pre-clean up

Spill #19-101 – On March 10, 2019, a powerhouse operator identified ethylene glycol coolant on the ground beneath one of the powerhouse generator modules while conducting the daily morning inspection. Glycol was found to be leaking out of the radiator cap on the top of the cooling system. The fluid leaked onto the roof of the generator module and some of the coolant flowed over the side of the building onto the crush pad and concrete foundation below.

Failed head gaskets on two of the cylinders had caused oil to pressurize the glycol cooling system. Pressure and volume increased until glycol leaked out of the radiator cap at the top of the system.

The generator was immediately shut down to prevent further release. Absorbent pads were used to clean glycol off the generator module to reduce the amount of spill contacting the ground surface. Contaminated materials were removed from the surface of the pad (spill pads, snow and crush) and taken to the waste management facility to be stored for offsite disposal. A small amount of coolant (estimated to be less than 1L) was inaccessible to the clean-up efforts. This material was located under a sheet of stainless steel that was buried under snow and ice. Figure 3 below shows the area pre- and post-cleanup.

The following preventative actions were identified in order to reduce the likelihood of a reoccurrence:

- Continue performing walk around checks twice daily on all generator components to identify potential issues; and
- Continue performing preventative maintenance programs on all generators at the recommended interval (every 500 operating hours).

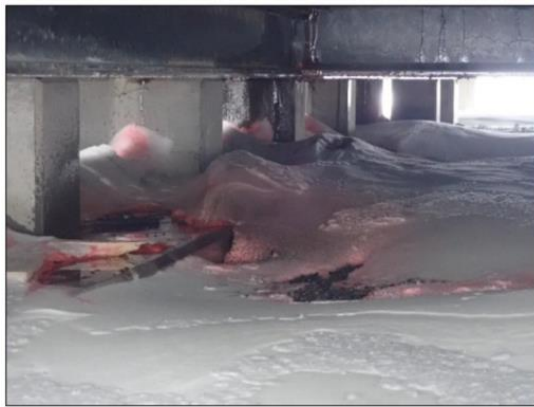
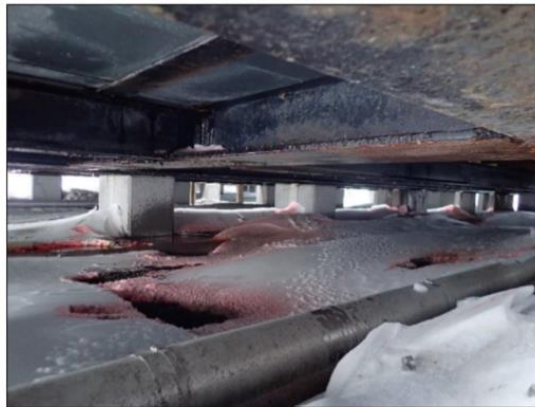
Pre-clean up

Spill #19-132 - On March 26, 2019, the powerhouse operator responded to an alarm within the powerhouse. It was discovered that generator #5 engine had experienced a catastrophic failure and released oil and glycol on to the deck of the generator module. The ethylene glycol coolant was dripping from the deck of the module and onto the crush pad and concrete foundation below the module.

Absorbent pads were used to contain and absorb the dripping and pooling glycol underneath the module. Contaminated materials were removed from the surface of the

The following preventative actions were identified in order to reduce the likelihood of a reoccurrence:

- Continue performing walk around checks twice daily on all generator components to identify potential issues;
- Continue performing preventative maintenance programs on all generators at the recommended interval (every 500 operating hours);
- Prior to placement of a replacement generator, the floor of the module will be inspected and any holes caused by the incident will be repaired; and
- A solution to seal the seams of each generator module enclosure is being investigated in order to contain any spills inside the module from reaching the crush pad and concrete foundation.

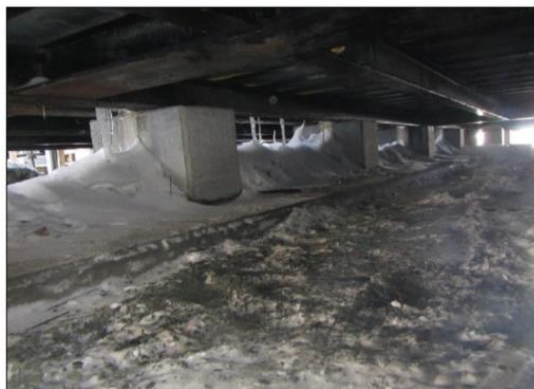
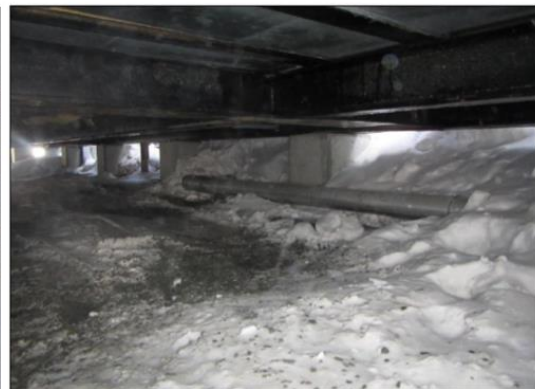
Post-clean up

pad (spill pads, snow and crush) and taken to the waste management facility to be stored for offsite disposal. Figure 4 below shows the spill location prior to and after clean-up.
