Re: April 2019 – Monthly Monitoring Report for Water Licence 2AM-DOH1335

This report is comprised of monitoring requirements as set out in Part I and Schedule I of water licence 2AM-DOH1335 Amendment 2, and additional requirements from CIRNAC.

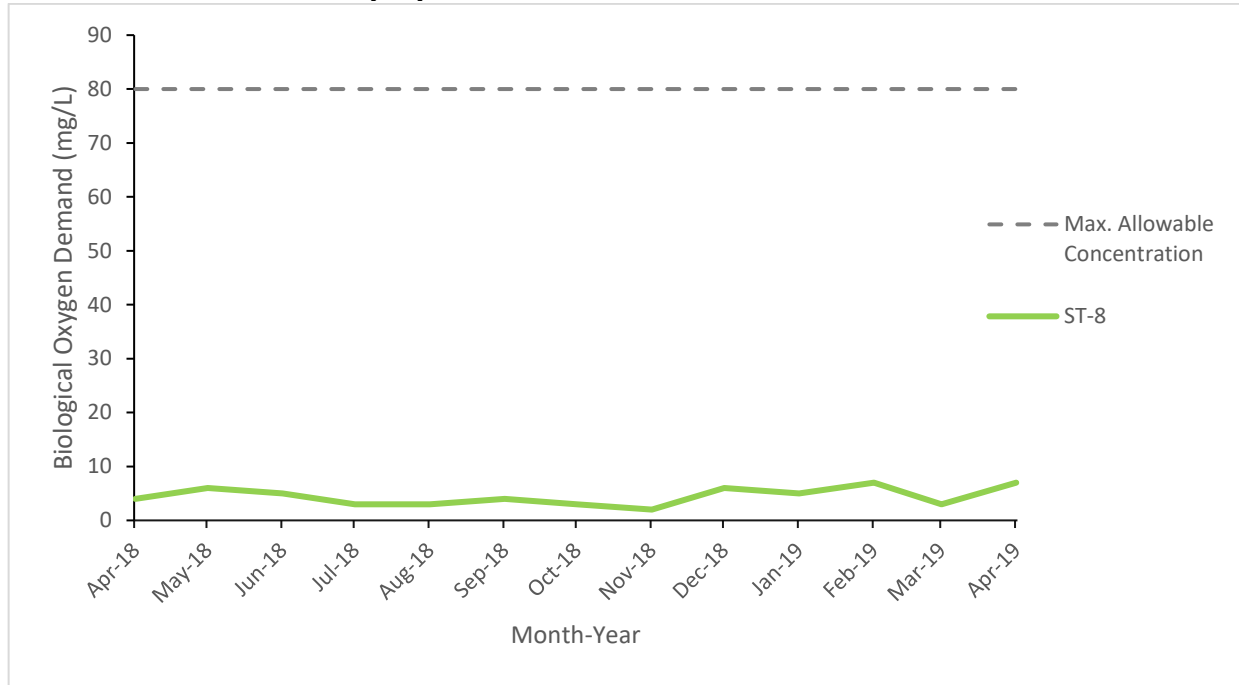
Figure 1. Biological Oxygen Demand Results Consistently Below Discharge Criteria for Wastewater Treatment Plant (ST8)

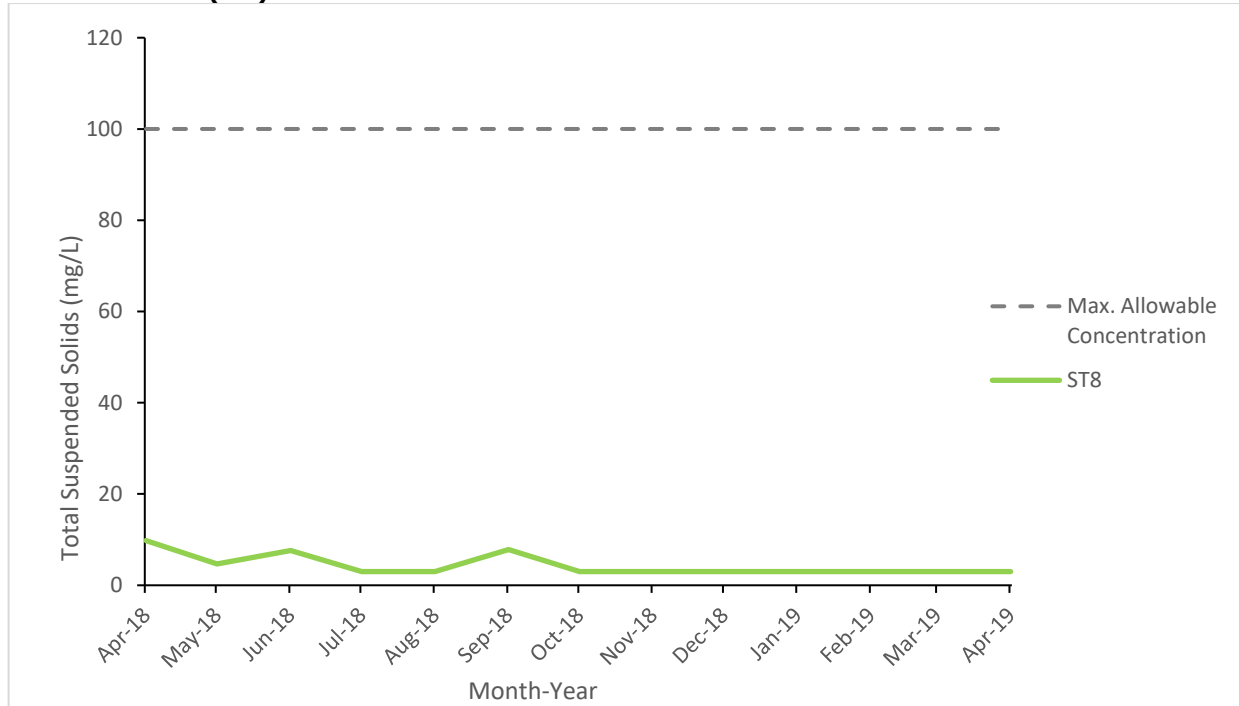
Figure 2. Total Suspended Solids Results Consistently Below Discharge Criteria for Wastewater Treatment Plant (ST8)

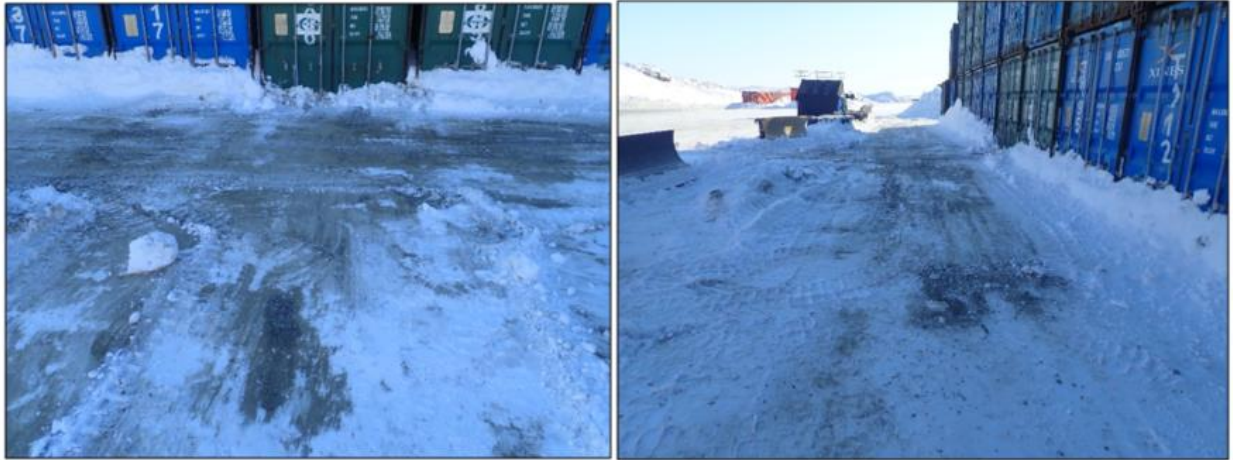
Figure 3. Spill #19-165 Pre- and Post-Cleanup

Spill #19-165 – On April 21, 2019, an employee was attempting to remove a mega-bag of cement mix out of a sea-can with a telehandler. While removing the mega-bag, it caught a sharp edge on the inside of the sea-can. As a result, approximately 375kg of the mega-bag spilled onto the ground in front of the sea-can. The majority of the contents remained contained within the mega-bag.

Spill location pre-cleanup

The cement bag was placed into another sea-can while the hole was being repaired and the area being cleared. Contaminated snow was removed with shovels and a Bobcat, placed into another mega-bag, and taken to the Tailings Impoundment Area for disposal. Figure 3 below shows the area pre- and post-cleanup.

- A spotter must be used for accessing and replacing material in sea-cans;
- Spotter and operator will properly assess challenges of area prior to making pick. During this time, they will also discuss the signal language to be used that will allow them to best support the move.

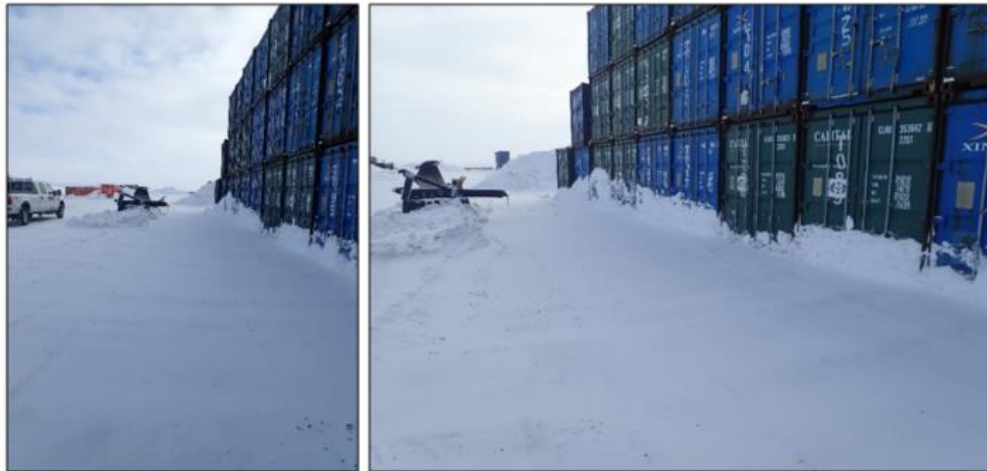
Spill location post-cleanup

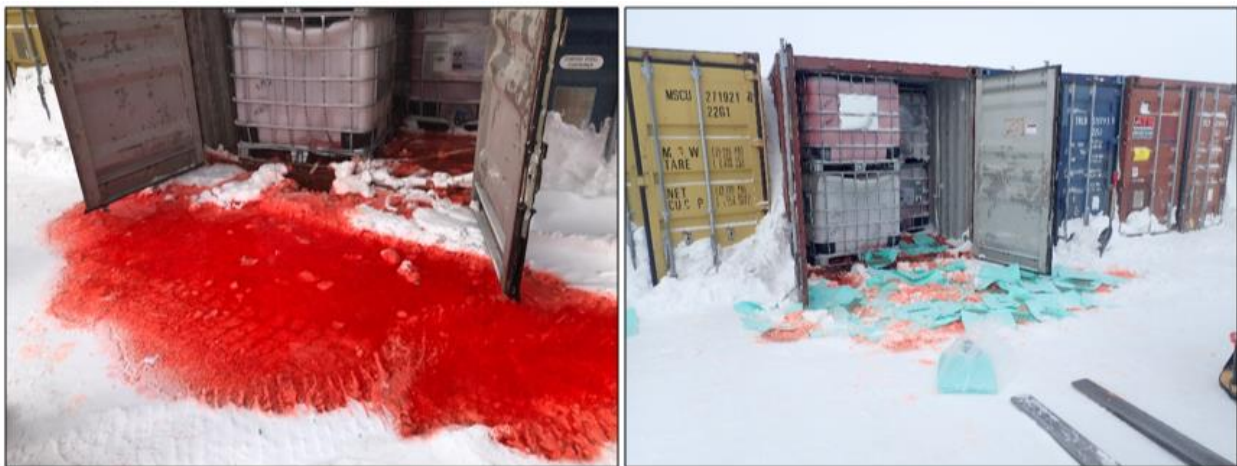
Figure 4. Spill #19-165 Pre- and Post-Cleanup

Spill #19-177 - On April 26, 2019, an employee was attempting to remove a plastic tote of ethylene glycol 60-40 coolant from a sea-can with a telehandler. While loading the tote, the forks of the telehandler shifted and punctured the tote. Approximately 950L of coolant was released into the sea-can and onto the camp pad in front of the sea-can doors.

Spill location pre-cleanup

Spill pads were placed to absorb spilled coolant. Contaminated snow was removed by hand and with equipment. This included material that migrated beneath the sea-cans. The sea-cans were moved and the contaminated material was excavated from the camp pad surface. Contaminated material was placed into drums and taken to the waste management facility to be stored for offsite disposal.

- A spotter must be used for accessing and replacing material in sea-cans.
- Spotter and operator will agree on a signal language to be used during pick.
- Spotter and operator will assess the material and the location for potential challenges associated with the pick. Challenges will be properly mitigated.
- The procedure for the unloading of totes will be thoroughly reviewed and gone over with the team members.

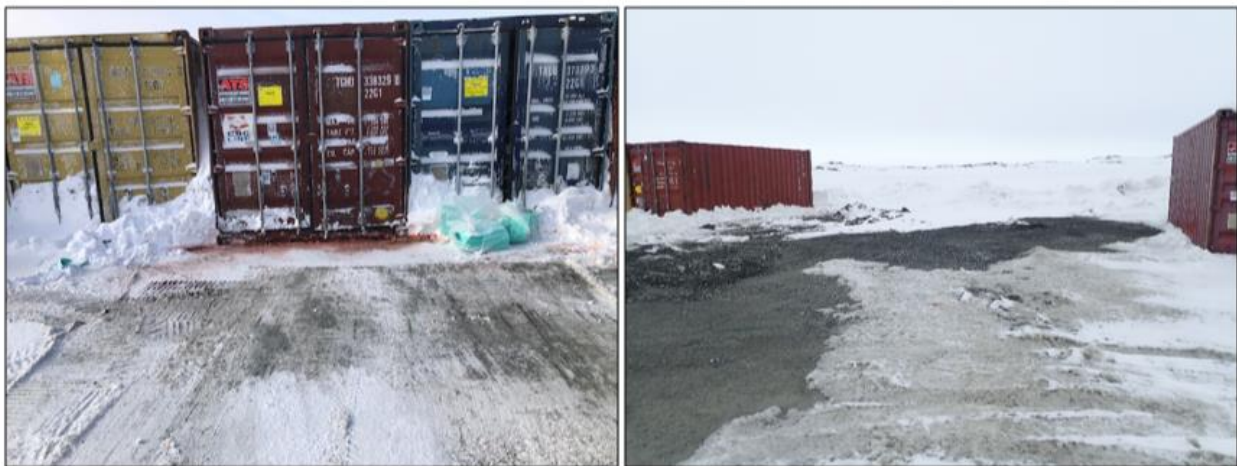
Spill location during clean up (left) and post-cleanup
