**Re: June 2019 – Monthly Monitoring Report for Water Licence 2AM-DOH1335**

This report is comprised of the monitoring requirements set out in Part I and Schedule I of water licence 2AM-DOH1335 Amendment 2, and additional requirements from CIRNAC.

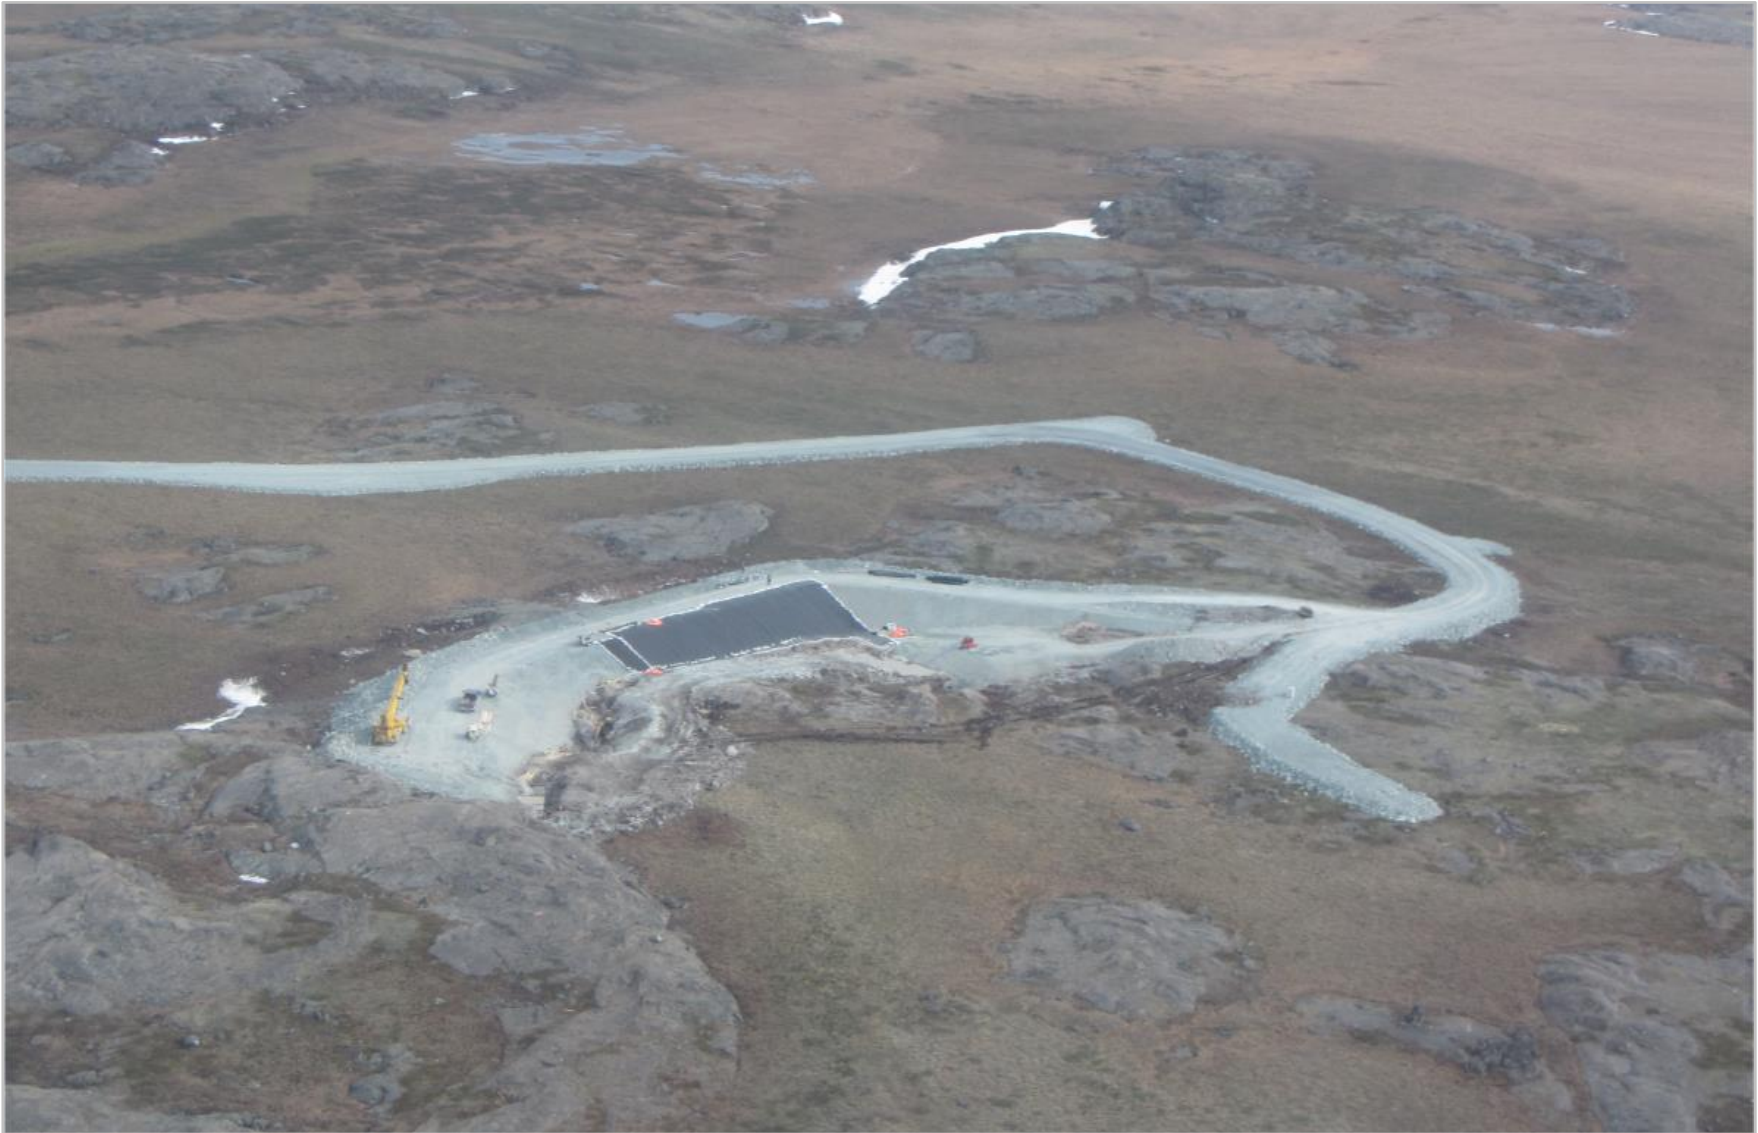
Construction of the first kilometer of the Madrid All-Weather Road was completed in June. Construction of the Madrid North Contact Water Pond (MMS-1) continued and overburden stripping of the Naartok East Crown Pillar Recovery Trench began under this licence in June. Figure 1 below shows progress of construction of the Madrid North Contact Water Pond. Figure 2 below shows progress of overburden stripping at the Naartok East Crown Pillar Recovery Trench. Monitoring locations associated with Madrid infrastructure (MMS) will be established with the Inspector as per Part I Item 3 as construction of Madrid facilities are completed.

**Figure 1. Construction Progress of Madrid North Contact Water Pond (MMS-1), June 2019**

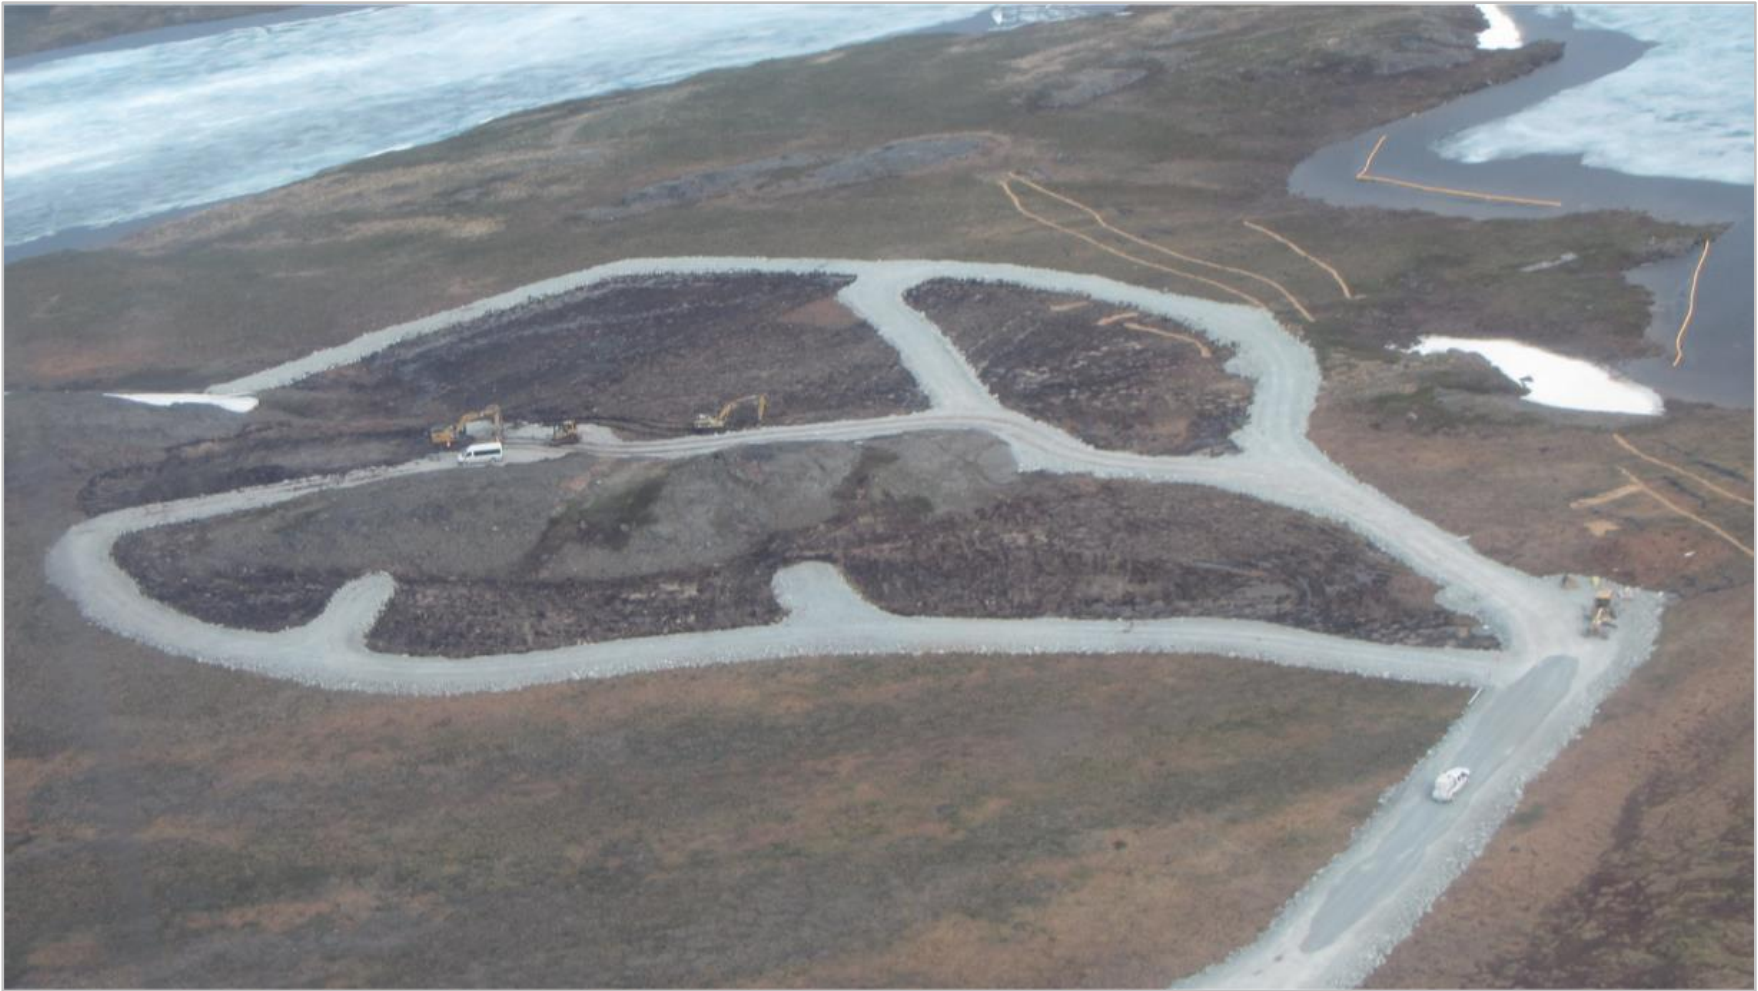
**Figure 2. Overburden Stripping at Naartok East Crown Pillar Recovery Trench, June 2019**

Sampling of surface runoff from the Madrid All-Weather Road, Madrid North Contact Water Pond and Naartok East Crown Pillar Recovery trench was completed in June (total of six locations). One sample (MMS9-C) collected from runoff at the Naartok East Crown Pillar trench on June 15 exceeded the allowable *Maximum Concentration of Any Grab Sample* for Total Suspended Solids identified in Part D Item 9 of the licence; all other samples were below this criteria and there was no exceedance of the *Maximum Average Concentration* for these samples.

In response to the high Total Suspended Solids and turbidity observed on June 15, additional silt fence and coco-matting were placed on the tundra downstream of the runoff. A rock berm was also constructed to manage runoff from the construction area. An additional sample was collected on June 16 and was below the *Maximum*

*Concentration of Any Grab Sample* for Total Suspended Solids demonstrating that sediment control barriers were effective.

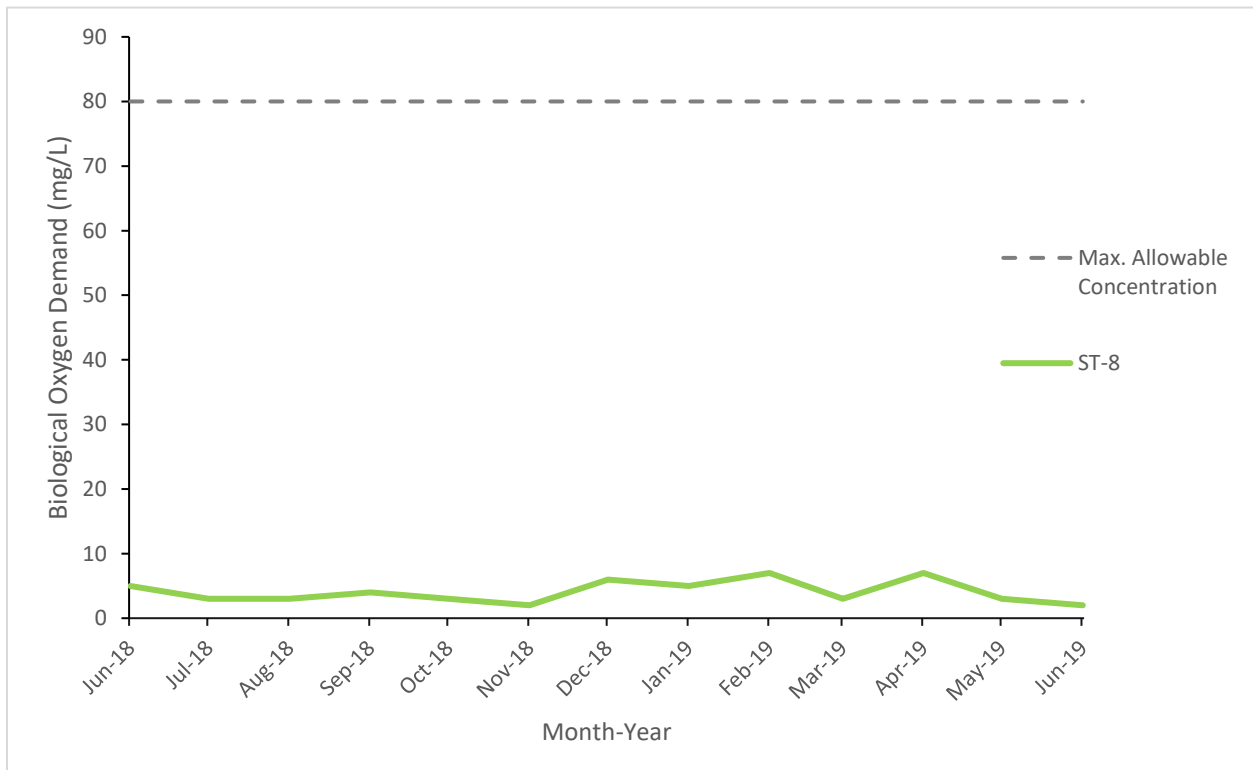
**Figure 3. Biological Oxygen Demand Results Consistently Below Discharge Criteria for Wastewater Treatment Plant (ST8)**

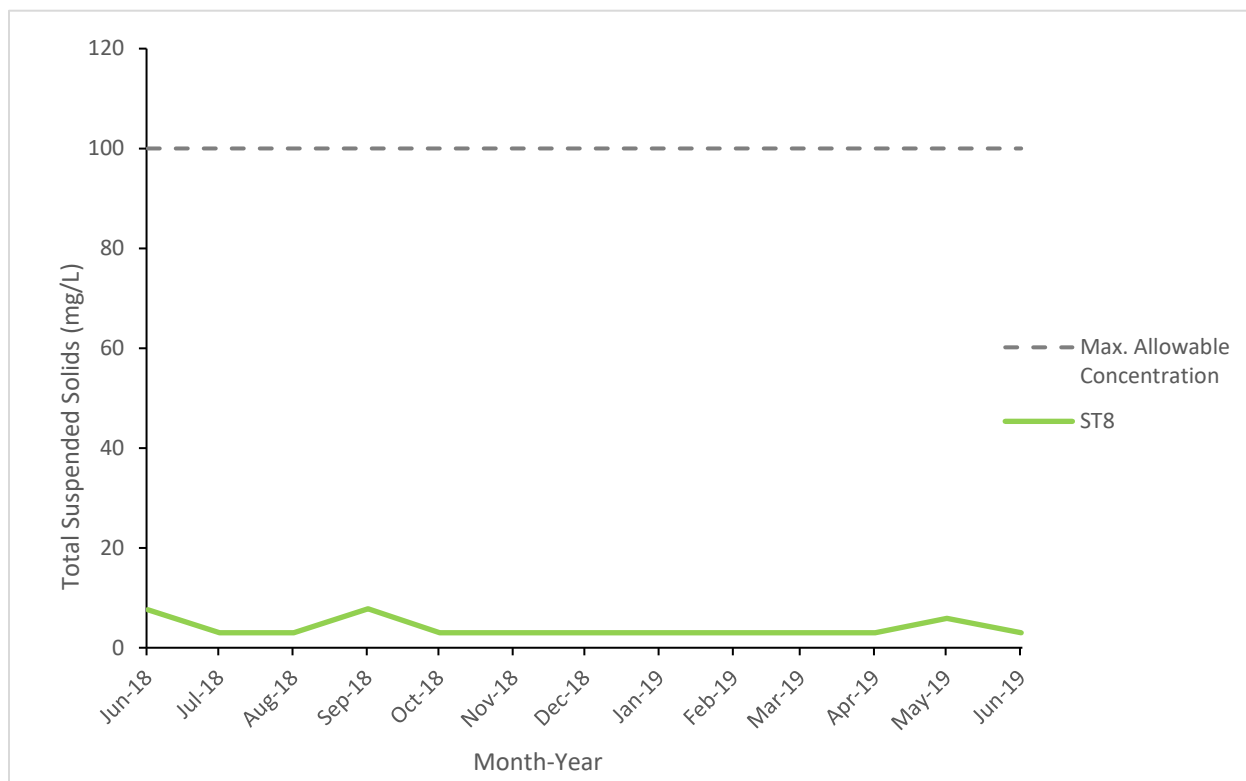
**Figure 4. Total Suspended Solids Results Consistently Below Discharge Criteria for Wastewater Treatment Plant (ST8)**

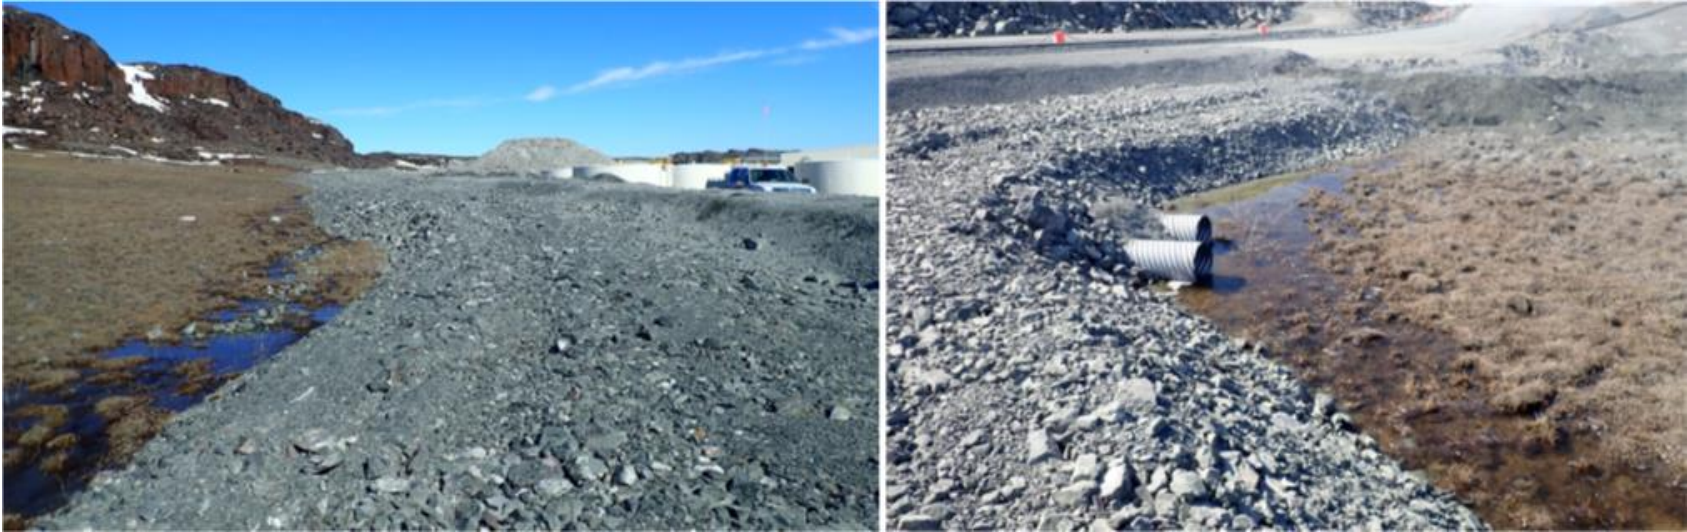
The Diversion Berm and associated check dam were observed to be functioning as designed and diverting non-contact water around the Doris site infrastructure. The maximum flow observed during June was 0.6 m/s on June 13. Some turbidity was identified prior to the check dam in flow observed on June 13, however the check dam reduced flow and eliminated turbidity in downstream flow. Photos of this infrastructure are provided in Figures 5 and 6 below.

**Figure 5. Diversion berm directing non-contact water (left) towards culverts (right)**

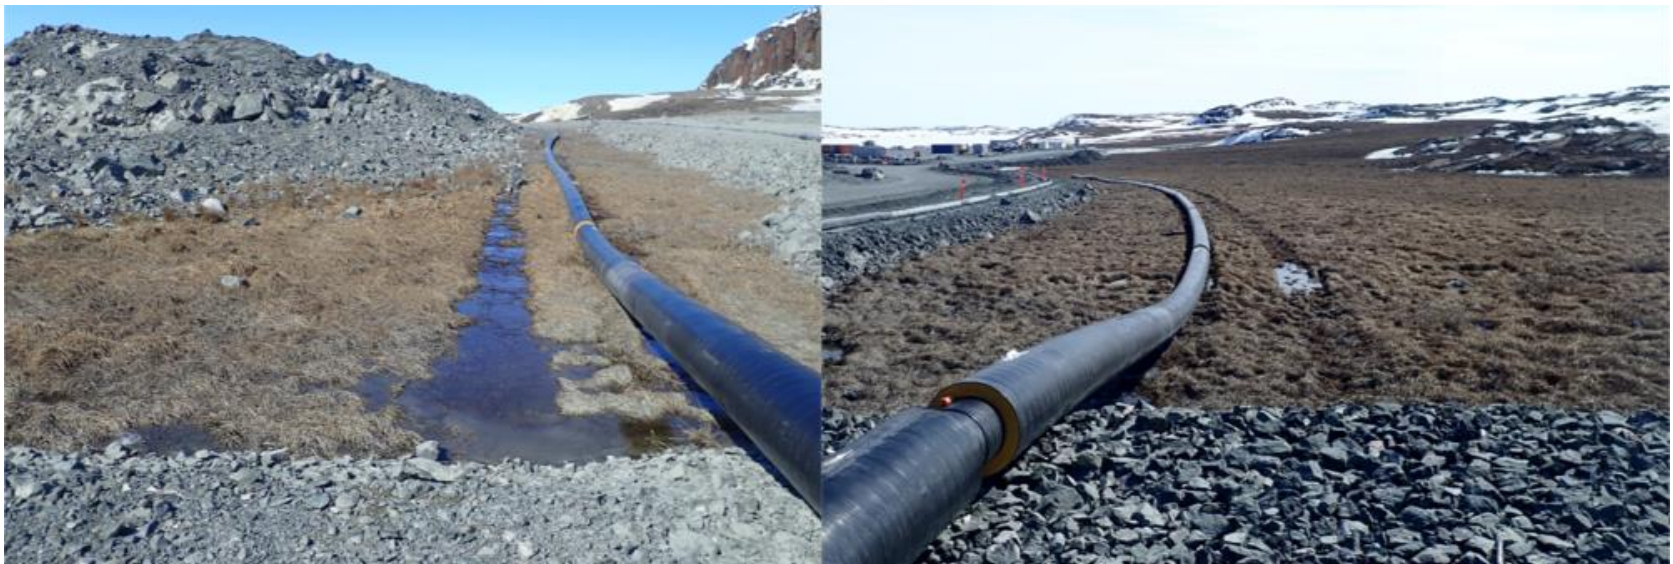
**Figure 6. Check dam upstream (left) and downstream (right). Check dam effective in slowing runoff and eliminating turbidity**

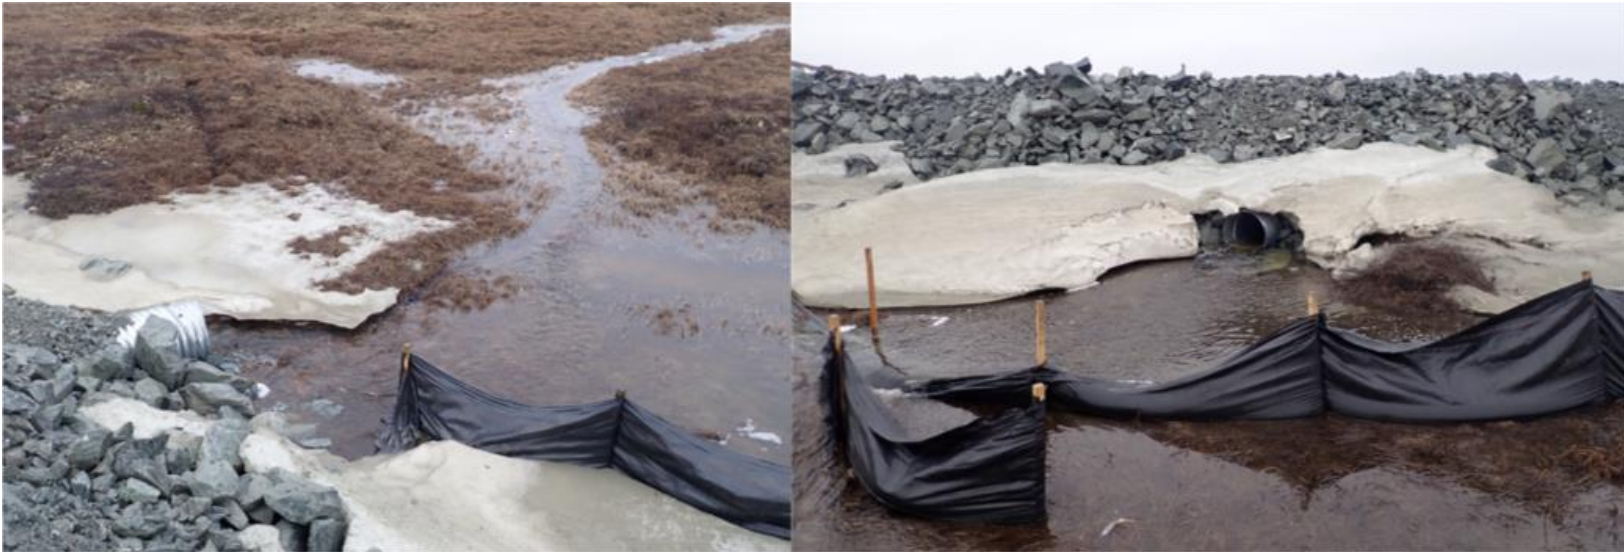
Inspections were completed of site culverts throughout the month of June. No issues were identified with these water management structures. Figure 7 and 8 below shows the upstream and downstream conditions of culverts located at the Doris Connector Vent Raise access road and the Madrid All-Weather road.

**Figure 7. Culvert at Doris Connector Vent Raise access road upstream (left) and downstream (right)**

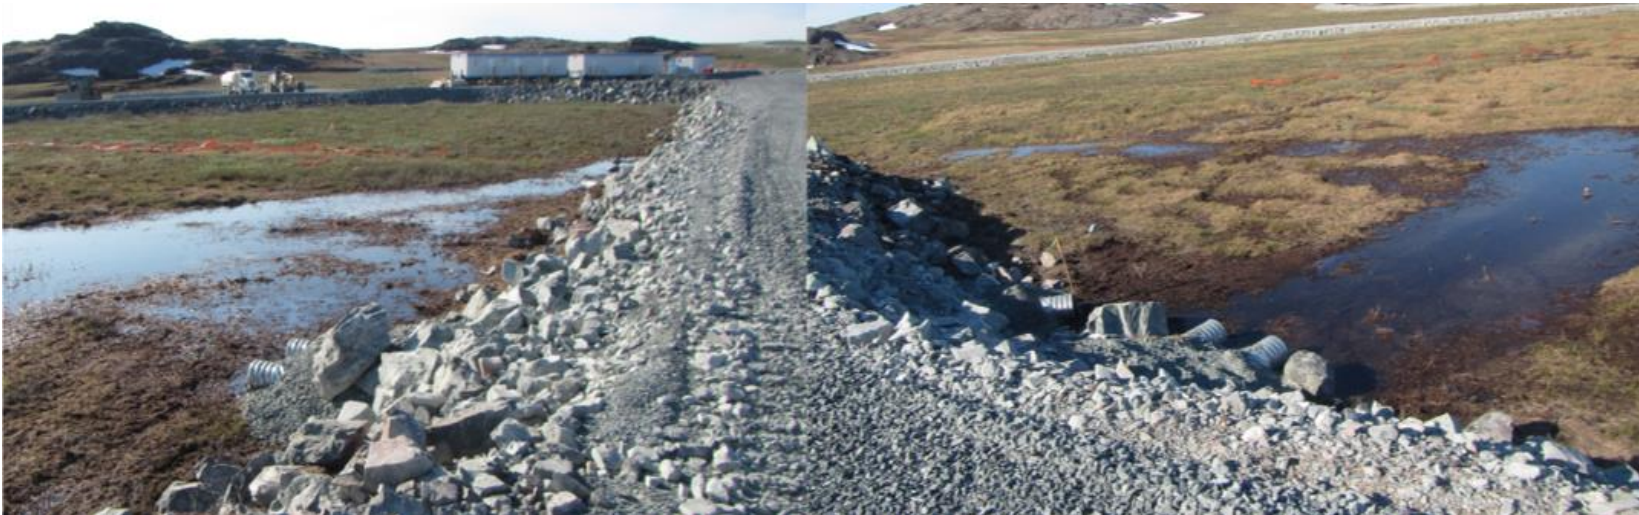
**Figure 8. Culvert at Madrid All-Weather Road upstream (left) and downstream (right)**
