**Re: July 2019 – Monthly Monitoring Report for Water Licence 2AM-DOH1335**

This report is comprised of the monitoring requirements set out in Part I and Schedule I of water licence 2AM-DOH1335 Amendment 2, and additional requirements from CIRNAC.

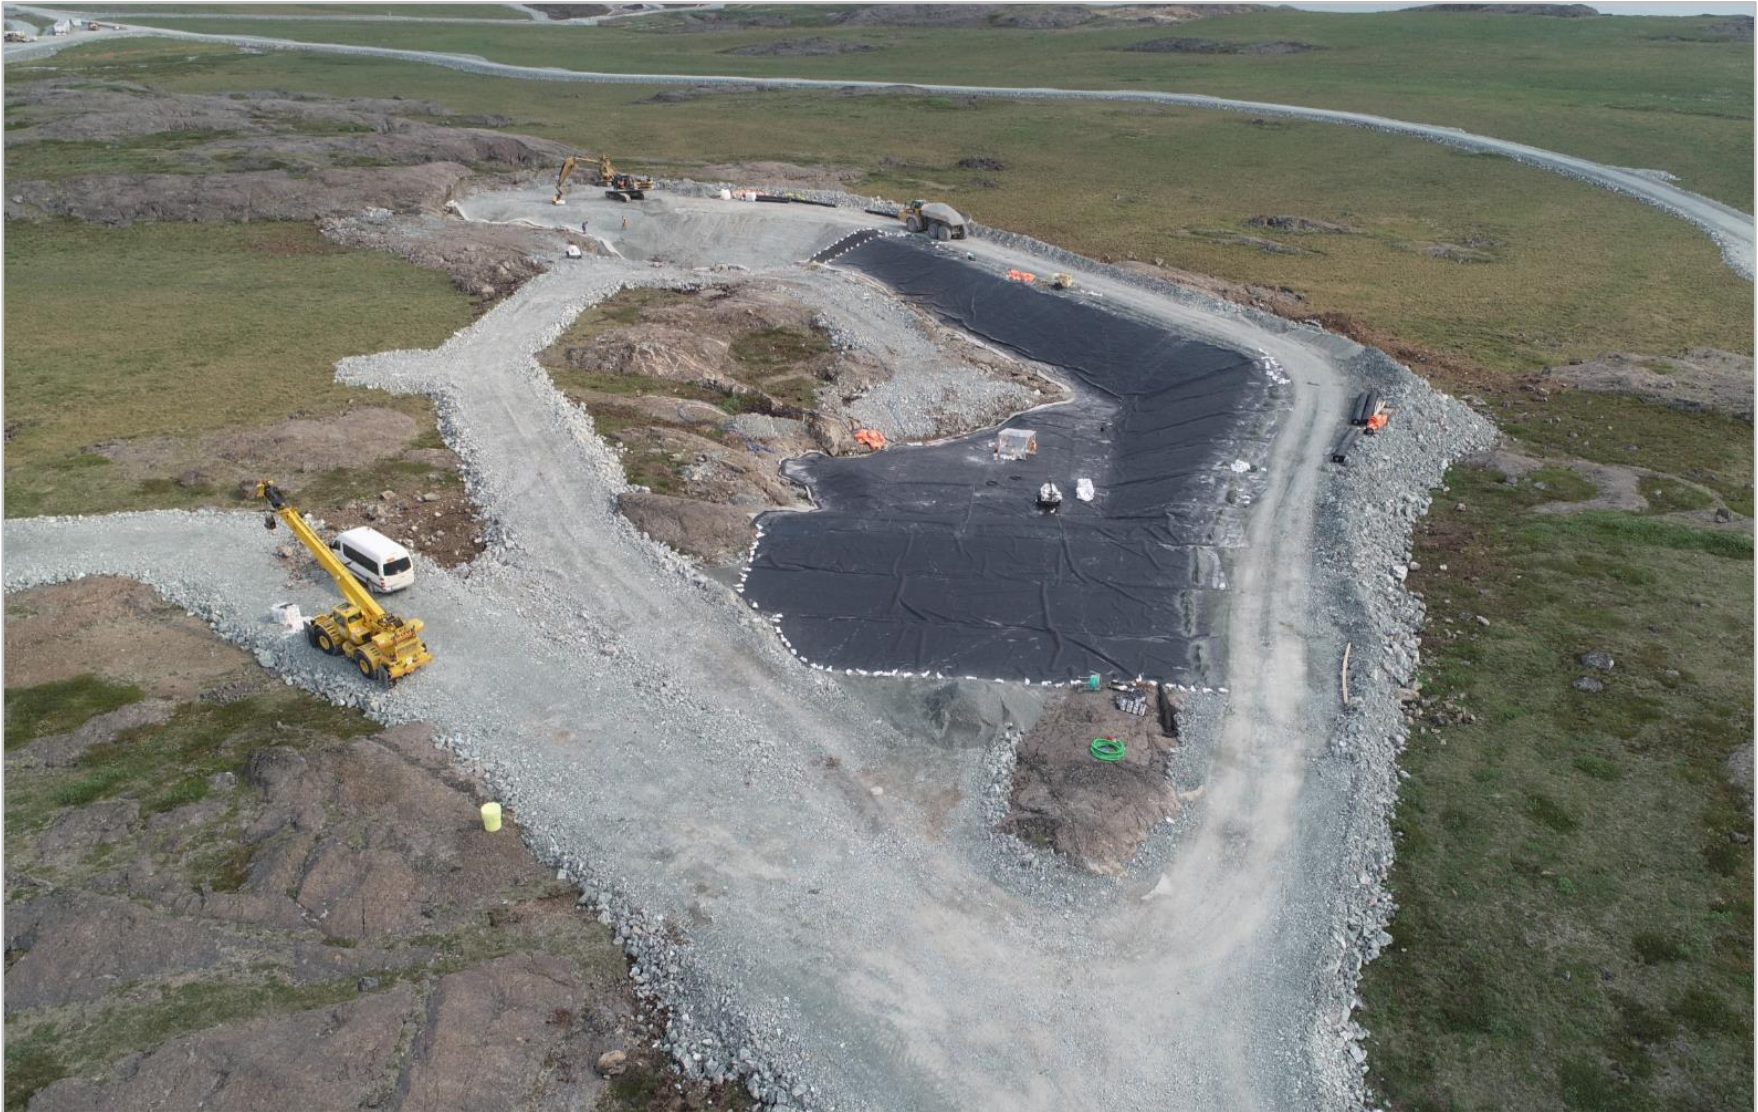
Construction of the Madrid North Contact Water Pond (MMS-1) and overburden stripping of the Naartok East Crown Pillar Recovery Trench continued under this licence in July. Drill and blast activities began in the Naartok East Crown Pillar Recovery Trench this month. Figure 1 below shows progress of construction of the Madrid North Contact Water Pond. Figure 2 below shows progress of overburden stripping at the Naartok East Crown Pillar Recovery Trench. Monitoring locations associated with Madrid infrastructure (MMS) will be established with the Inspector as per Part I Item 3 as construction of Madrid facilities are completed.

**Figure 1. Construction Progress of Madrid North Contact Water Pond (MMS-1), July 2019**

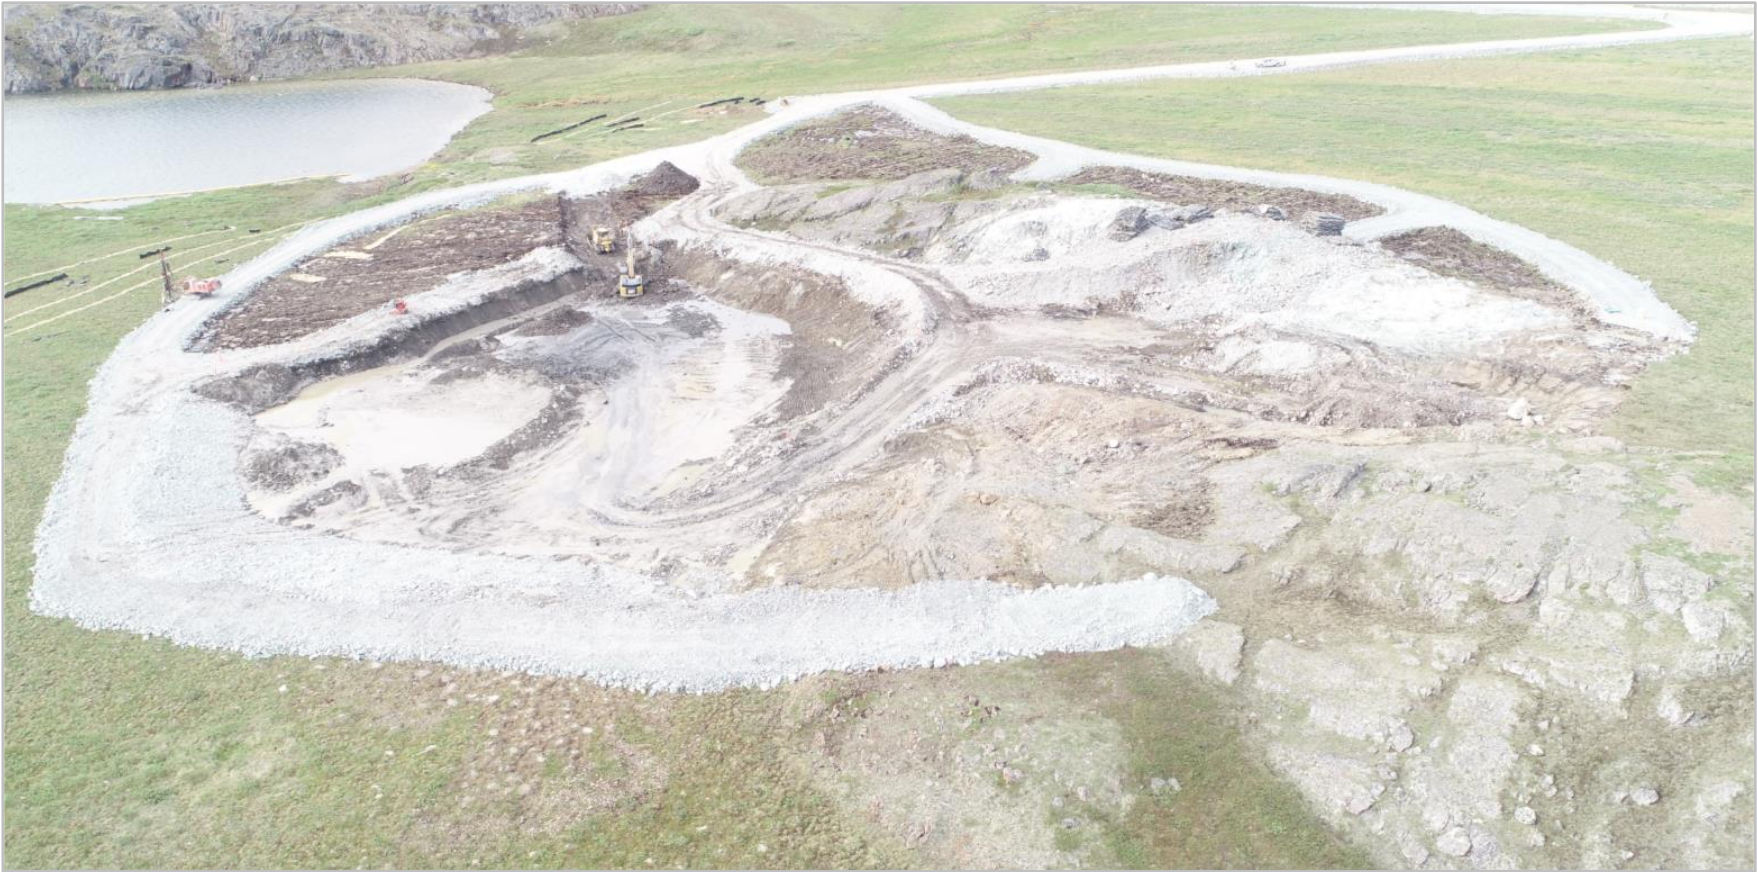
**Figure 2. Overburden Stripping at Naartok East Crown Pillar Recovery Trench, July 2019**

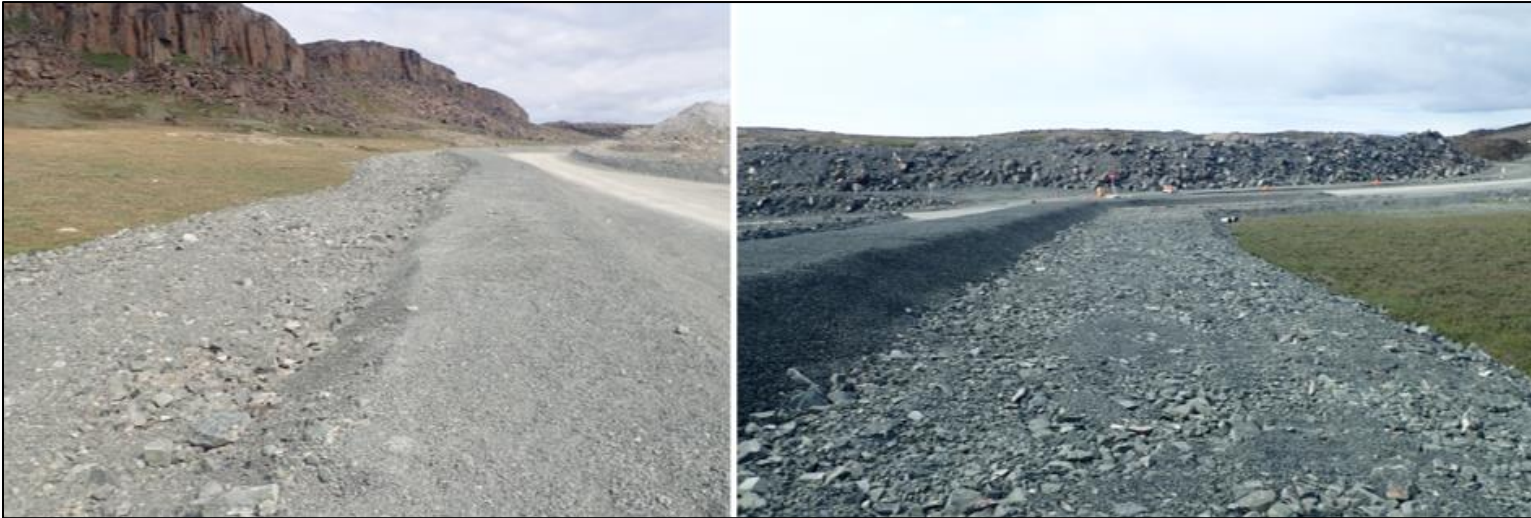
The Diversion Berm and associated check dam were observed to be functioning as designed and diverting non-contact water around the Doris site infrastructure. The maximum flow observed during July was 0.282 m/s on July 11. Photos of this infrastructure are provided in Figures 5 and 6 below.

**Figure 5. Diversion berm dry during July (left) towards culverts (right)**

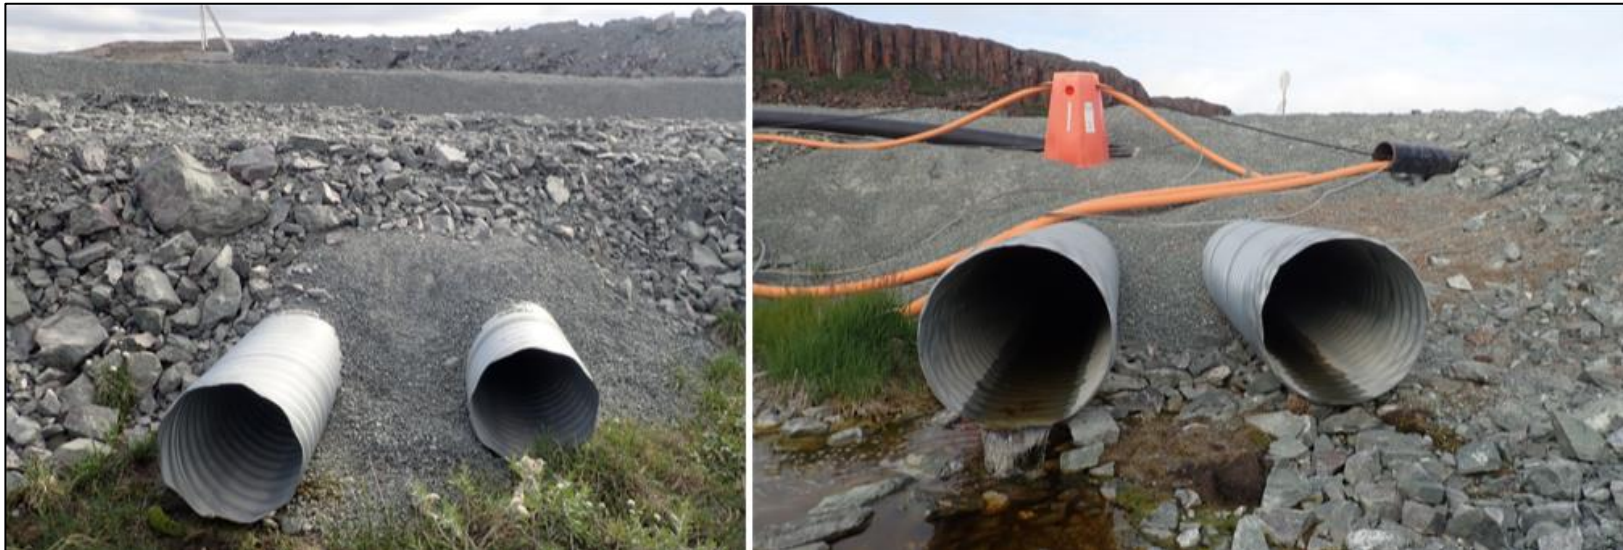
**Figure 6. Diversion Berm culverts. Reduced flow observed in July compared to June**

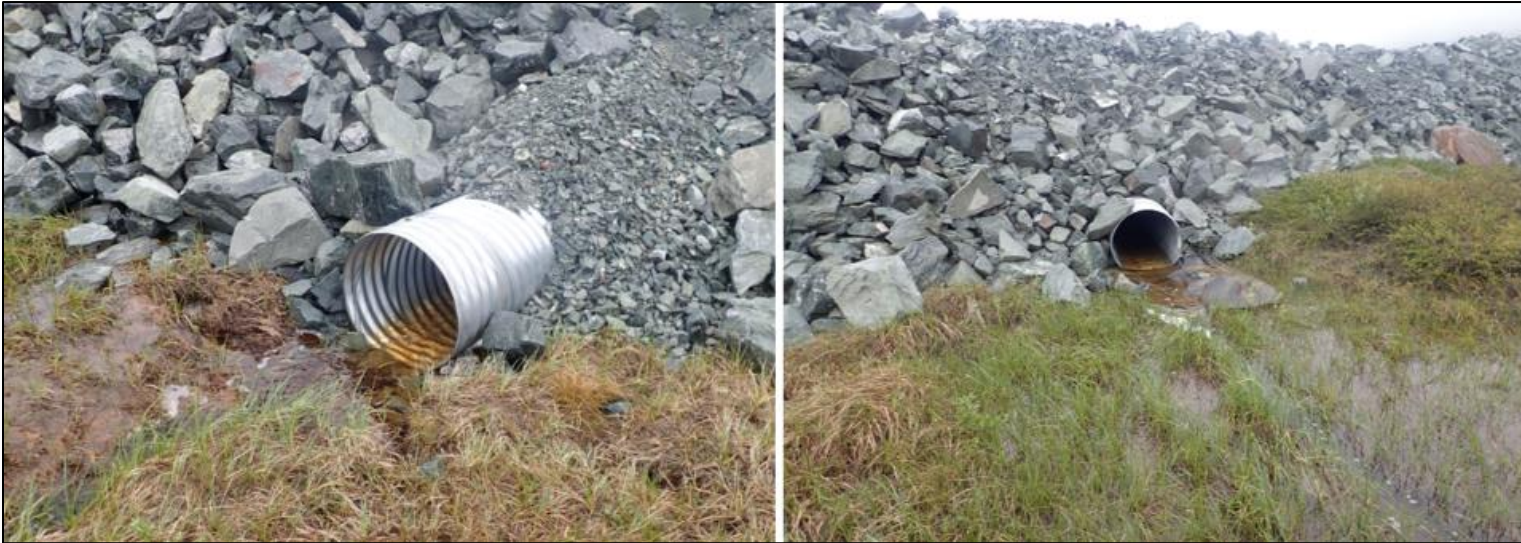
Inspections were completed of site culverts throughout the month of June. No issues were identified with these water management structures. Figure 7 and 8 below shows the upstream and downstream conditions of culverts located at the Doris Connector Vent Raise access road and the Madrid All-Weather road.

**Figure 7. Culvert at Doris Connector Vent Raise access road upstream (left) and downstream (right)**

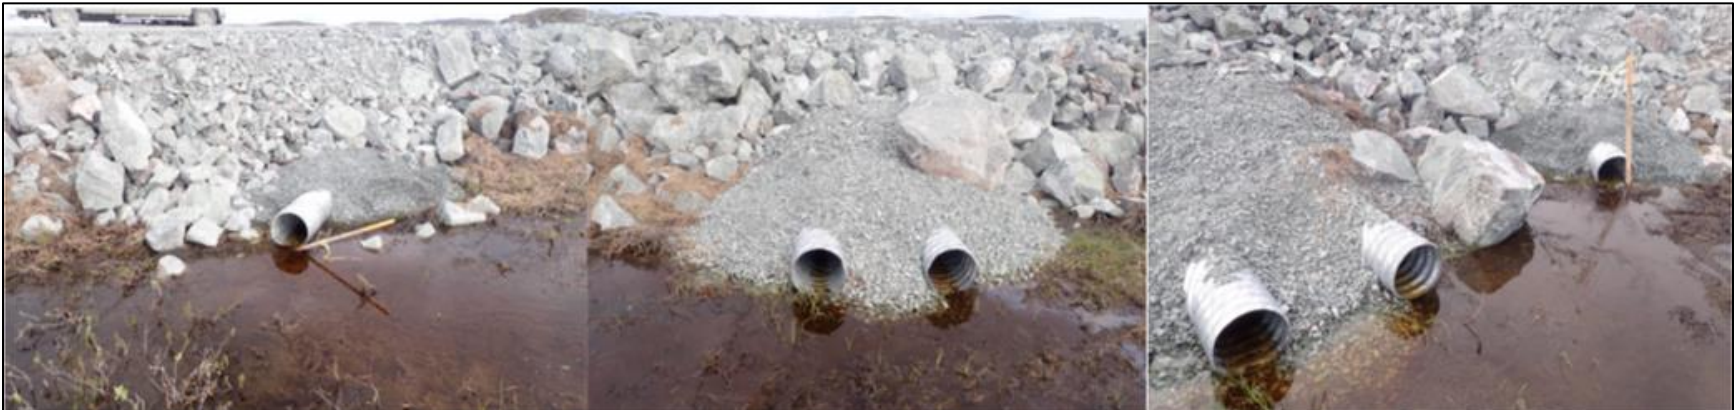
**Figure 8. Culvert at Madrid All-Weather Road upstream (left, middle) and downstream (right)**
