November 27, 2019

Re: October 2019 – Monthly Monitoring Report for Water Licence 2AM-DOH1335

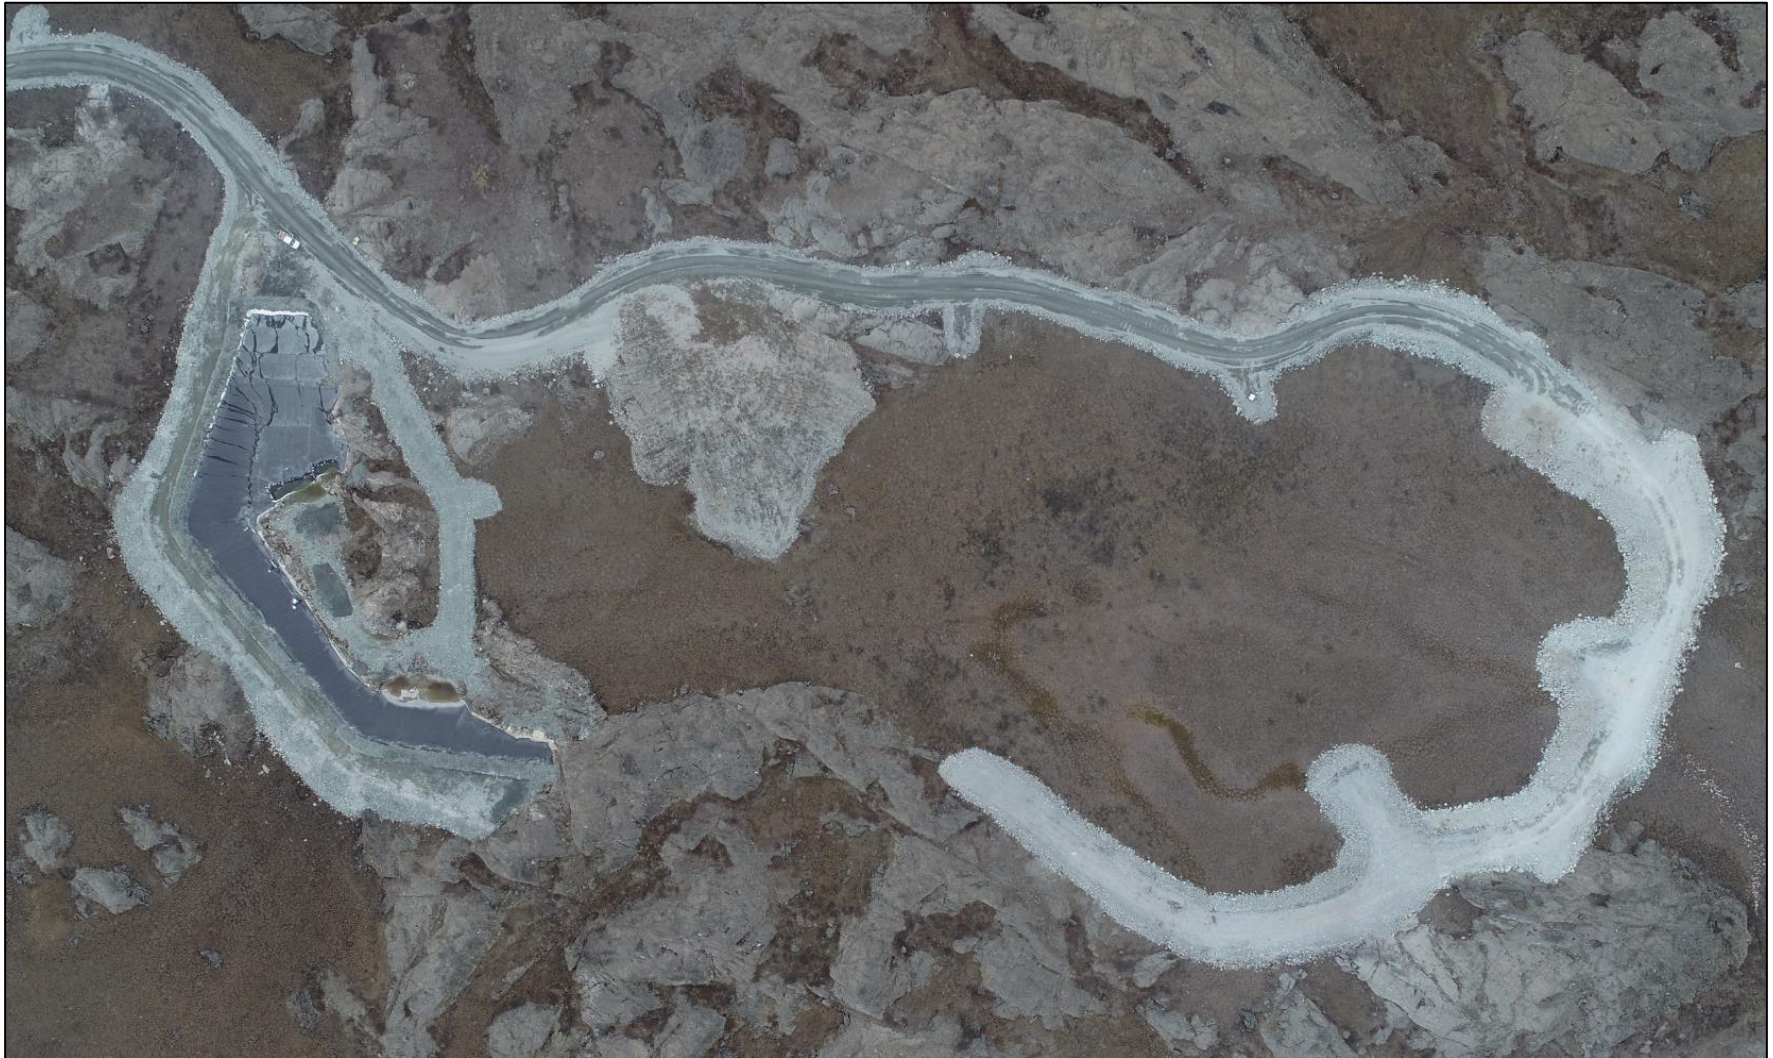
Construction of the Madrid North Portal laydowns and the Waste Rock Pile continued in October. Overburden stripping and blast activities continued in the Naartok East Crown Pillar Recovery Trench under this licence for the month. Figure 1 shows construction activities at the Madrid North Waste Rock Pile. Figure 2 shows progress of overburden stripping and mining activities at the Naartok East Crown Pillar Recovery Trench.

Figure 1. Madrid North Waste Rock Pile, October 2019

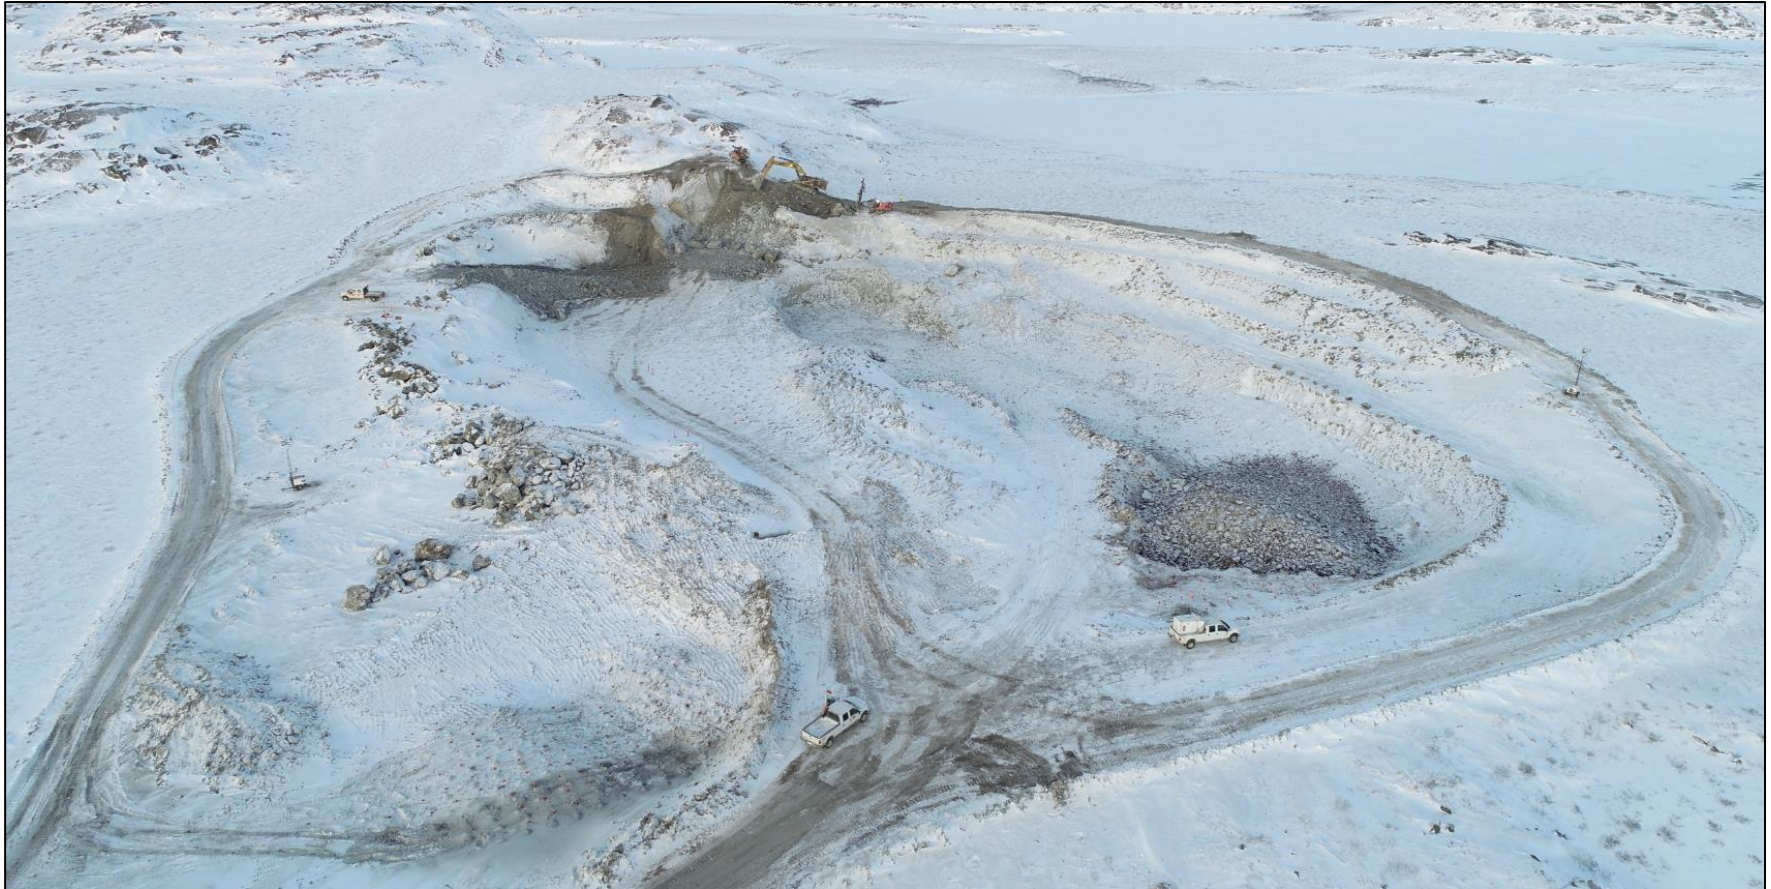
Figure 2. Naartok East Crown Pillar Recovery Trench, October 2019

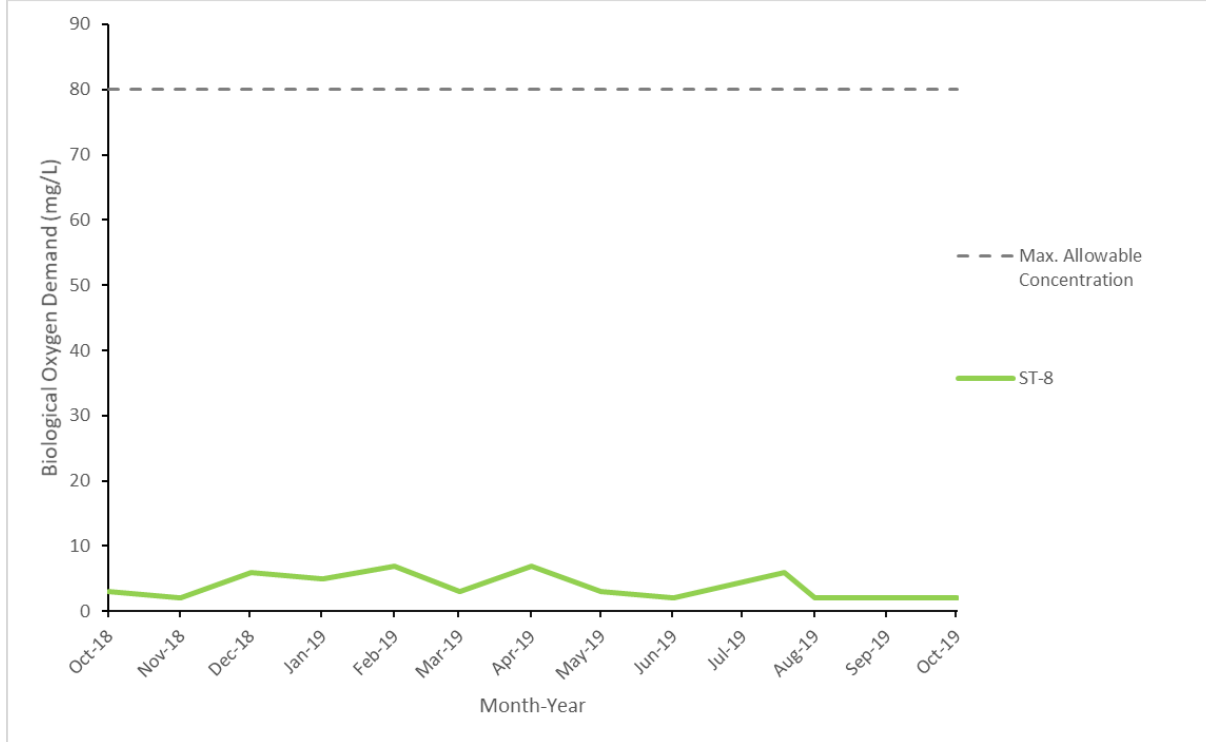
Figure 3. Biological Oxygen Demand Results Consistently Below Discharge Criteria for Wastewater Treatment Plant (ST8)

Note: Maximum Average Concentration as per Part F Item 4(b).

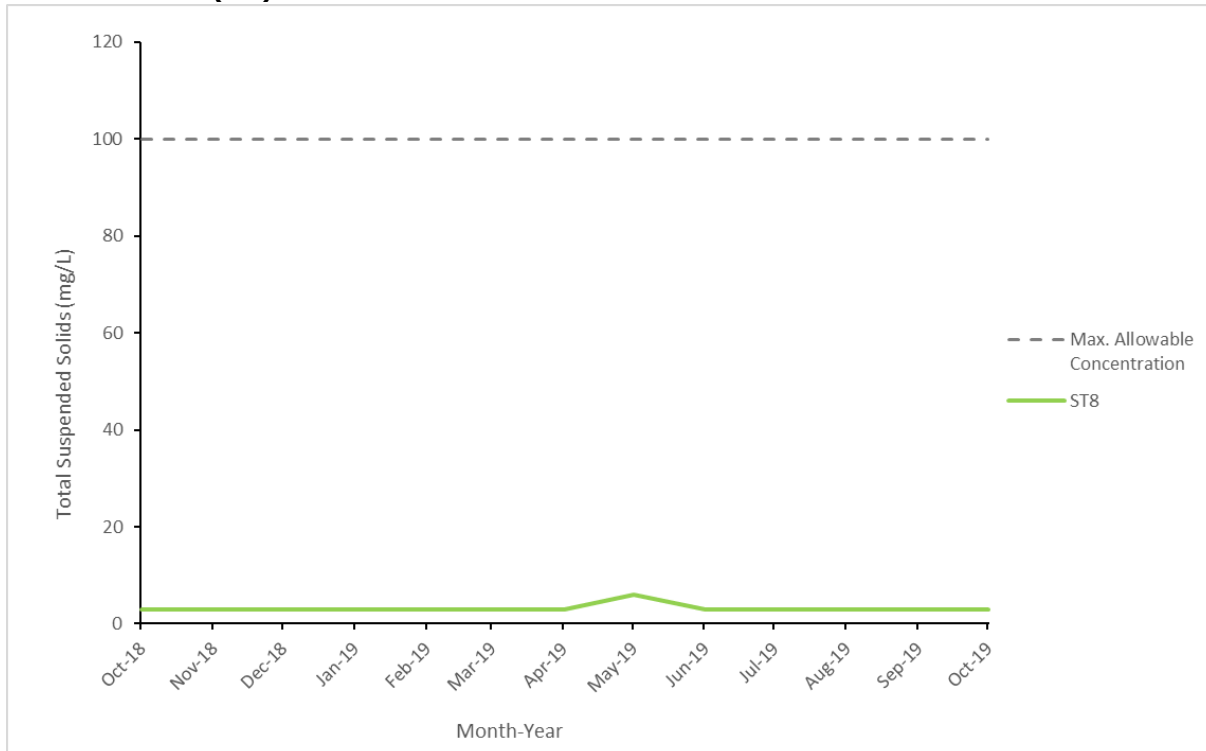
Figure 4. Total Suspended Solids Results Consistently Below Discharge Criteria for Wastewater Treatment Plant (ST8)

Note: Maximum Average Concentration as per Part F Item 4(b).

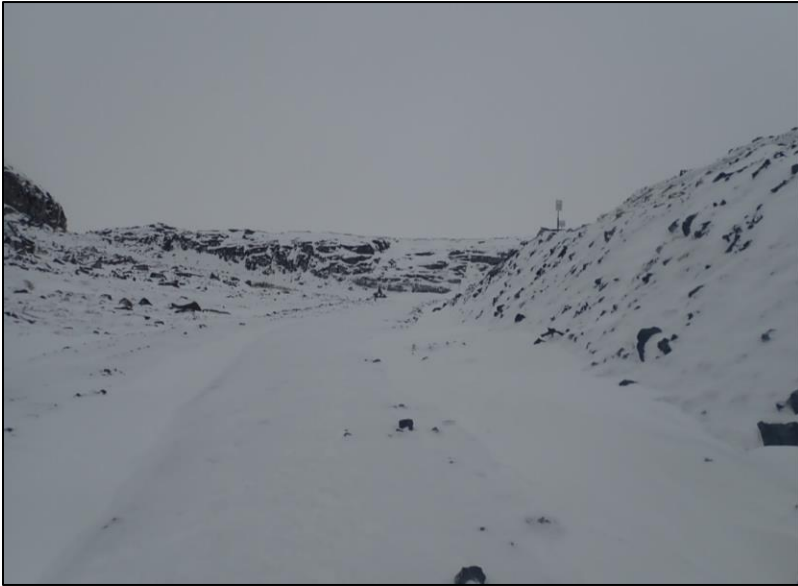
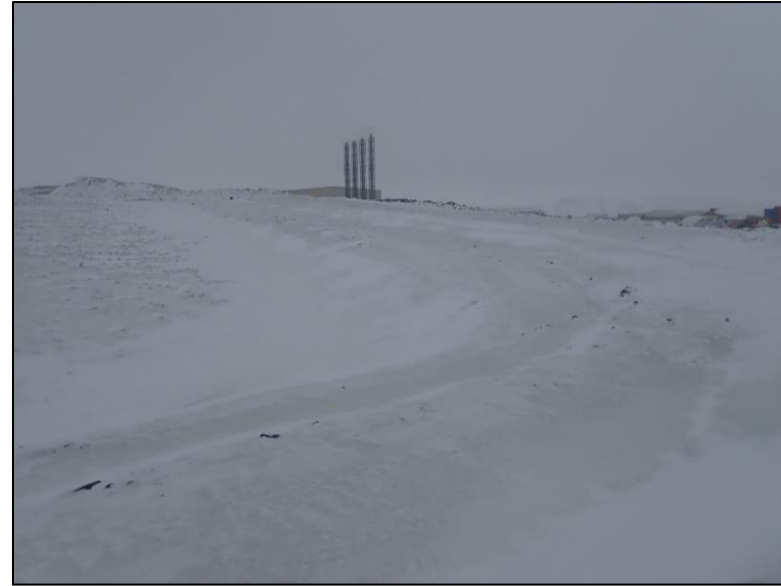
The Diversion Berm and associated check dam were observed to be functioning as designed and diverting non-contact water around the Doris site infrastructure. Photos of this infrastructure are provided in Figures 5 and 6 below.

Inspections were completed of site culverts throughout the month of October. No issues were identified with these water management structures as they were observed to be frozen due to the onset of winter.

Figure 5. Diversion berm dry during October (left) towards culverts (right)
