Re: November 2019 – Monthly Monitoring Report for Water Licence 2AM-DOH1335

This report is comprised of the monitoring requirements set out in Part I and Schedule I of water licence 2AM-DOH1335 Amendment 2 (the licence), and additional requirements from CIRNAC.

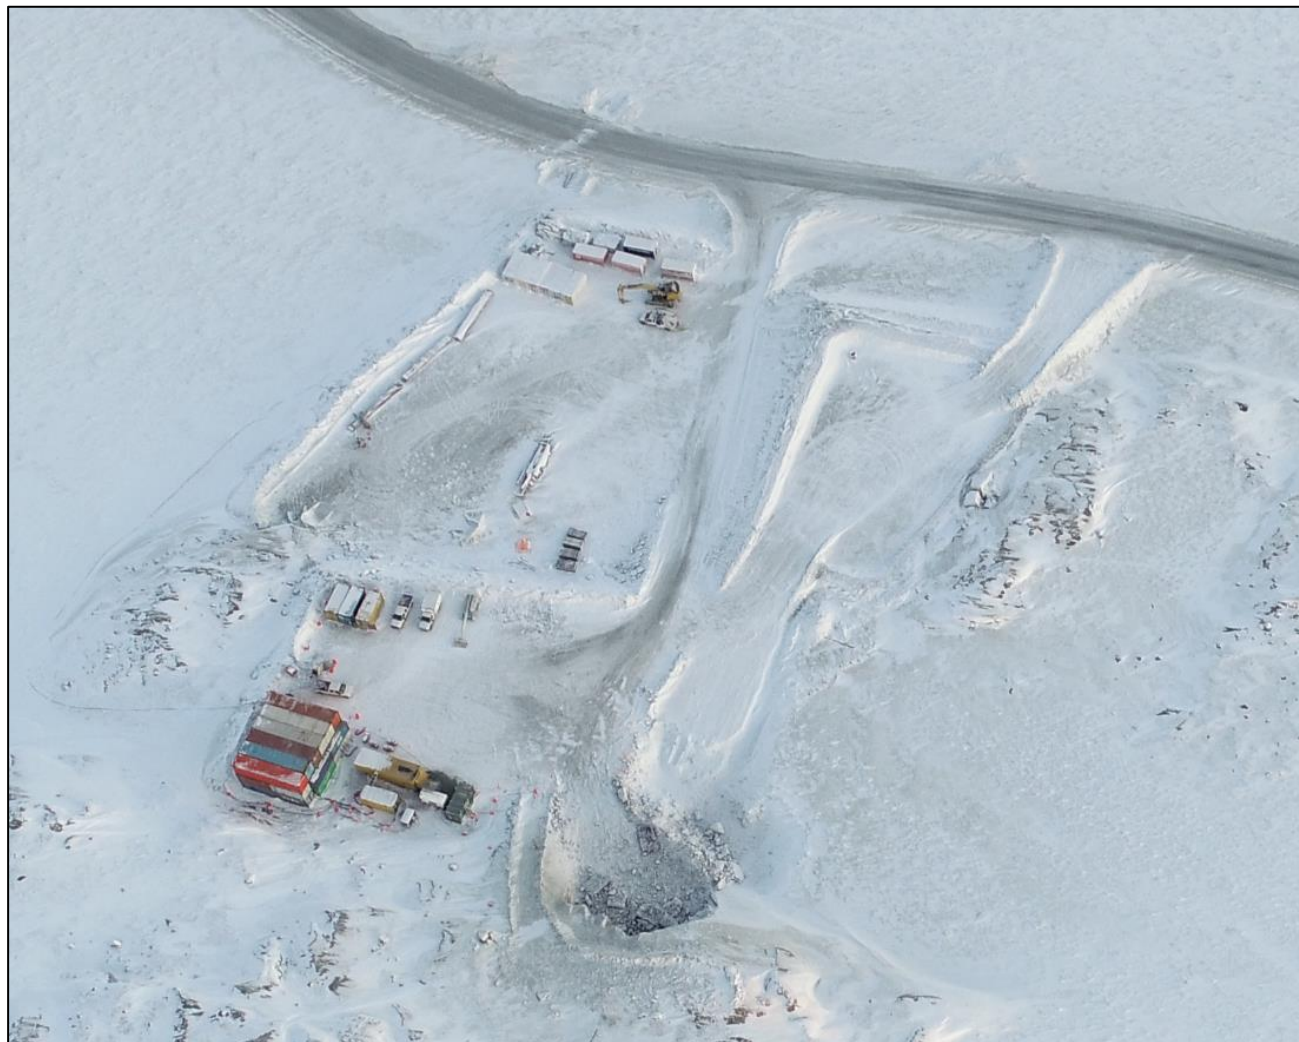
Figure 1. Madrid North Portal Laydown, November 2019

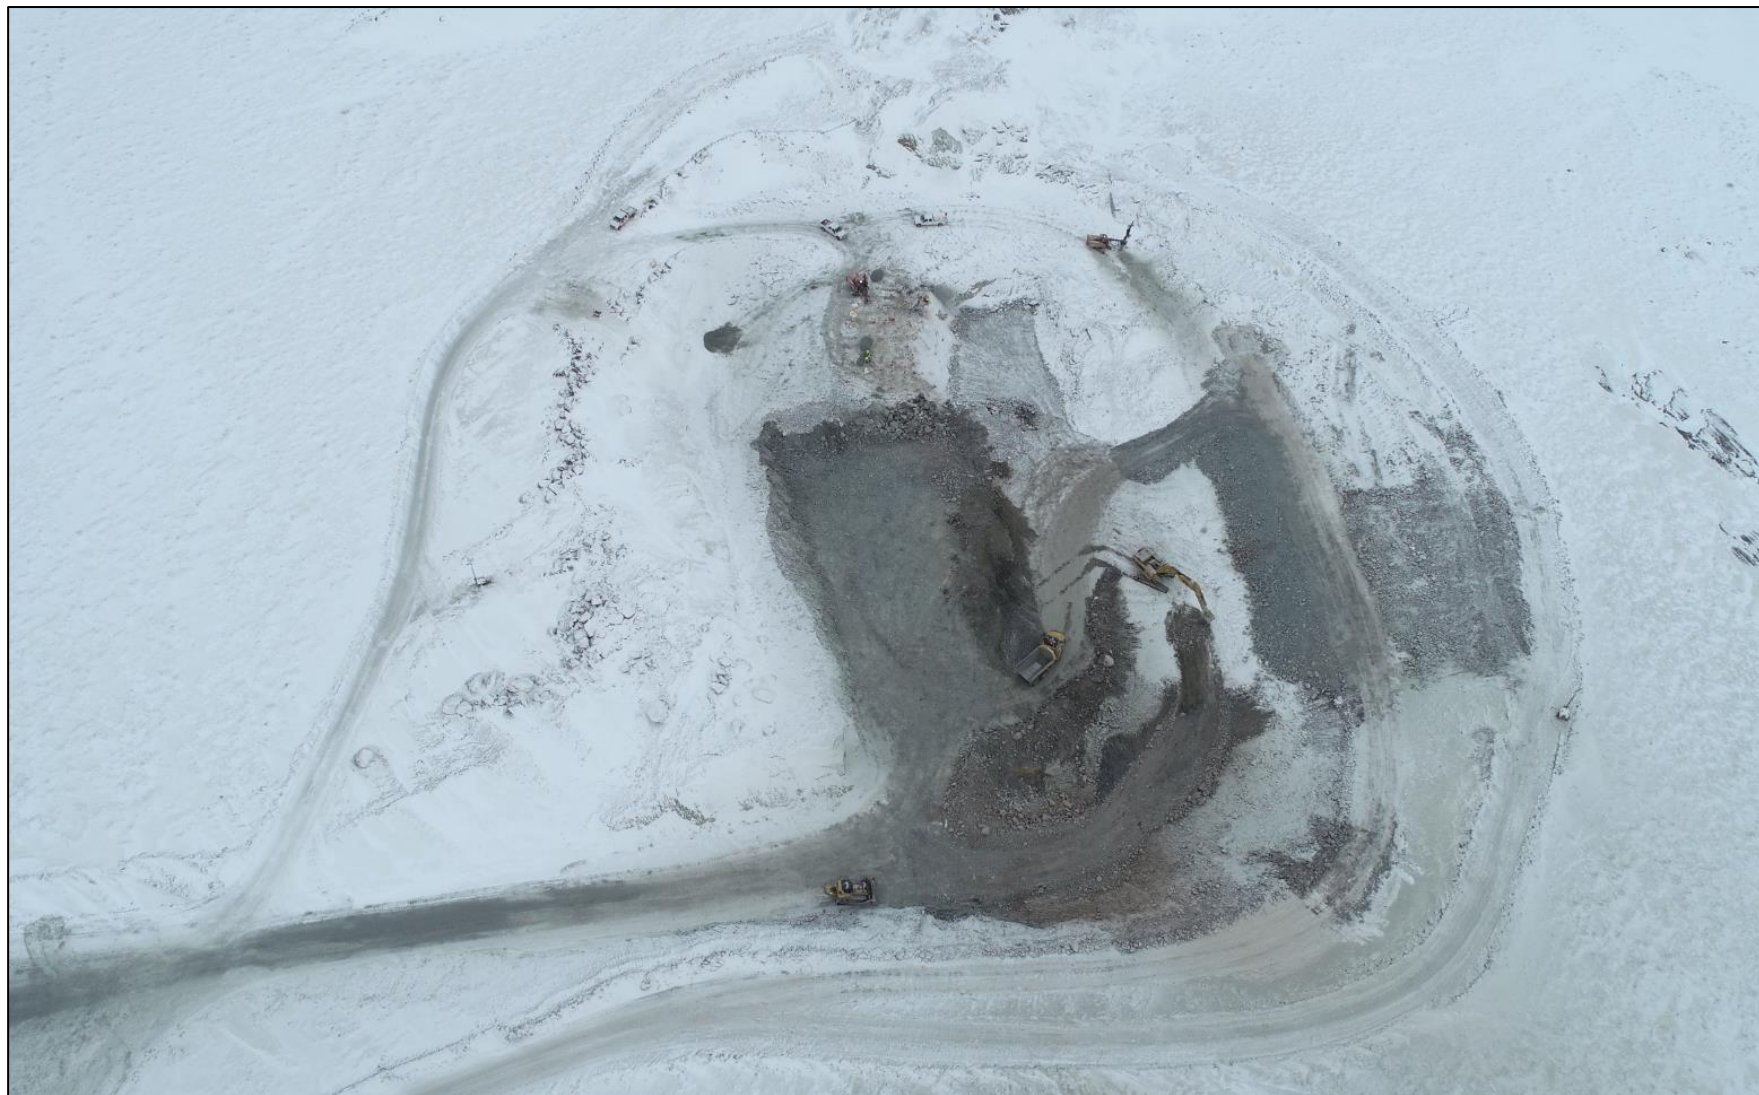
Figure 2. Naartok East Crown Pillar Recovery Trench, November 2019

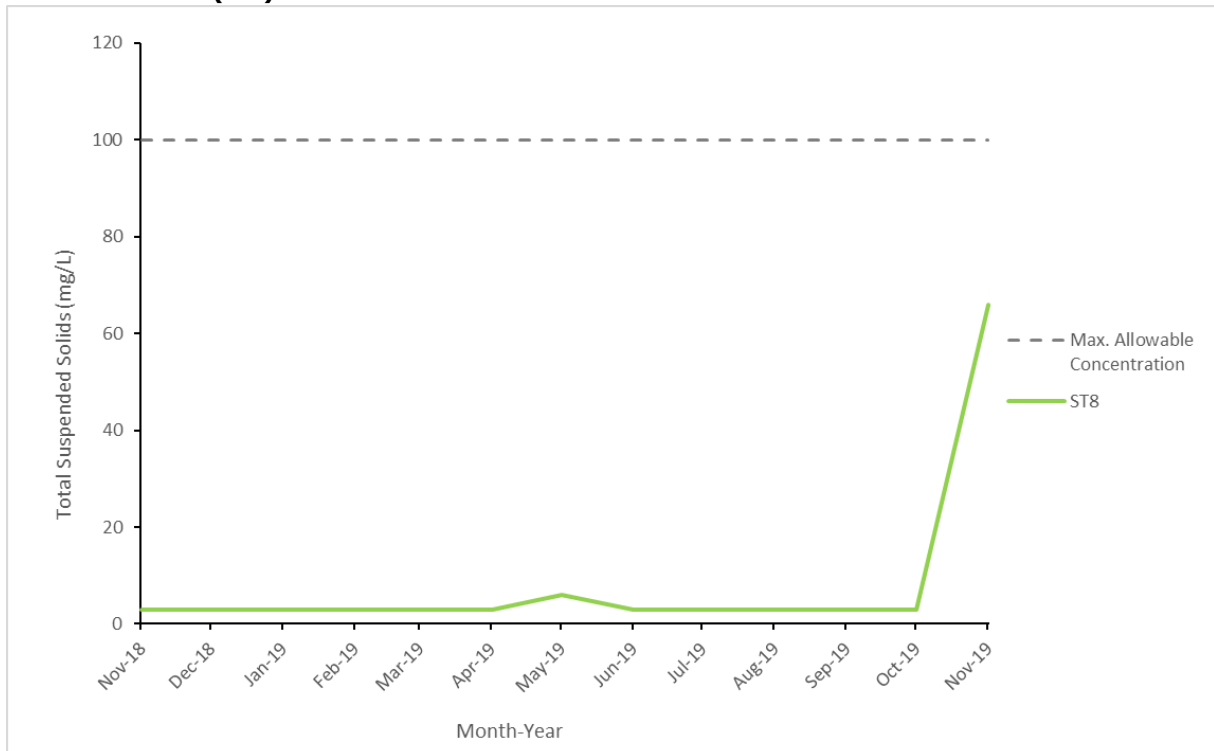
A spike in TSS was observed at ST-8 from the sample collected in November, although the results were below the Maximum Average Concentration outlined in Part F, Item 5(a). An investigation was conducted upon receipt of the results. One of the sewage treatment units experienced a temporary upset due to a drop in pH that had an impact on treatment performance. This appears to have been an isolated event as subsequent sampling results were below detection limits, falling in line with the trend observed over the last monitoring year.

Figure 4. Total Suspended Solids Results Consistently Below Discharge Criteria for Wastewater Treatment Plant (ST8)

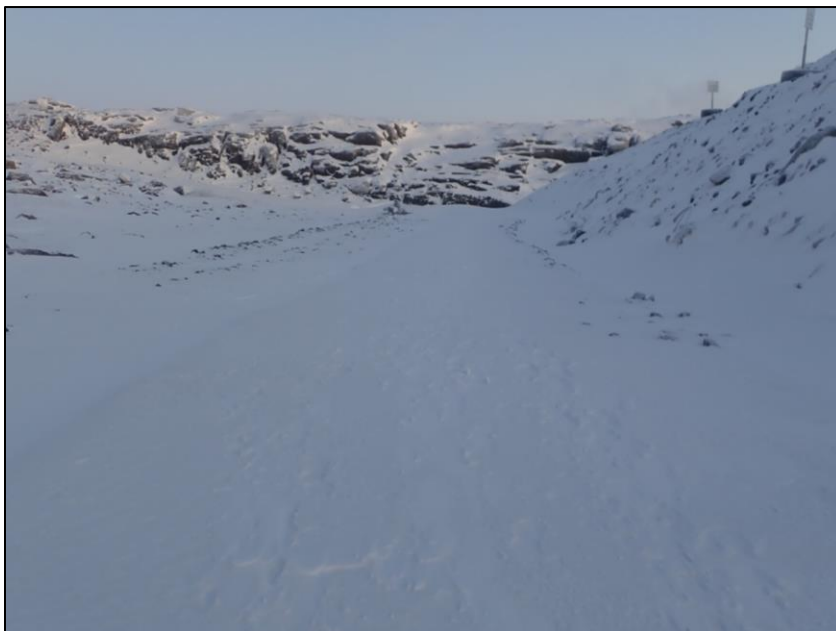
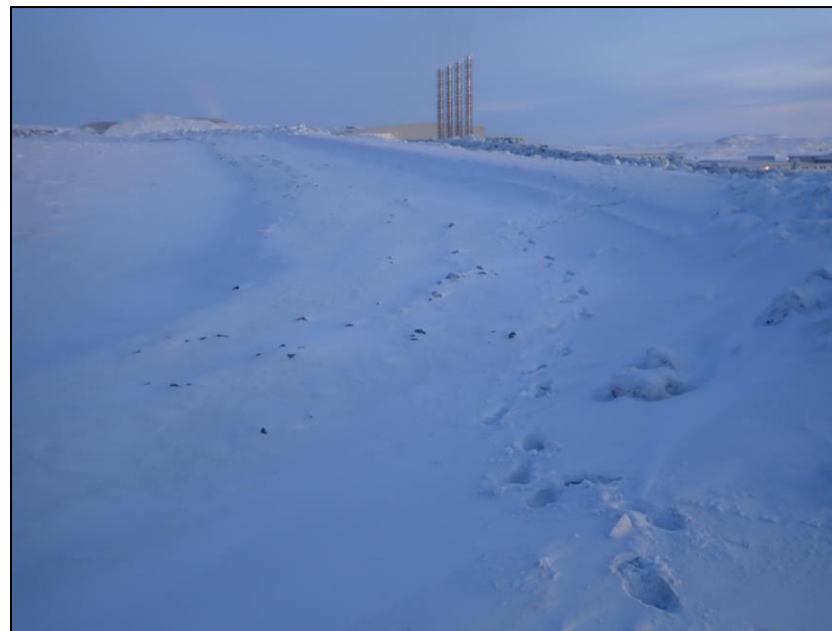
The Diversion Berm and associated check dam were observed to be functioning as designed and diverting non-contact water around the Doris site infrastructure. Photos of this infrastructure are provided in Figures 5 and 6 below.

Figure 5. Diversion berm dry during November
