January 29, 2020

Re: December 2019 – Monthly Monitoring Report for Water Licence 2AM-DOH1335

This report is comprised of the monitoring requirements set out in Part I and Schedule I of water licence 2AM-DOH1335 Amendment 2 (the licence), and additional requirements from CIRNAC.

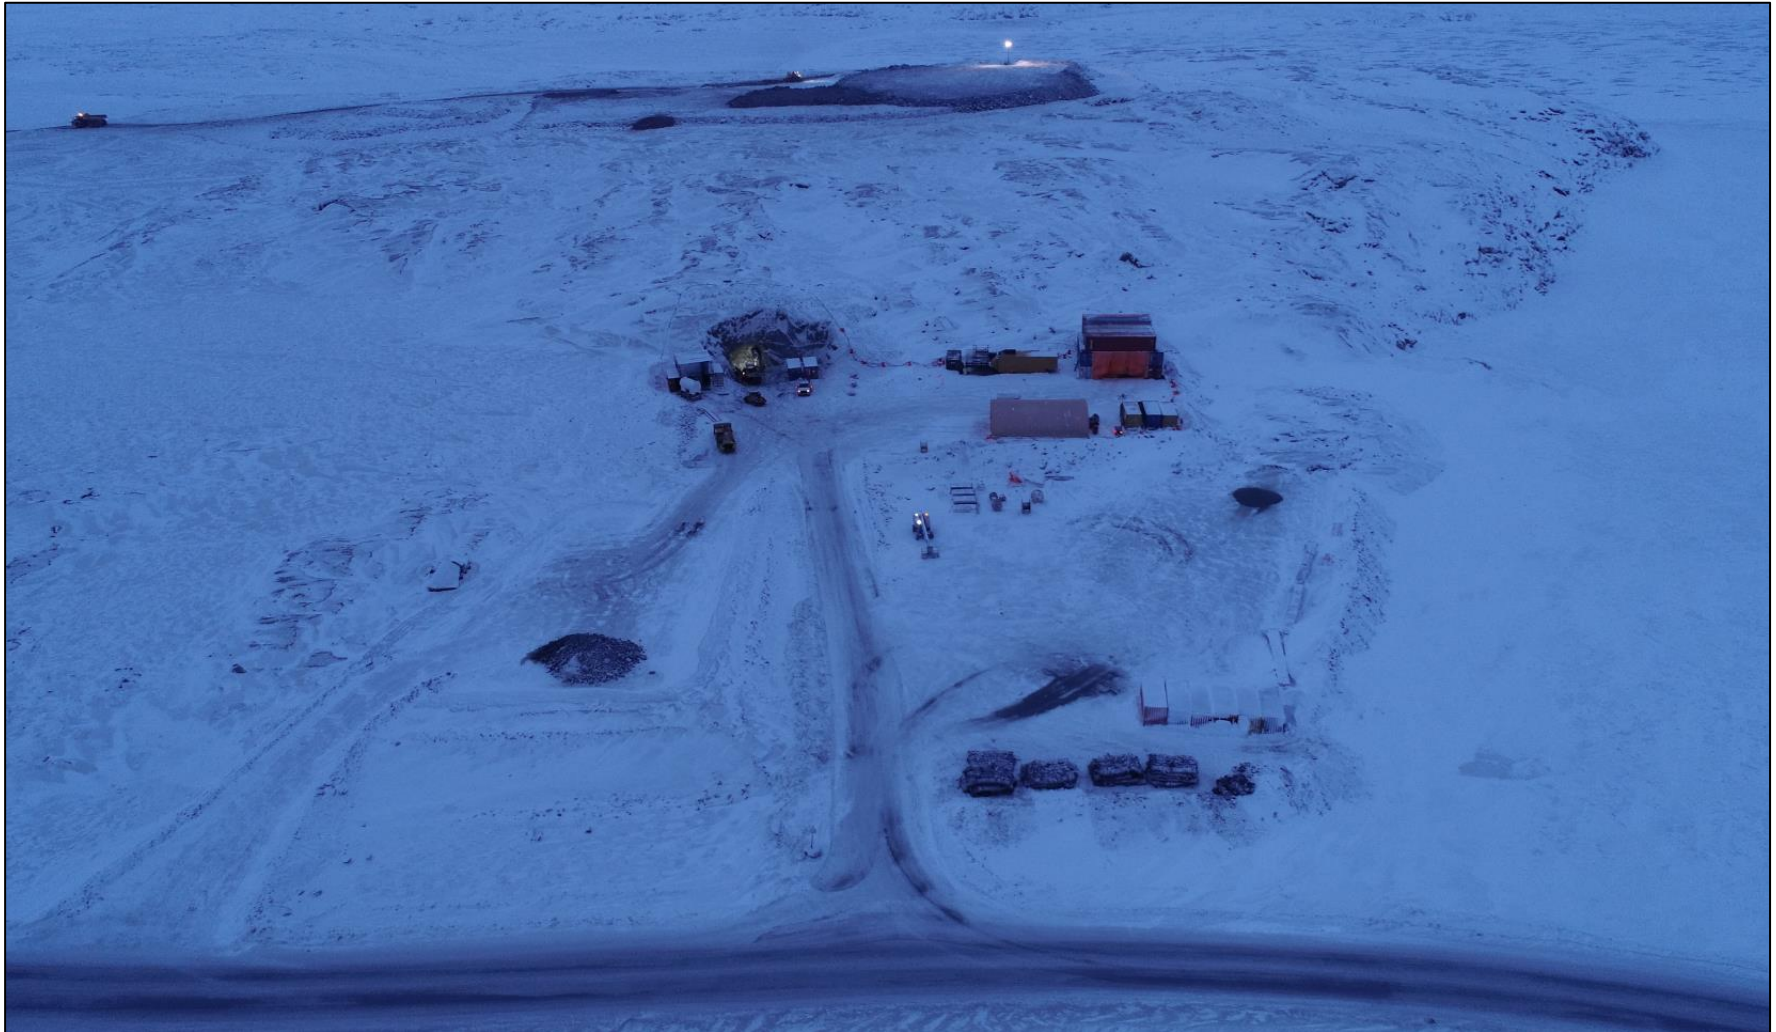
Development of the Madrid North Portal continued in December. Mining activities continued in the Naartok East Crown Pillar Recovery Trench under this licence during the month. Figure 1 shows construction activities at the Madrid North Portal laydown including portal development and the waste rock pad. Figure 2 shows mining activities at the Naartok East Crown Pillar Recovery Trench.

Figure 1. Madrid North Portal Laydown and Waste Rock Storage Pad, December 2019

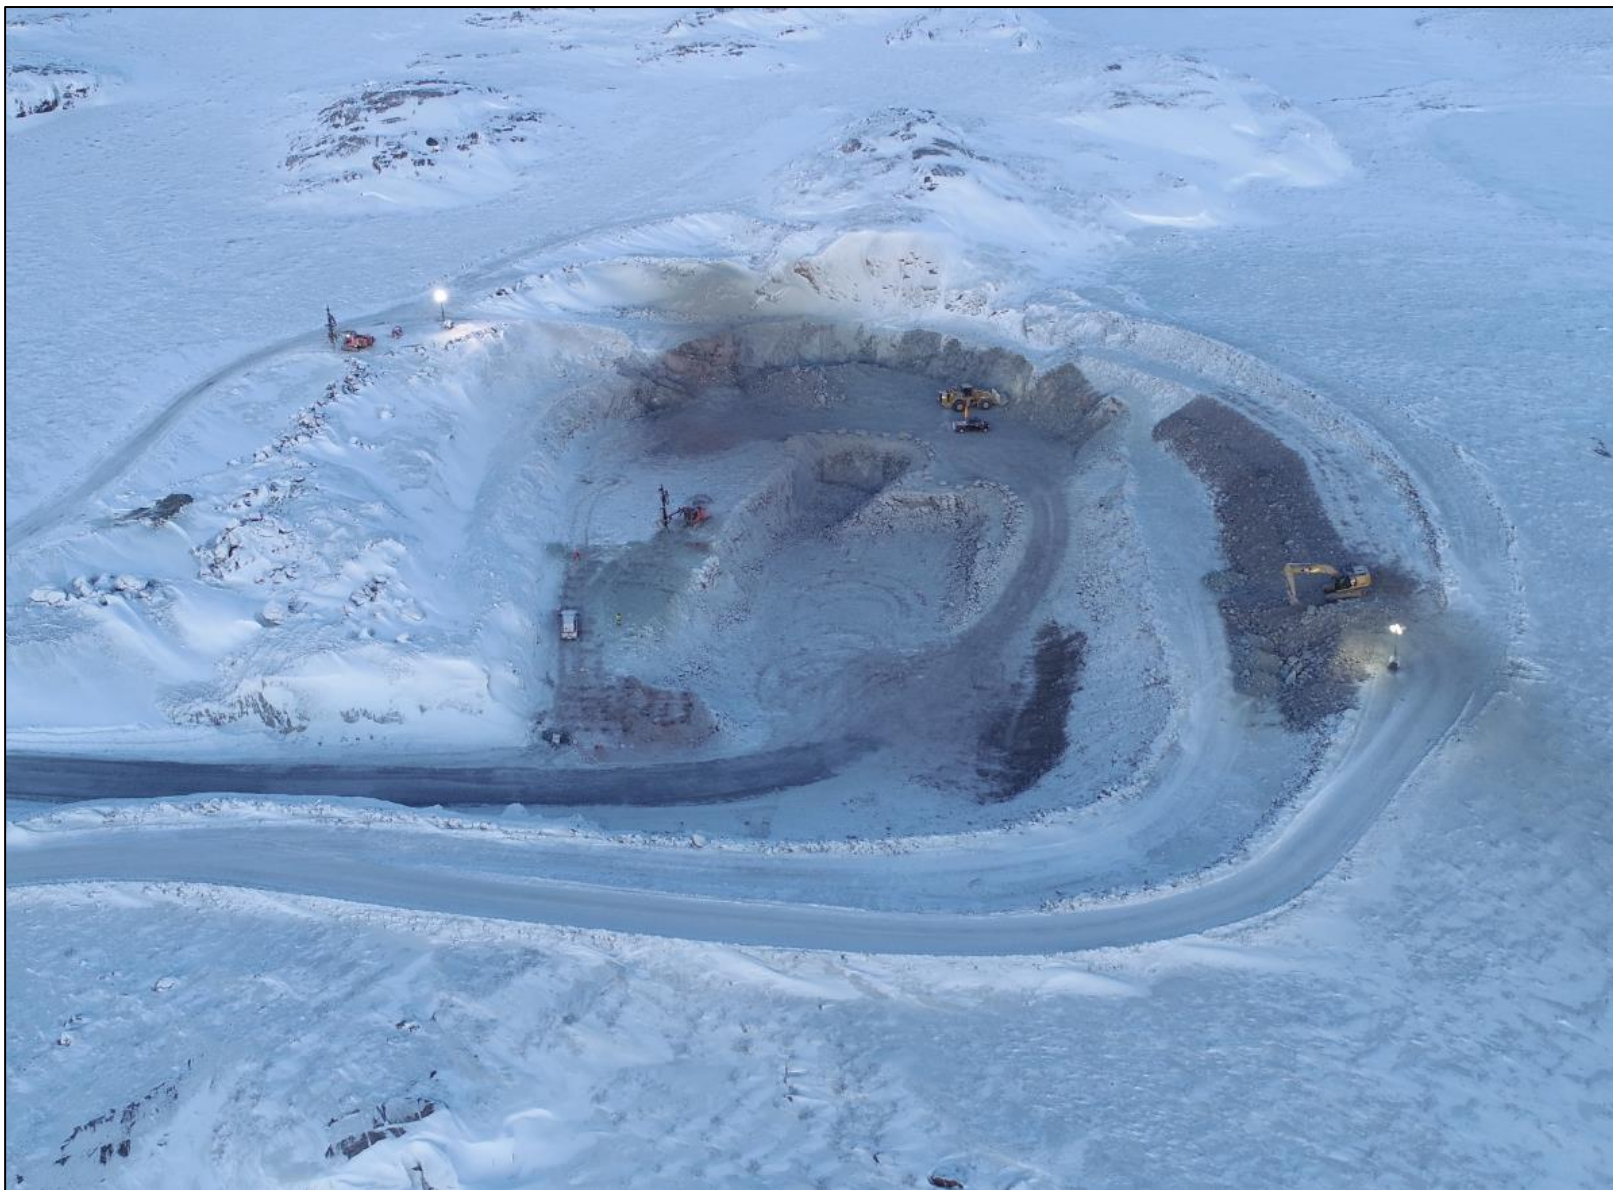
Figure 2. Naartok East Crown Pillar Recovery Trench, December 2019

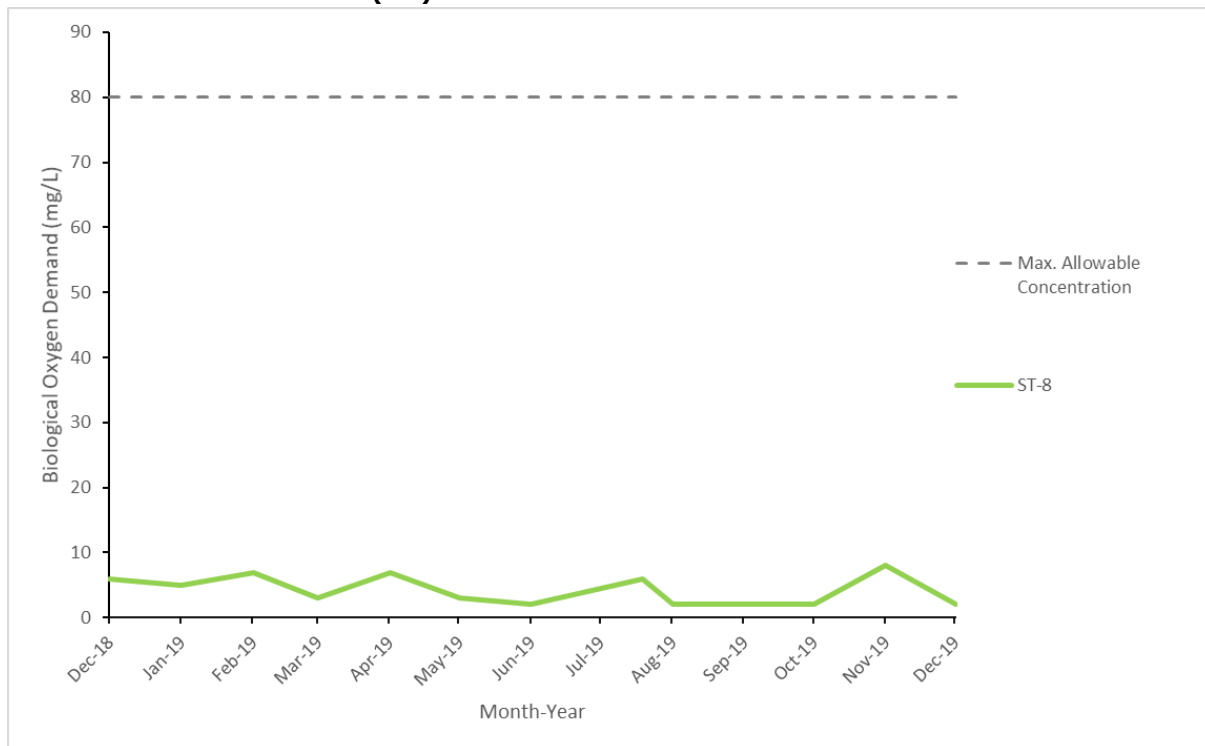
Figure 3. Biological Oxygen Demand Results Consistently Below Discharge Criteria for Wastewater Treatment Plant (ST8)

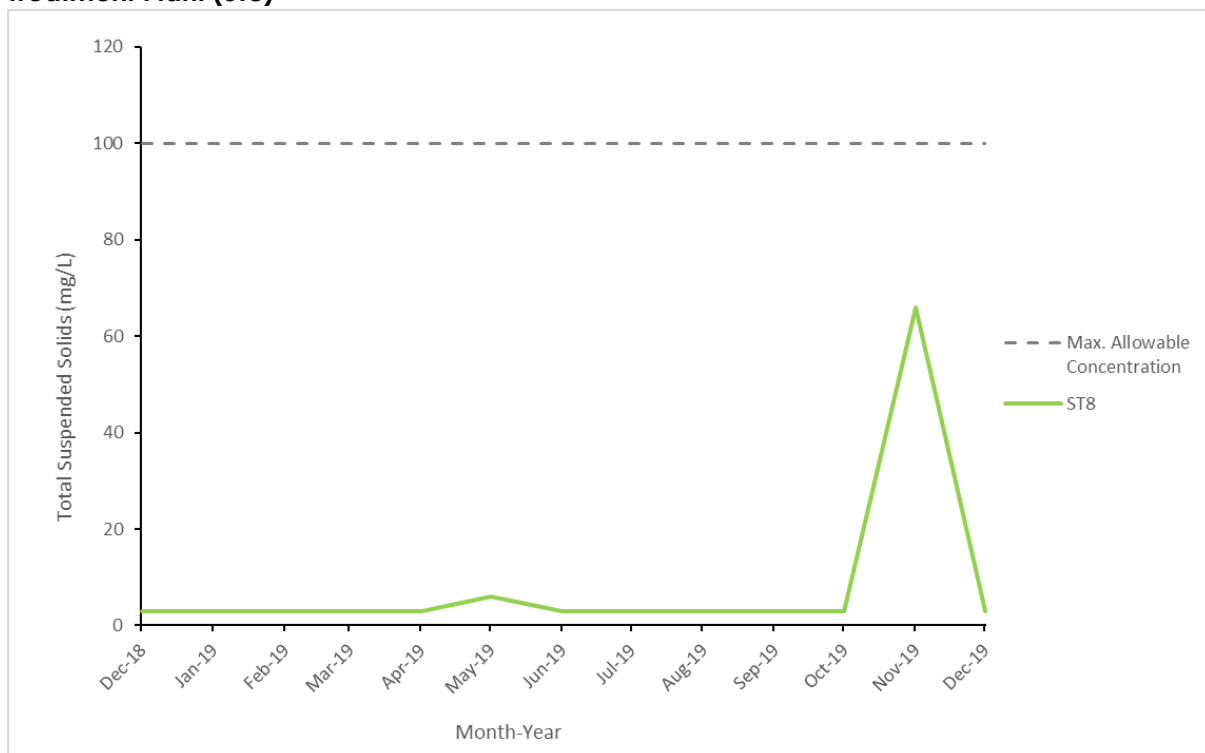
Figure 4. Total Suspended Solids Results Consistently Below Discharge Criteria for Wastewater Treatment Plant (ST8)

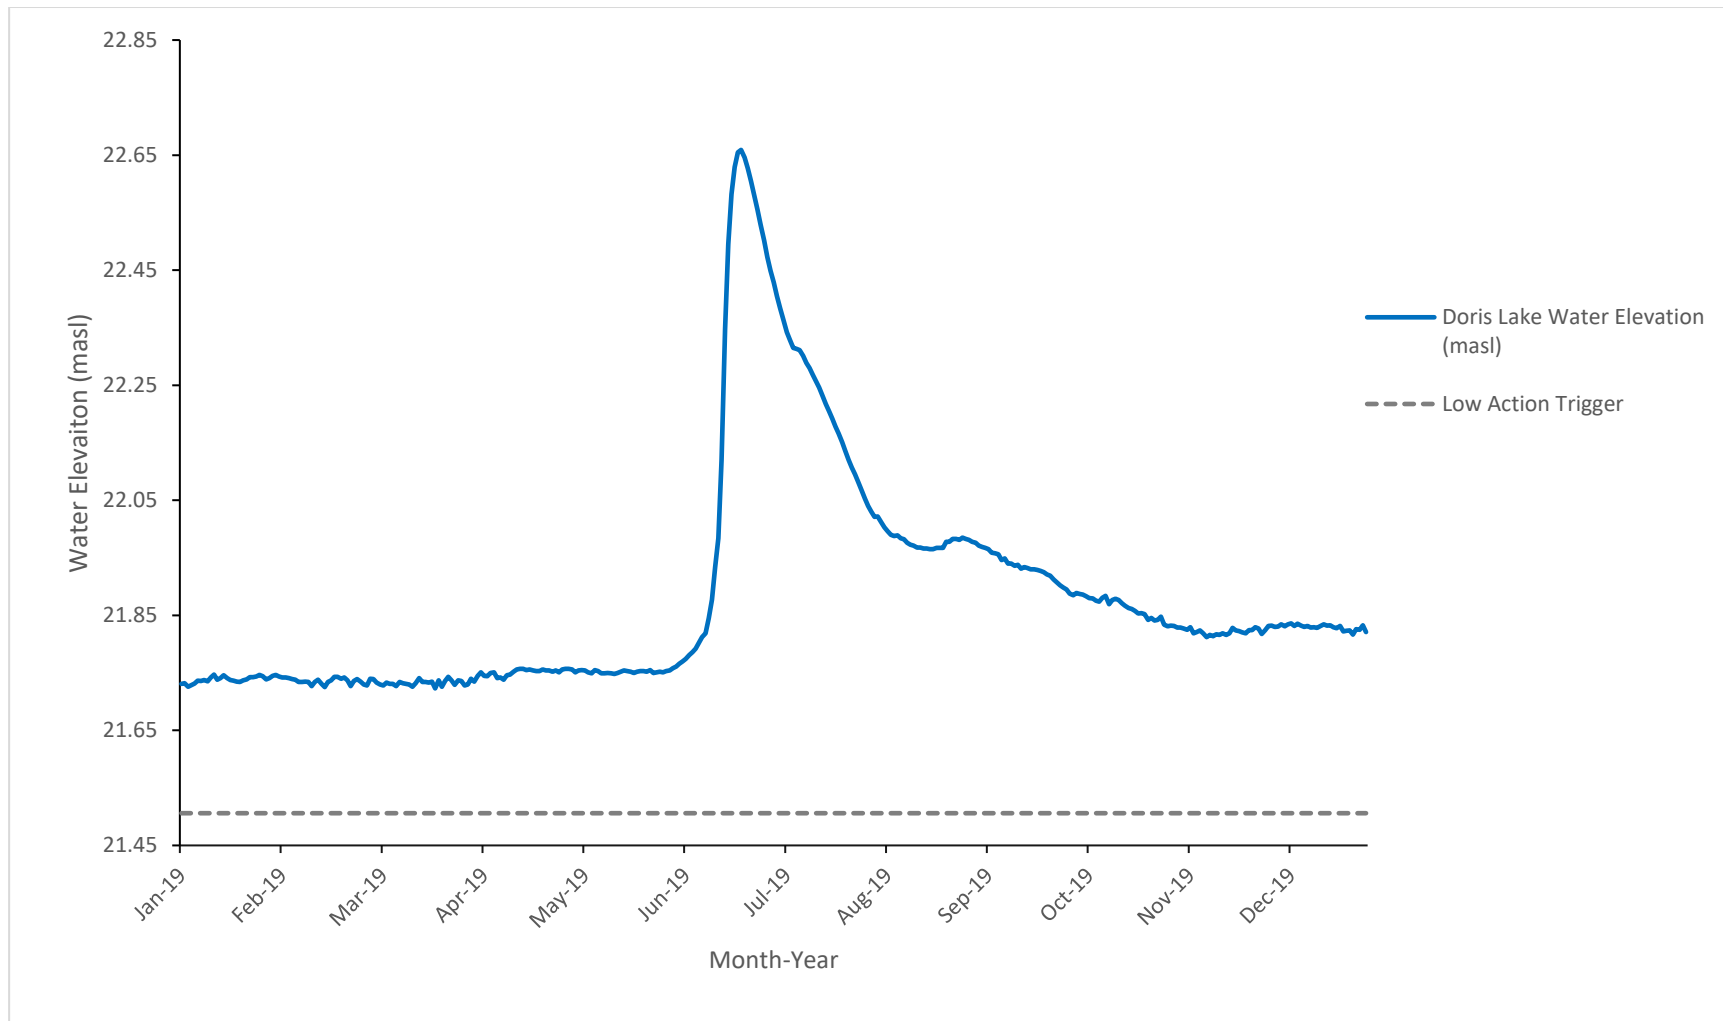
No discernable decrease in water level was observed in Doris Lake in December. Water level elevations appear consistent with past variations during December, and the water elevation remained above the Low Action Trigger of 21.506 masl. Refer to Table 7 and Figure 6 below for Doris Lake water elevation data.

Figure 5. Doris Lake Water Level (ST-12), 2019

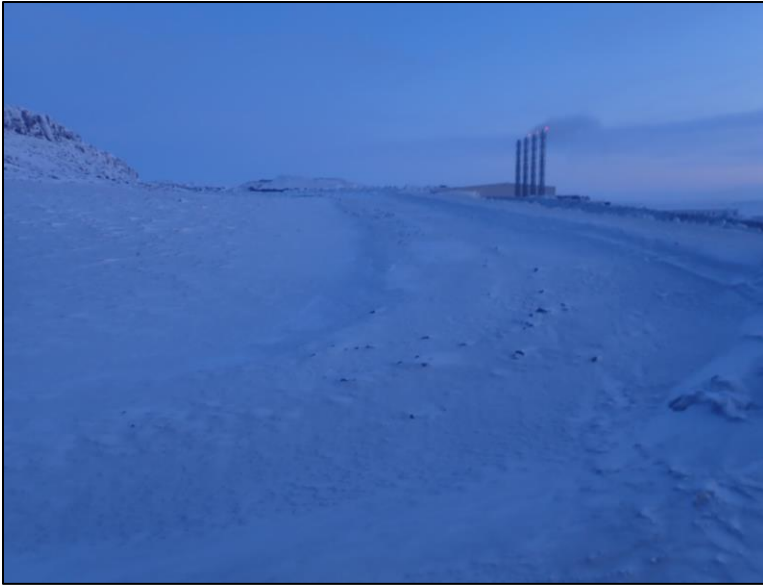
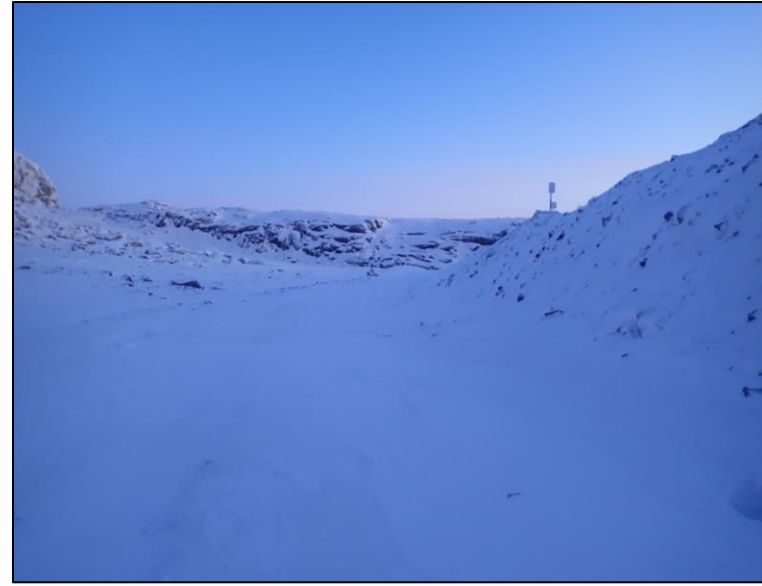
The Diversion Berm and associated check dam were observed to be functioning as designed and diverting non-contact water around the Doris site infrastructure. Photos of this infrastructure are provided in Figure 5 below.

Figure 6. Diversion berm dry during December
