Re: January 2020 – Monthly Monitoring Report for Water Licence 2AM-DOH1335

This report is comprised of the monitoring requirements set out in Part I and Schedule I of water licence 2AM-DOH1335 Amendment 2 (the licence), and additional requirements from CIRNAC.

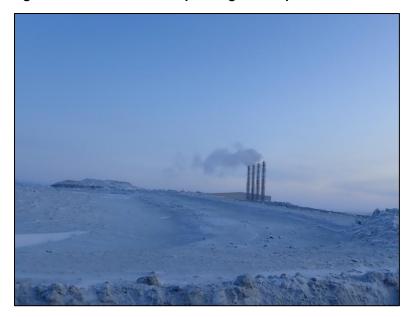
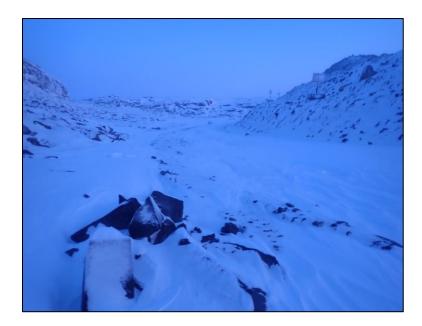
The Diversion Berm and associated check dam were observed to be functioning as designed and diverting non-contact water around the Doris site infrastructure. Photos of this infrastructure are provided in Figure 3 below.

Figure 3. Diversion berm dry during January 2020
