Re: February 2020 – Monthly Monitoring Report for Water Licence 2AM-DOH1335

This report is comprised of the monitoring requirements set out in Part I and Schedule I of water licence 2AM-DOH1335 Amendment 2 (the licence), and additional requirements from CIRNAC.

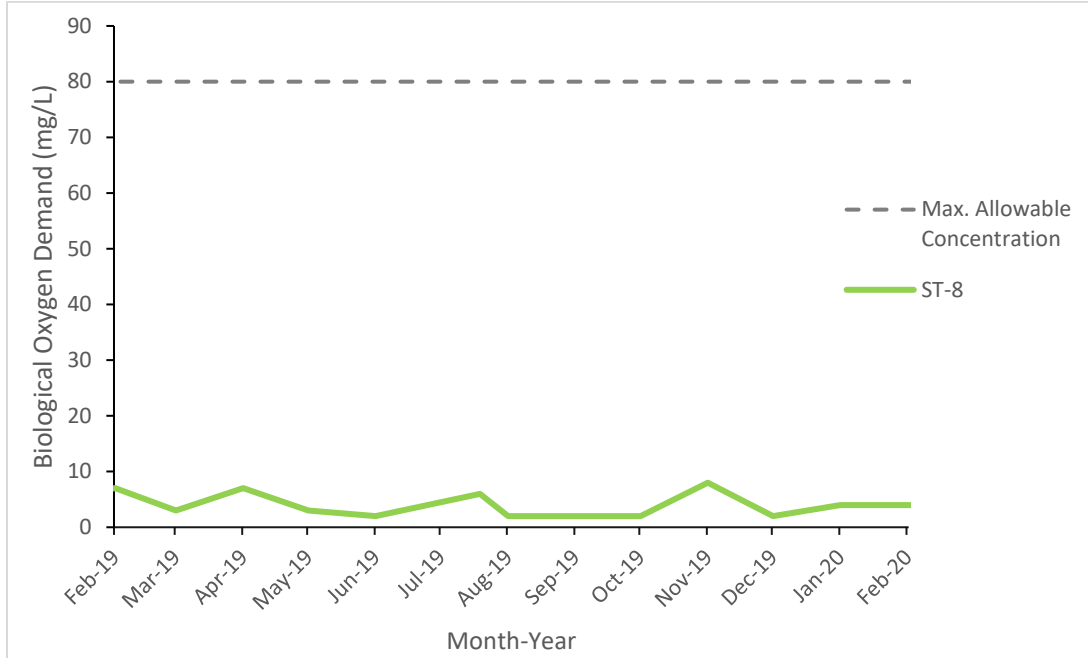
Figure 1. Biological Oxygen Demand Results Consistently Below Discharge Criteria for Wastewater Treatment Plant (ST8)

Note: Maximum Average Concentration as per Part F Item 4(b).

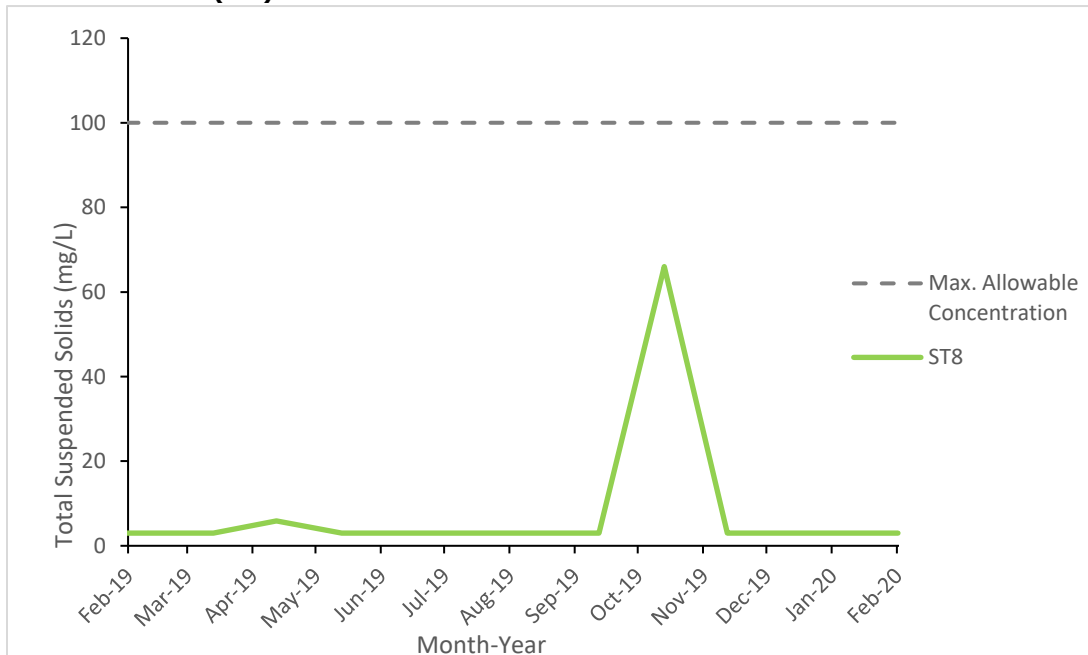
Figure 2. Total Suspended Solids Results Consistently Below Discharge Criteria for Wastewater Treatment Plant (ST8)

Note: Maximum Average Concentration as per Part F Item 4(b).

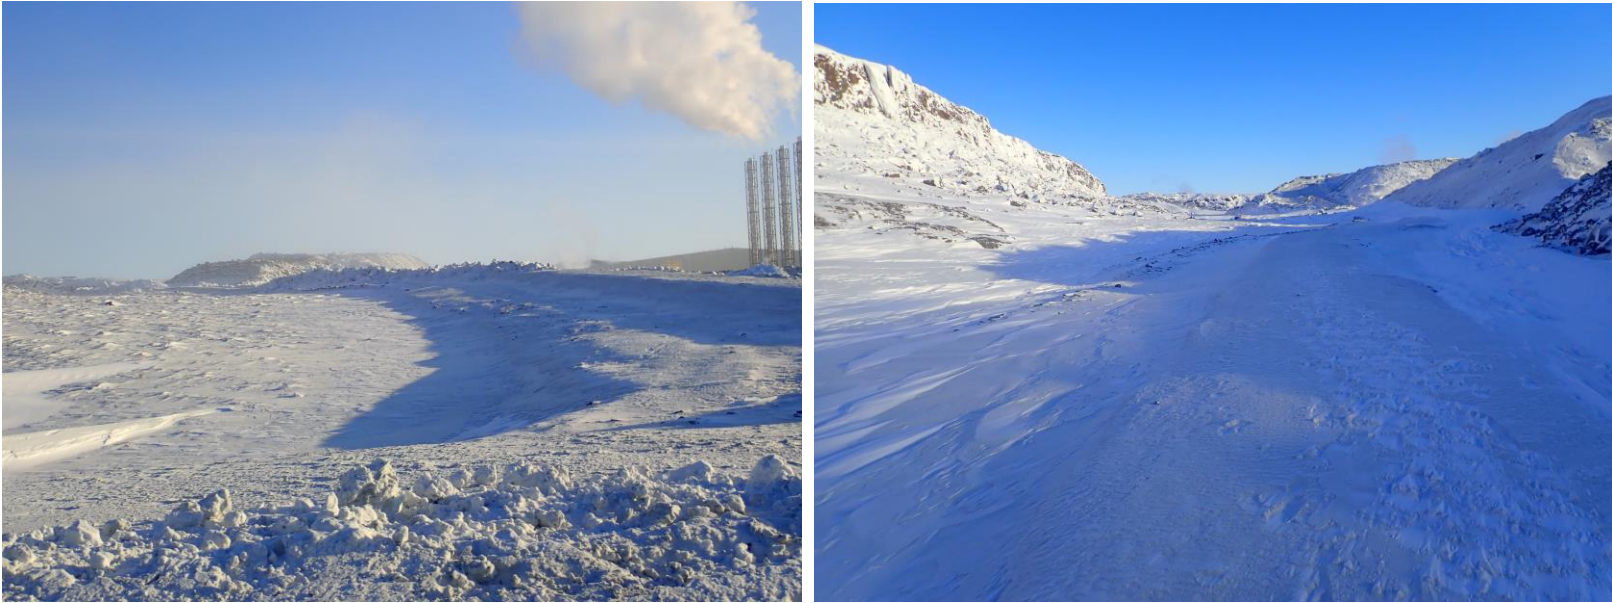
The Diversion Berm and associated check dam were observed to be functioning as designed and diverting non-contact water around the Doris site infrastructure. Photos of this infrastructure are provided in Figure 3 below.

Figure 3. Diversion berm dry during February 2020
