Re: June 2021 – Monthly Monitoring Report for Water Licence 2AM-DOH1335

This report is comprised of the monitoring requirements set out in Part I and Schedule I of water licence 2AM-DOH1335 Amendment 2 (the licence), and additional requirements from CIRNAC.

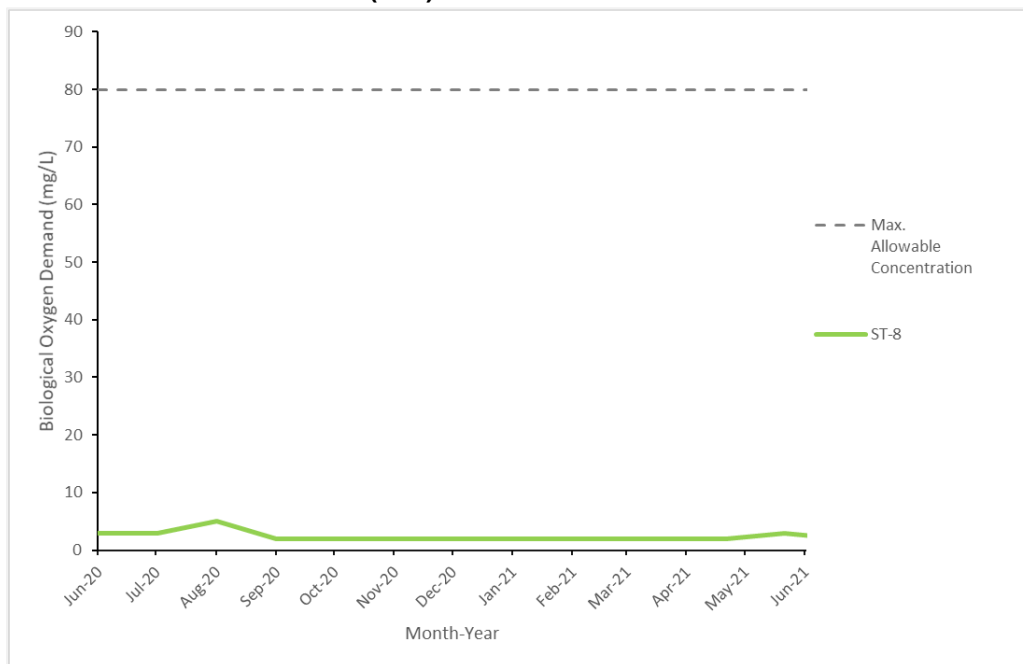
Figure 1. Biological Oxygen Demand Results Consistently Below Discharge Criteria for Wastewater Treatment Plant (ST8)

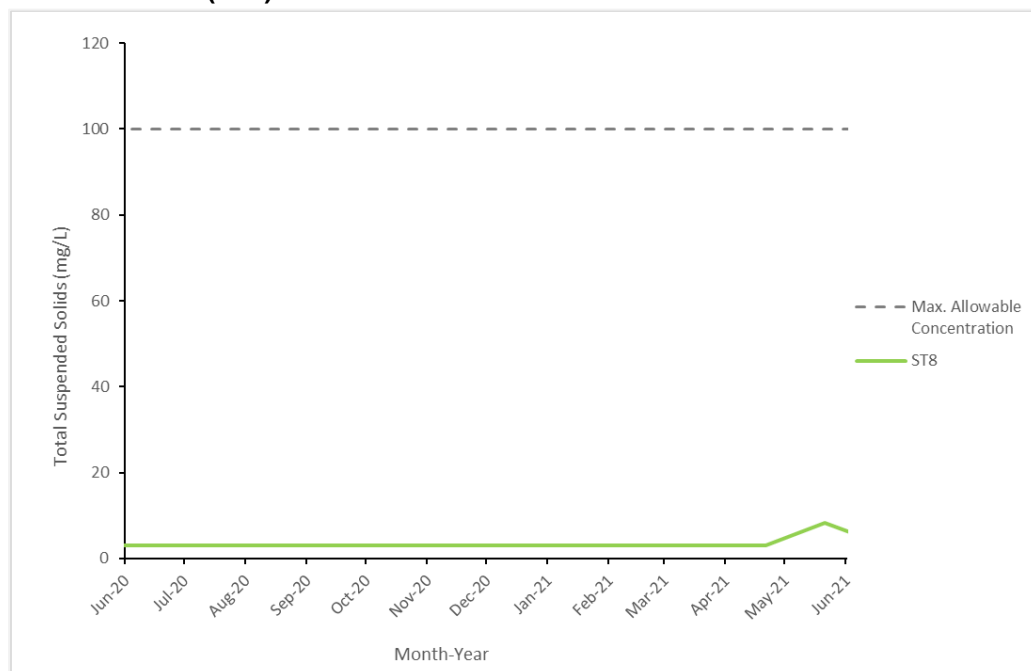
Figure 2. Total Suspended Solids Results Consistently Below Discharge Criteria for Wastewater Treatment Plant (ST8)

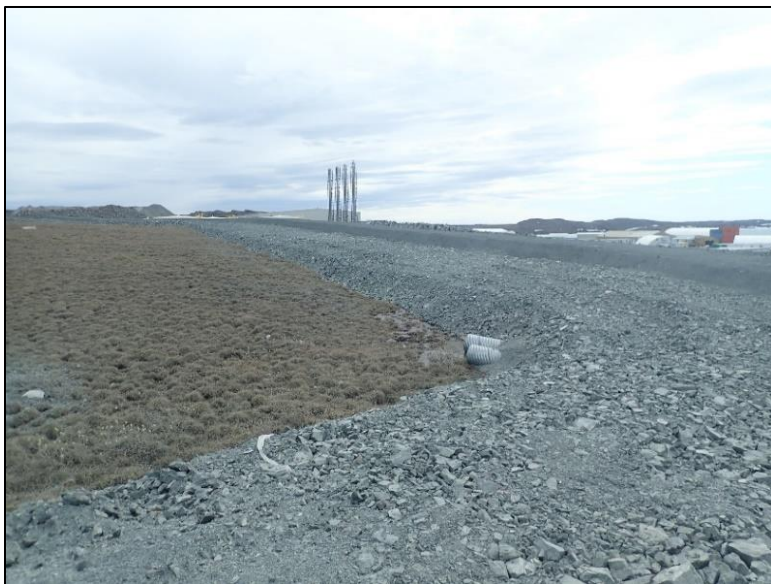
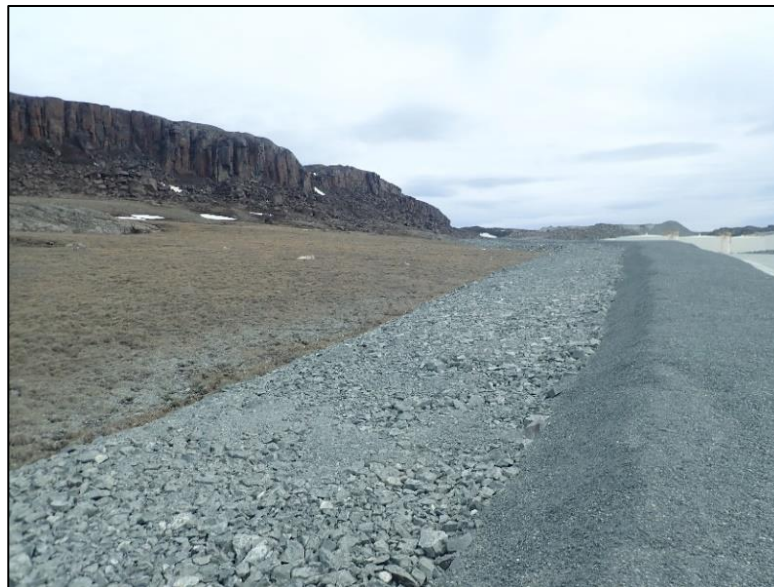
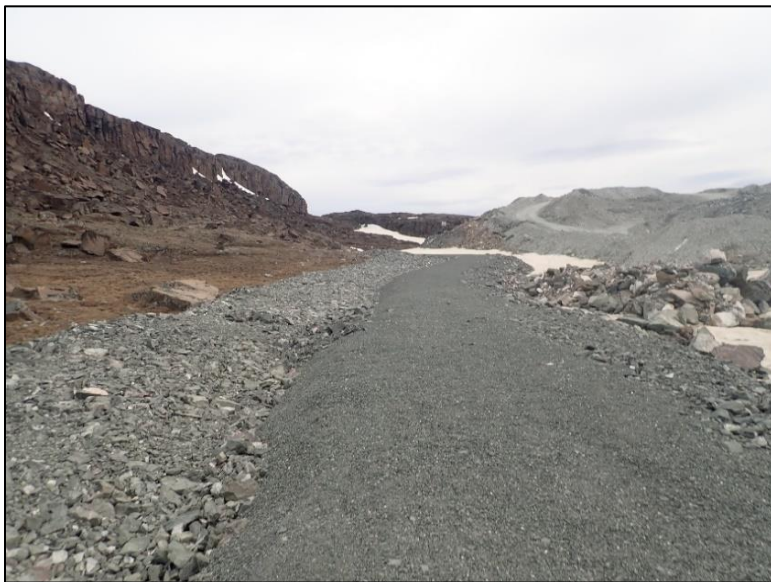
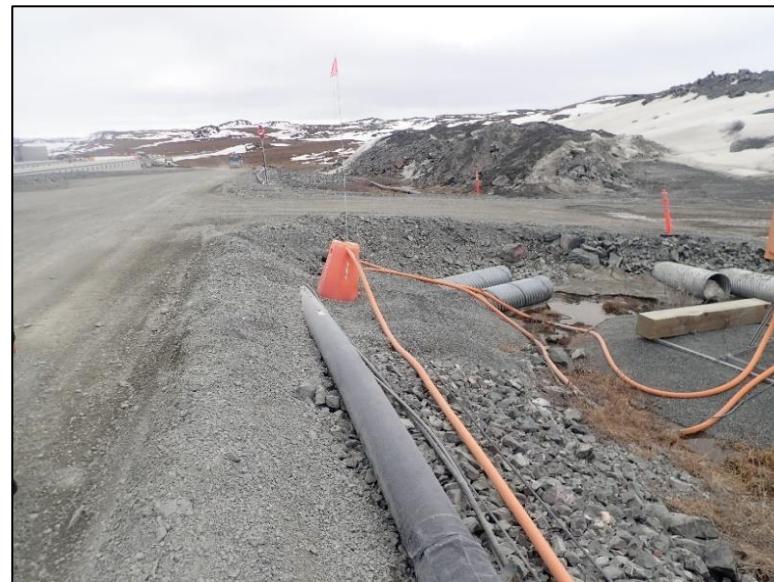
Figure 3. Diversion berm during June 2021

Visual monitoring was conducted at the Diversion Berm this month. No issues were identified at the Diversion Berm and associated check dam in June. Photos of this infrastructure are provided in Figure 3 below.

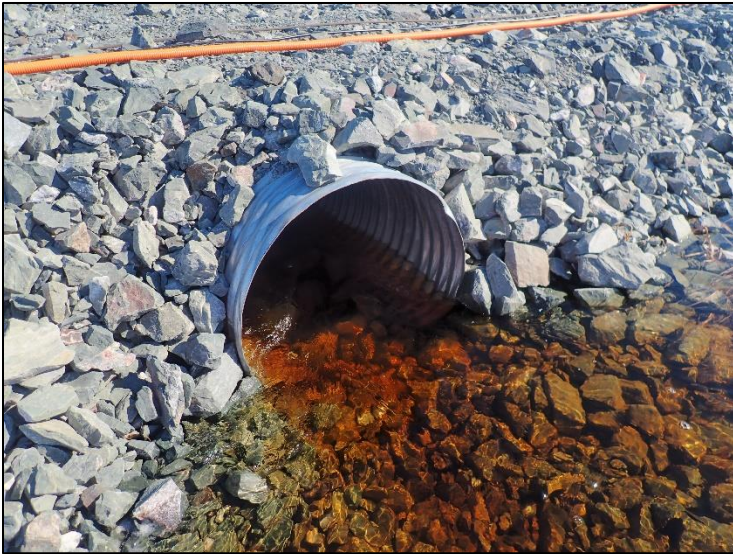
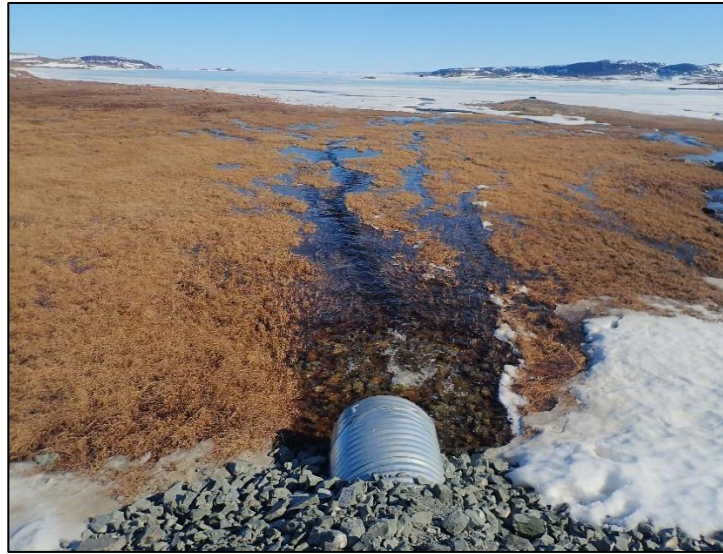
Figure 4. Culvert at Marine Outfall Berm Access Road upstream (right) and downstream (left) June 2021

Inspections were completed of site culverts throughout the month of June. No issues were identified with these water management structures. Figure 4 and 5 below shows the upstream and downstream conditions of culverts located at the Marine Outfall Berm Access Road and the Madrid All-Weather Road.
