Re: May 2022 – Monthly Monitoring Report for Water Licence 2AM-DOH1335

This report is comprised of the monitoring requirements set out in Part I and Schedule I of water licence 2AM-DOH1335 Amendment 2 (the licence), and additional requirements from CIRNAC.

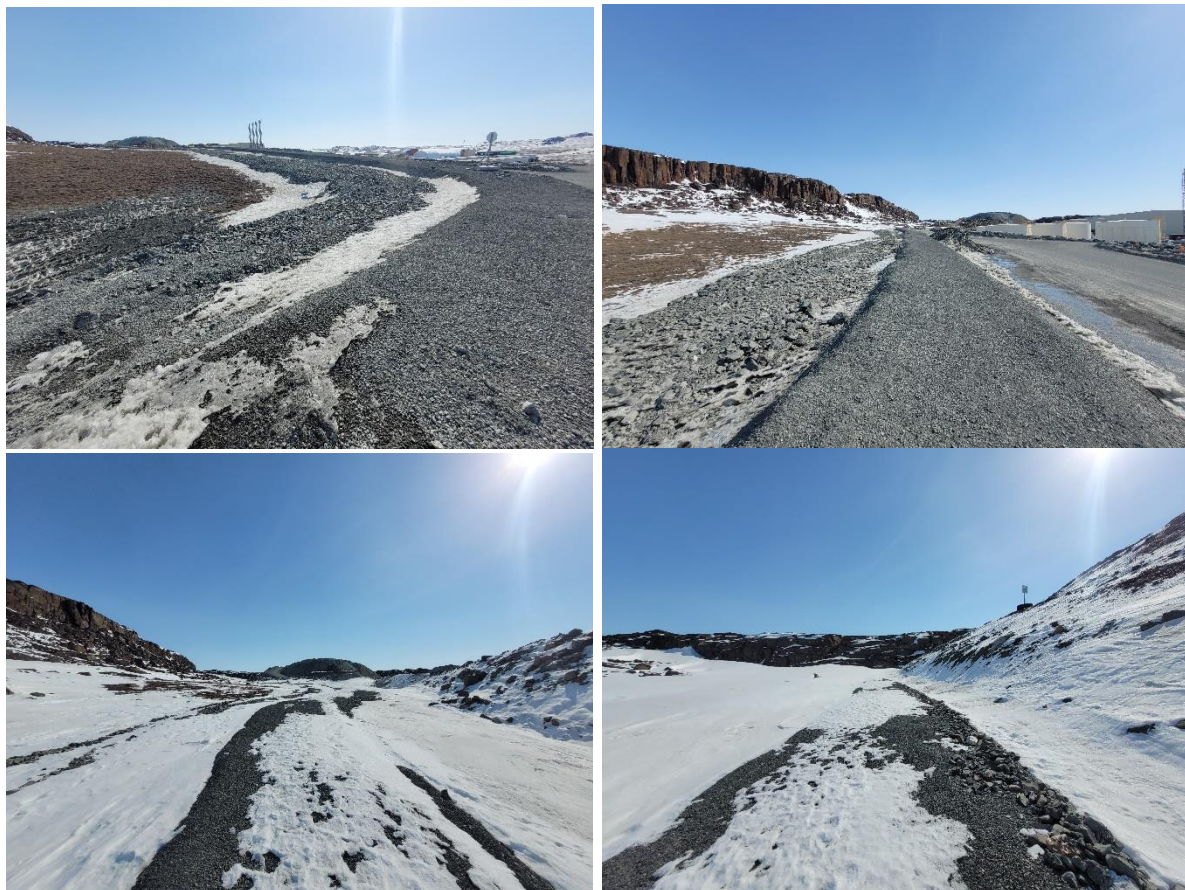
Figure 3. Diversion berm during May 2022

Visual monitoring was conducted at the Diversion Berm this month. No issues were identified at the Diversion Berm and associated check dam in April. Photos of this infrastructure are provided in Figure 3 below.
