Re: June 2022 – Monthly Monitoring Report for Water License 2AM-DOH1335

This report is comprised of the monitoring requirements set out in Part I and Schedule I of water licence 2AM-DOH1335 Amendment 2 (the license), and additional requirements from CIRNAC.

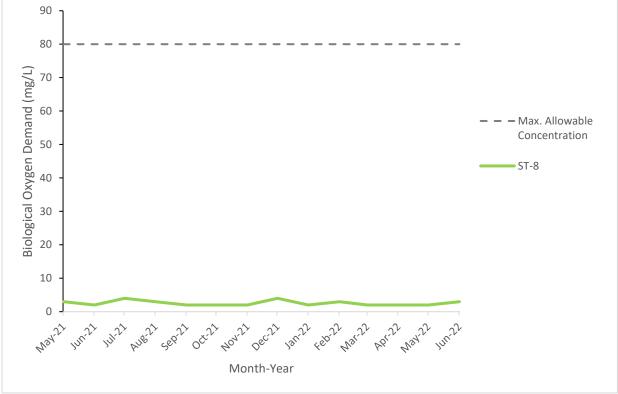
Figure 1. Biological Oxygen Demand Results Consistently Below Discharge Criteria for Wastewater Treatment Plant (ST8)

Note: Maximum Average Concentration as per Part F Item 4(b).

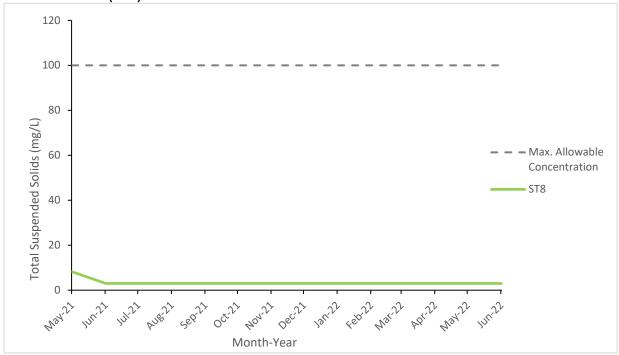
Figure 2. Total Suspended Solids Results Consistently Below Discharge Criteria for Wastewater Treatment Plant (ST8)

Note: Maximum Average Concentration as per Part F Item 4(b).

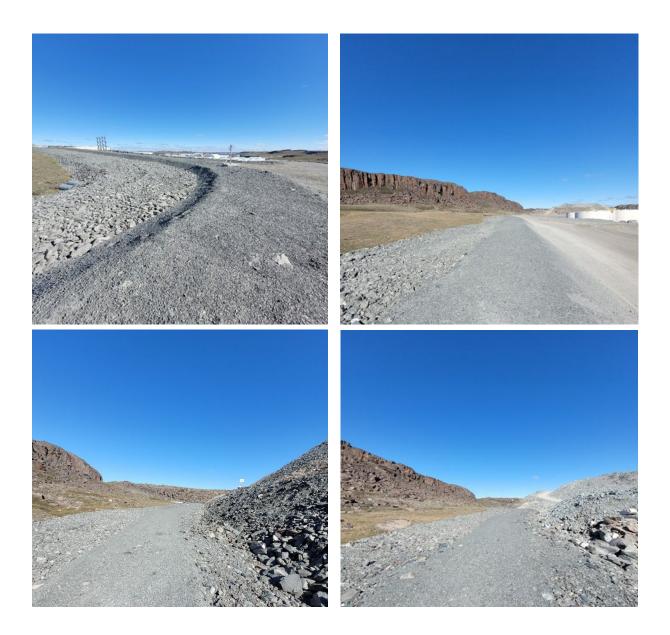
Figure 3. Diversion berm during June 2022

Visual monitoring was conducted at the Diversion Berm this month. No issues were identified at the Diversion Berm and associated check dam in June. Photos of this infrastructure are provided in Figure 3 below.
