Re: July 2022 – Monthly Monitoring Report for Water License 2AM-DOH1335

This report is comprised of the monitoring requirements set out in Part I and Schedule I of water licence 2AM-DOH1335 Amendment 2 (the license), and additional requirements from CIRNAC.

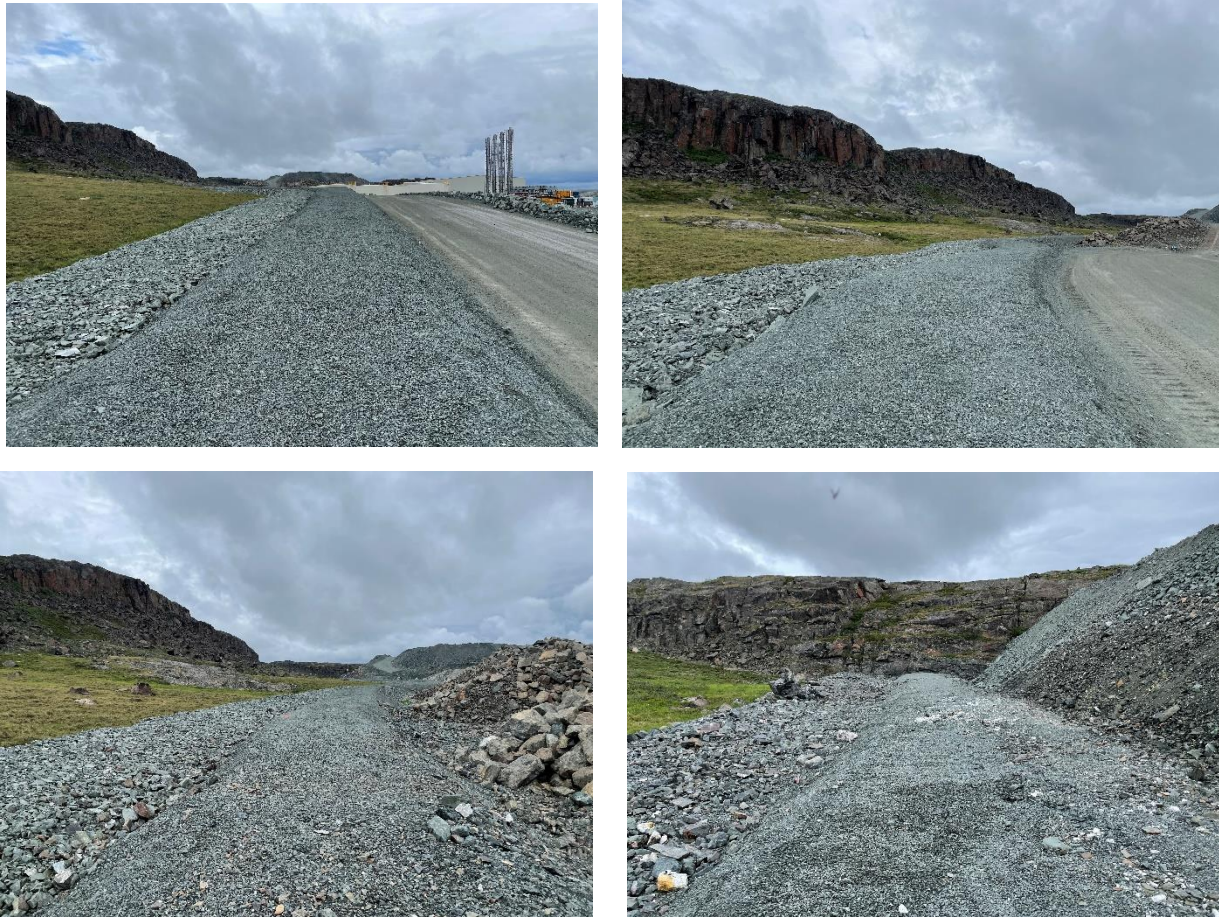
Figure 3. Diversion berm during July 2022

Visual monitoring was conducted at the Diversion Berm this month. No issues were identified at the Diversion Berm and associated check dam in July. Photos of this infrastructure are provided in Figure 3 below.

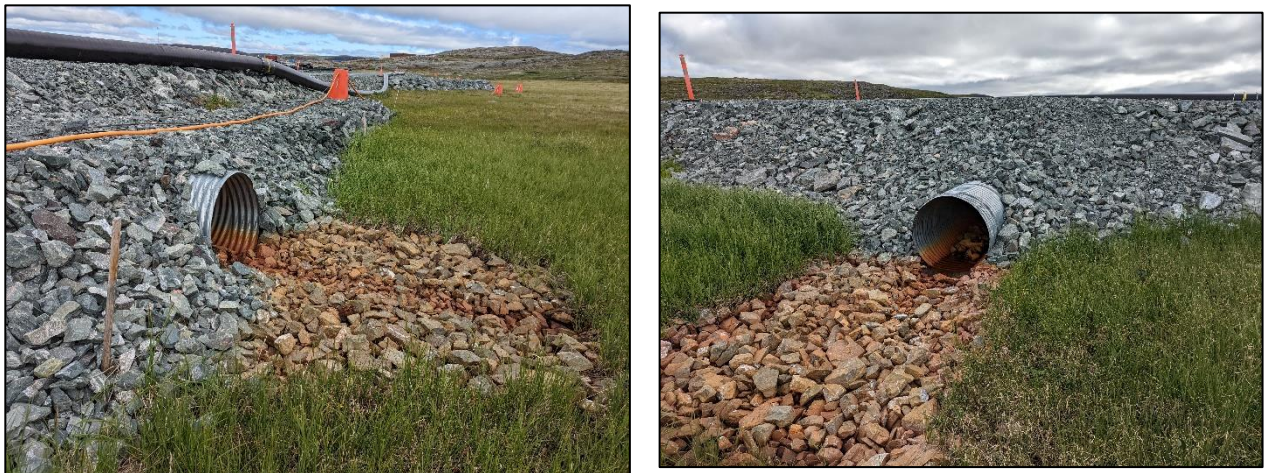
Figure 4. Culvert on 730 pumphouse access road upstream (left) and downstream (right) July 2022

Inspections were completed of site culverts throughout the month of July. No issues were identified with these water management structures. Figure 4 and 5 below shows the upstream and downstream conditions of culverts located at the Marine Outfall Berm Access Road and the Madrid All-Weather Road.
