**Re: August 2022 – Monthly Monitoring Report for Water License 2AM-DOH1335**

This report is comprised of the monitoring requirements set out in Part I and Schedule I of water licence 2AM-DOH1335 Amendment 2 (the license), and additional requirements from CIRNAC.

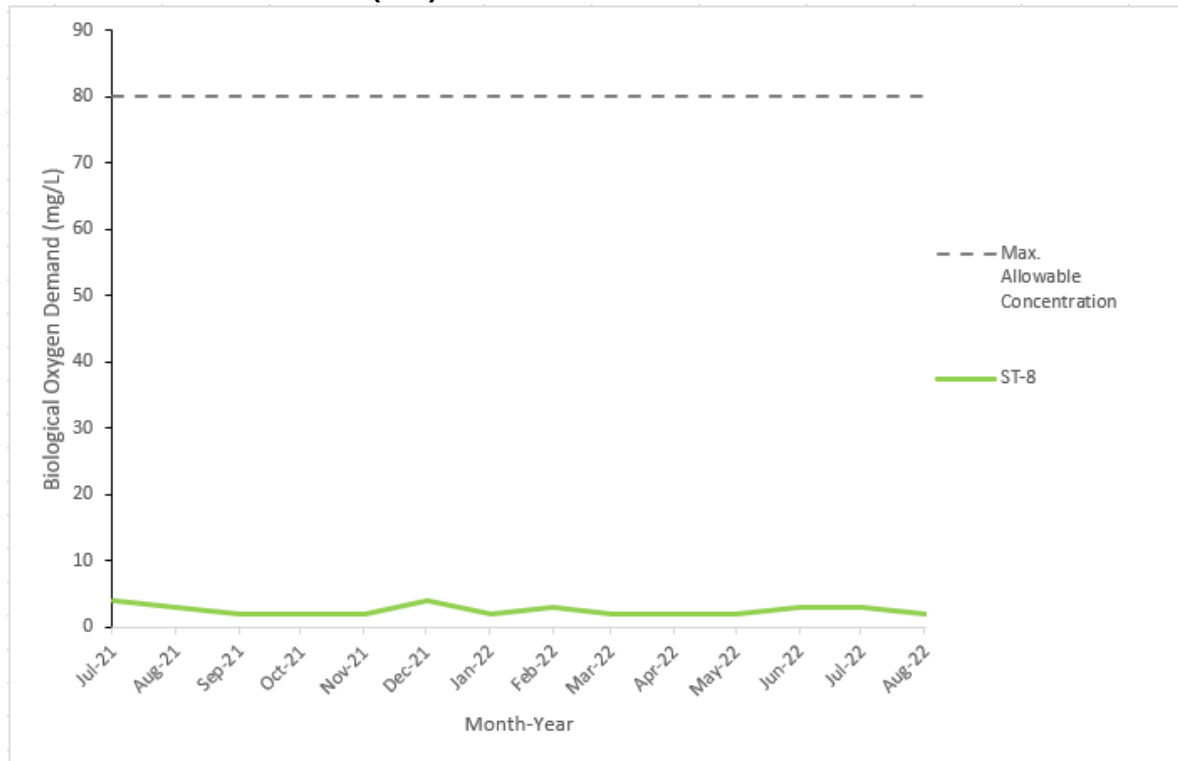
**Figure 1. Biological Oxygen Demand Results Consistently Below Discharge Criteria for Wastewater Treatment Plant (ST8)**

Note: Maximum Average Concentration as per Part F Item 4(b).

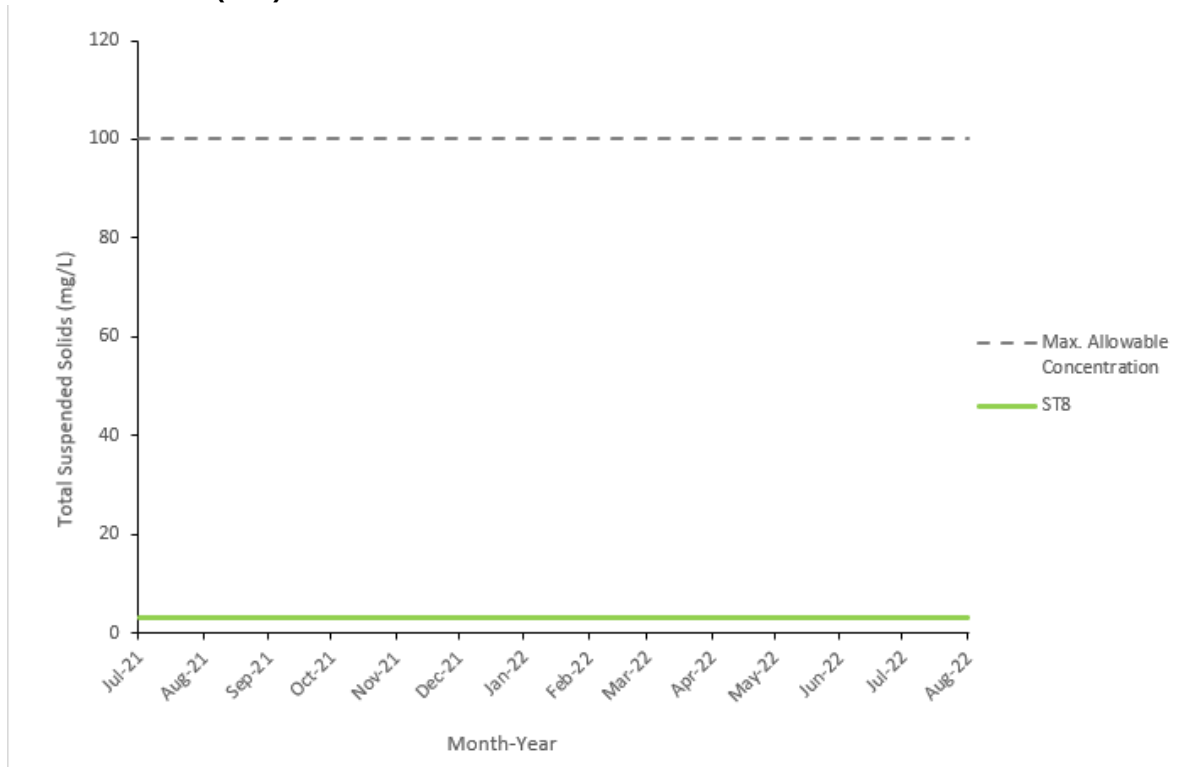
**Figure 2. Total Suspended Solids Results Consistently Below Discharge Criteria for Wastewater Treatment Plant (ST8)**

Note: Maximum Average Concentration as per Part F Item 4(b).

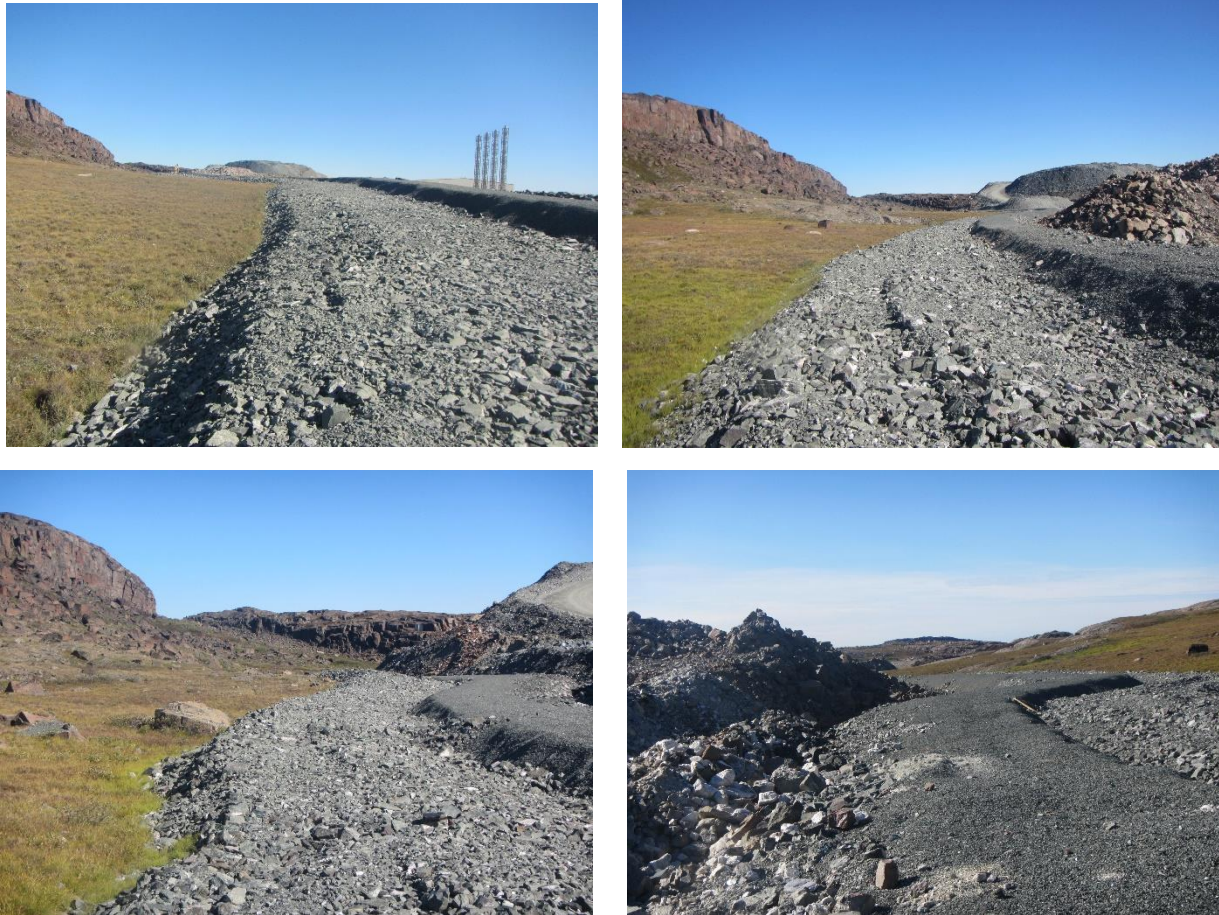
Visual monitoring was conducted at the Diversion Berm this month. No issues were identified at the Diversion Berm and associated check dam in August. Photos of this infrastructure are provided in Figure 3 below.

**Figure 3. Diversion berm during August 2022**

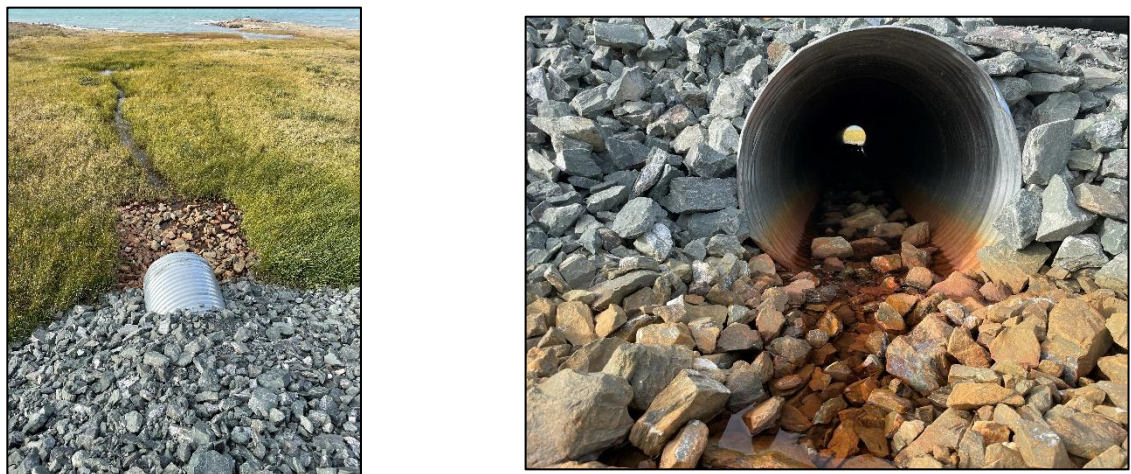
Inspections were completed of site culverts throughout the month of August. No issues were identified with these water management structures. Figure 4 and 5 below shows the upstream and downstream conditions of culverts located at the 730 pumphouse access road and the Madrid All-Weather Road.

**Figure 4. Culvert on 730 pumphouse access road upstream (right) and downstream (left) August 2022**

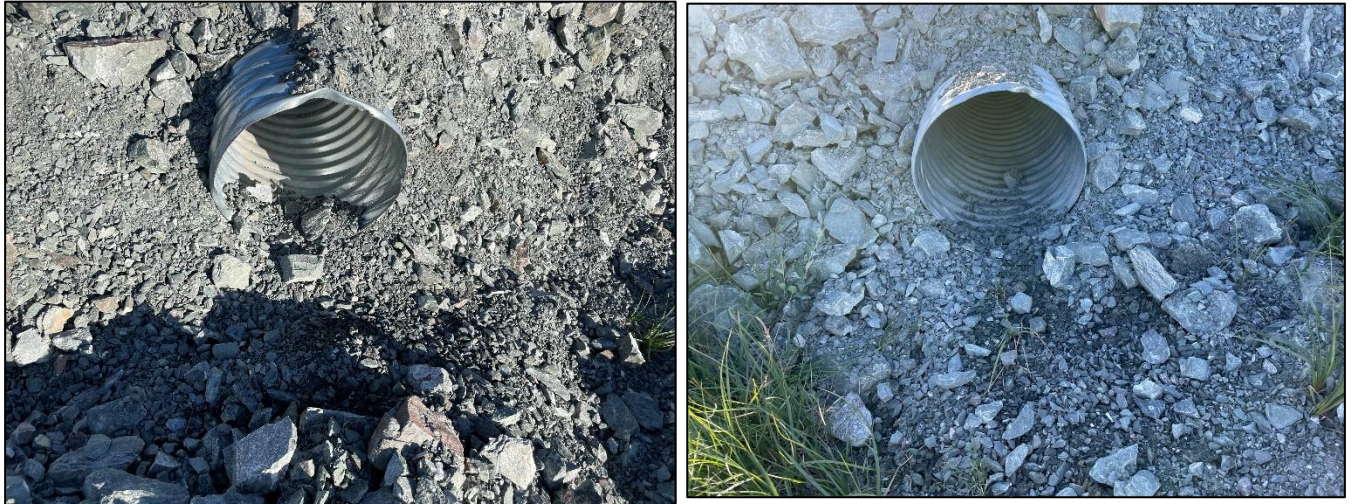
**Figure 5. Culvert at km 8 on Madrid All-Weather Road at Naartok intersection upstream (left) and downstream (right) August 2022**
