145 King Street East  
Suite 400,  
Toronto, Ontario M5C 2Y7  
416-628-0216

**February 28, 2023**

**Re: January 2023 – Monthly Monitoring Report for Water License 2AM-DOH1335**

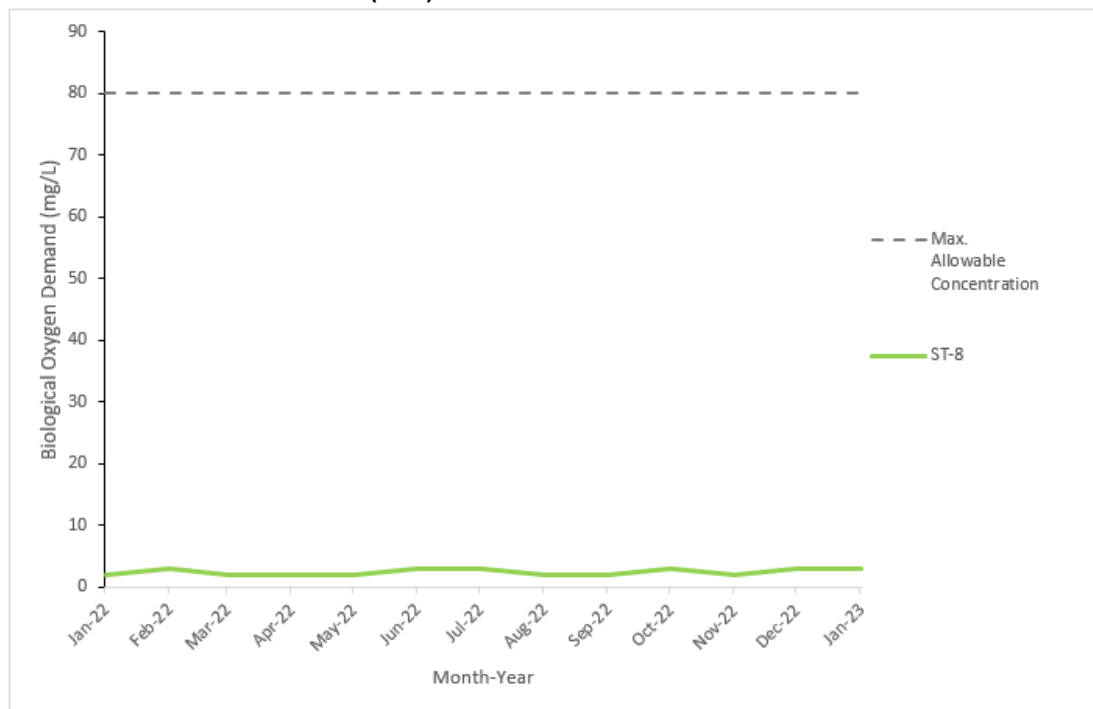
**Figure 1. Biological Oxygen Demand Results Consistently Below Discharge Criteria for Wastewater Treatment Plant (ST8)**

Note: Maximum Average Concentration as per Part F Item 4(b).

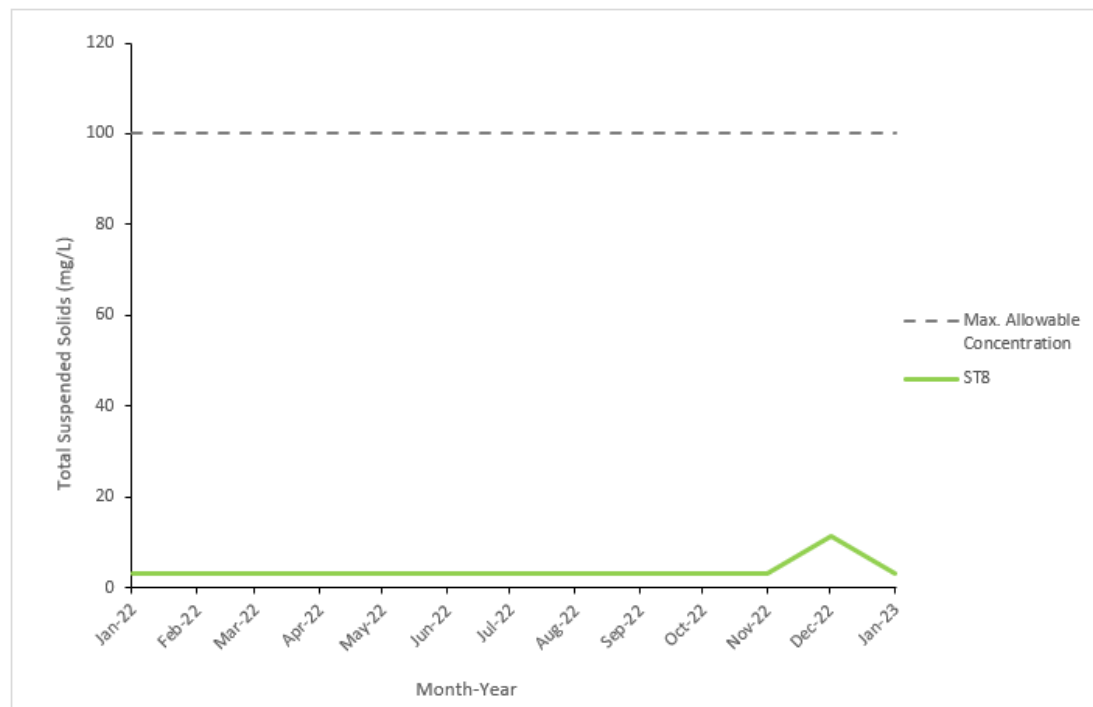
**Figure 2. Total Suspended Solids Results Consistently Below Discharge Criteria for Wastewater Treatment Plant (ST8)**

Note: Maximum Average Concentration as per Part F Item 4(b).

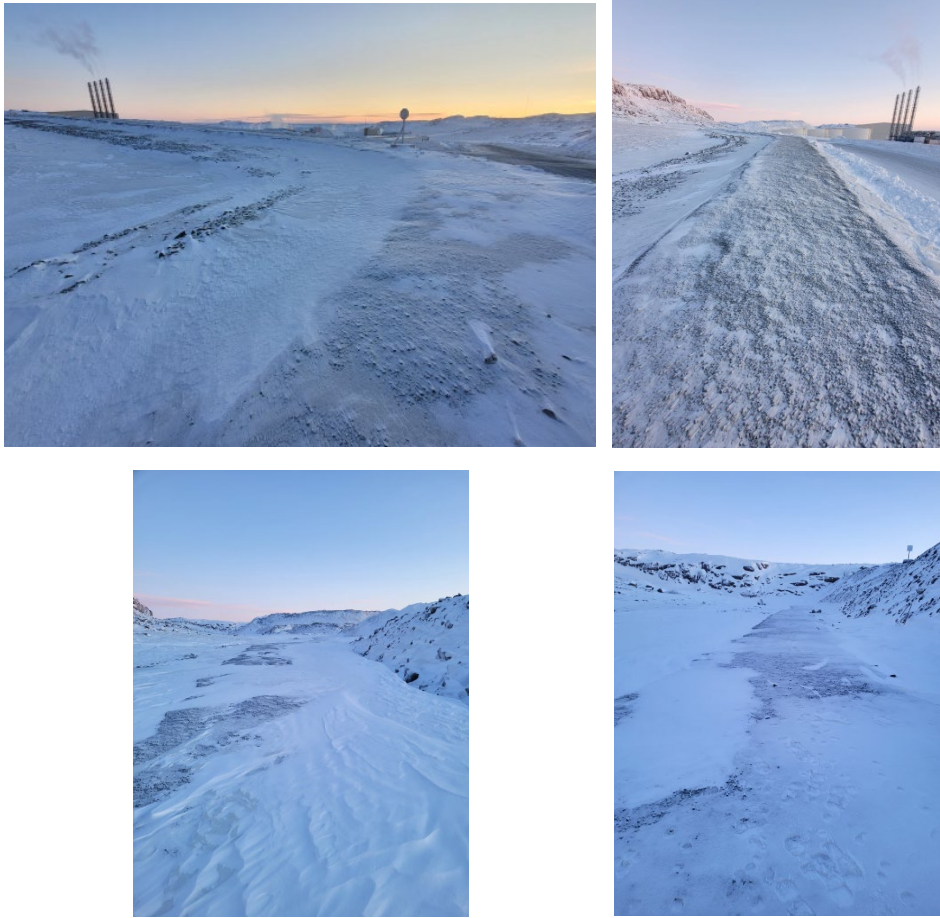
**Figure 3. Diversion berm during January 2023**

Visual monitoring was conducted at the Diversion Berm this month. No issues were identified at the Diversion Berm and associated check dam in January. Photos of this infrastructure are provided in Figure 3 below.
