Re: December 2023 – Monthly Monitoring Report for Water License 2AM-DOH1335

This report is comprised of the monitoring requirements set out in Part I and Schedule I of water licence 2AM-DOH1335 Amendment 2 (the license), and additional requirements from CIRNAC.

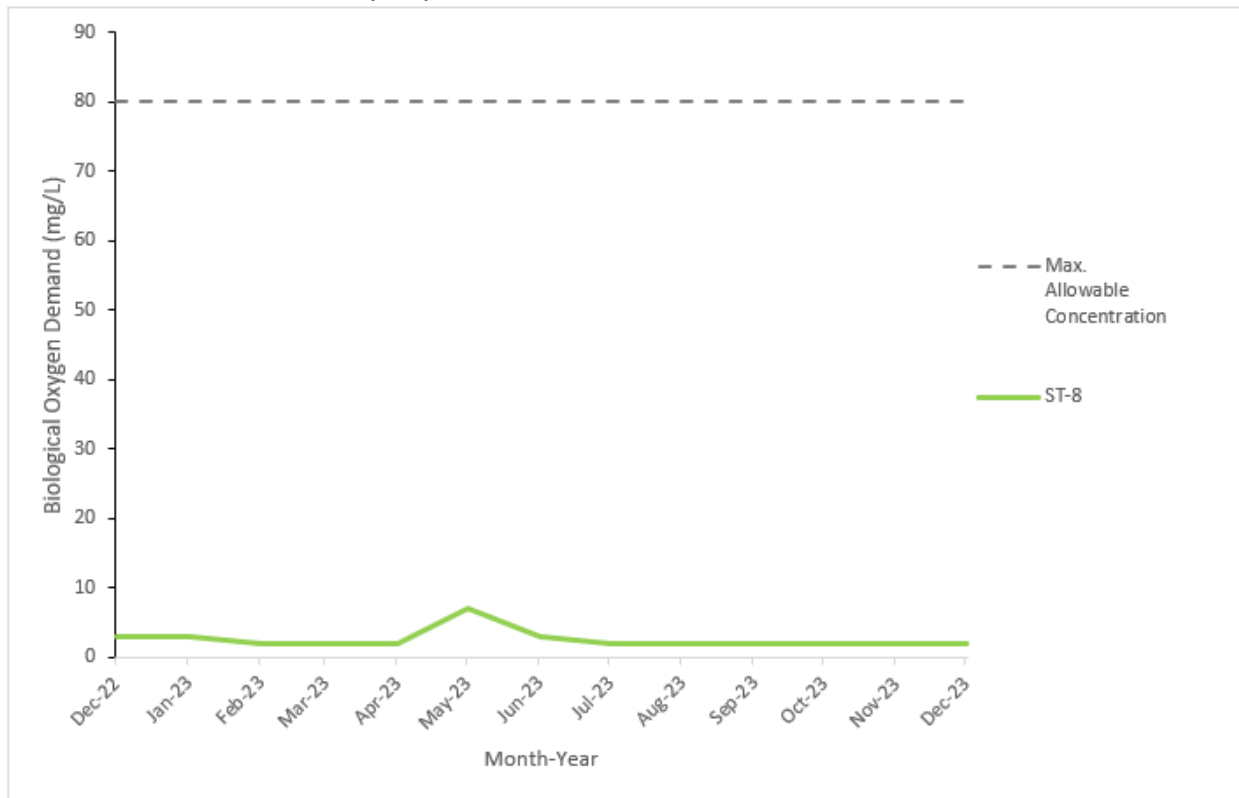
Figure 1. Biological Oxygen Demand Results Consistently Below Discharge Criteria for Wastewater Treatment Plant (ST8)

Note: Maximum Average Concentration as per Part F Item 4(b).

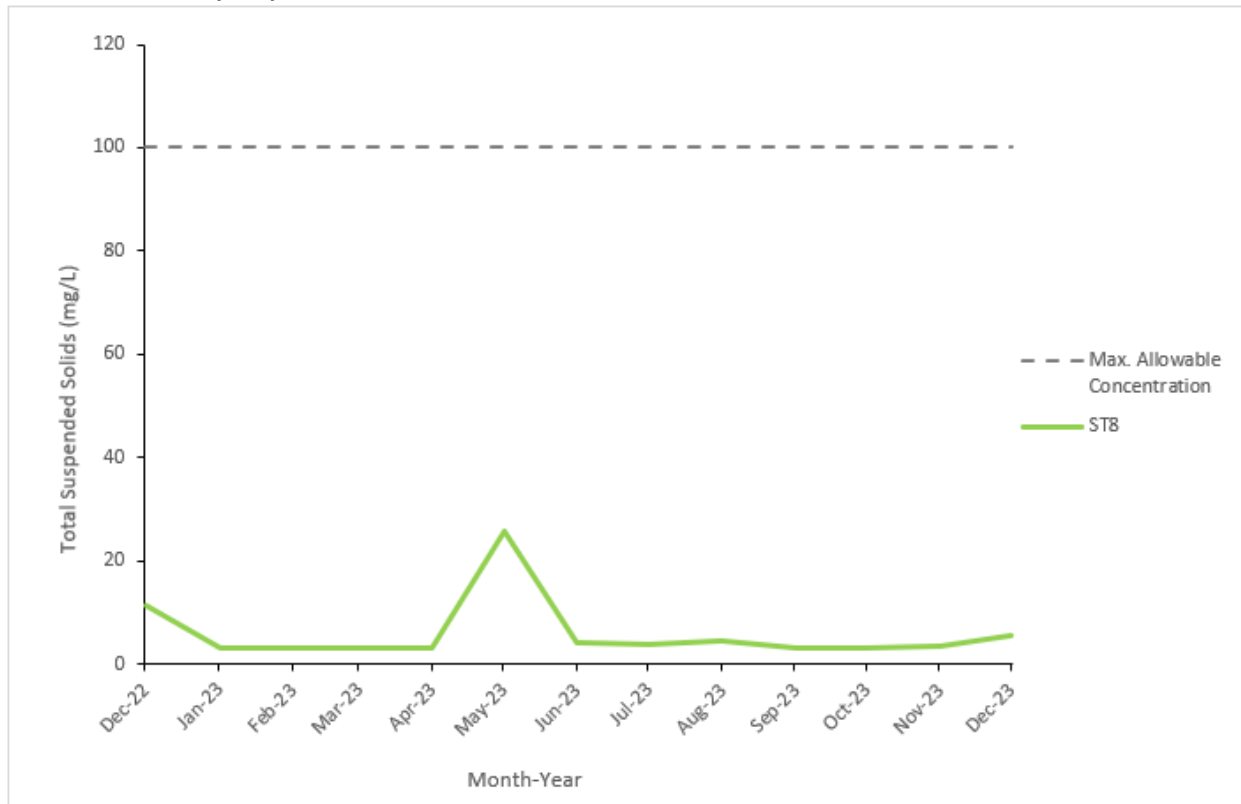
Figure 2. Total Suspended Solids Results Consistently Below Discharge Criteria for Wastewater Treatment Plant (ST8)

Note: Maximum Average Concentration as per Part F Item 4(b).
