Re: January 2024 – Monthly Monitoring Report for Water License 2AM-DOH1335

This report is comprised of the monitoring requirements set out in Part I and Schedule I of water licence 2AM-DOH1335 Amendment 2 (the license), and additional requirements from CIRNAC.

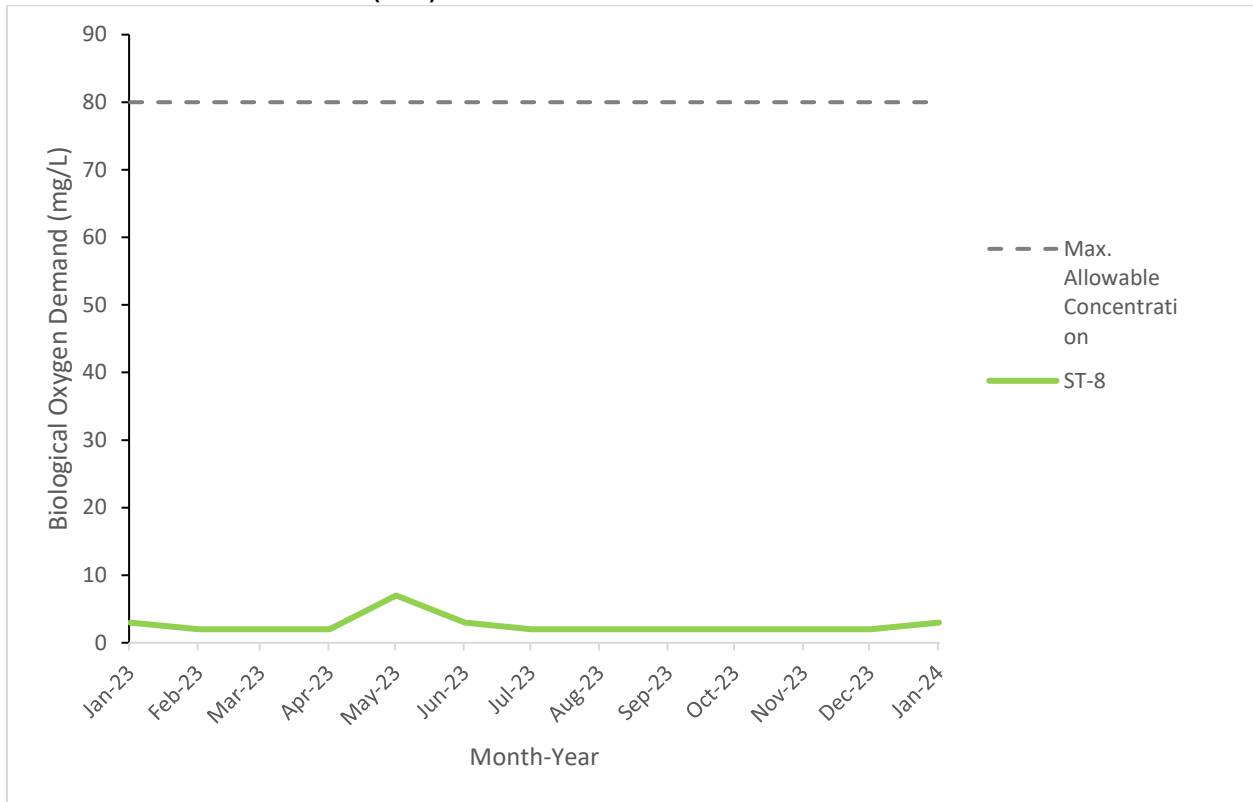
Figure 1. Biological Oxygen Demand Results Consistently Below Discharge Criteria for Wastewater Treatment Plant (ST8)

Note: Maximum Average Concentration as per Part F Item 4(b).

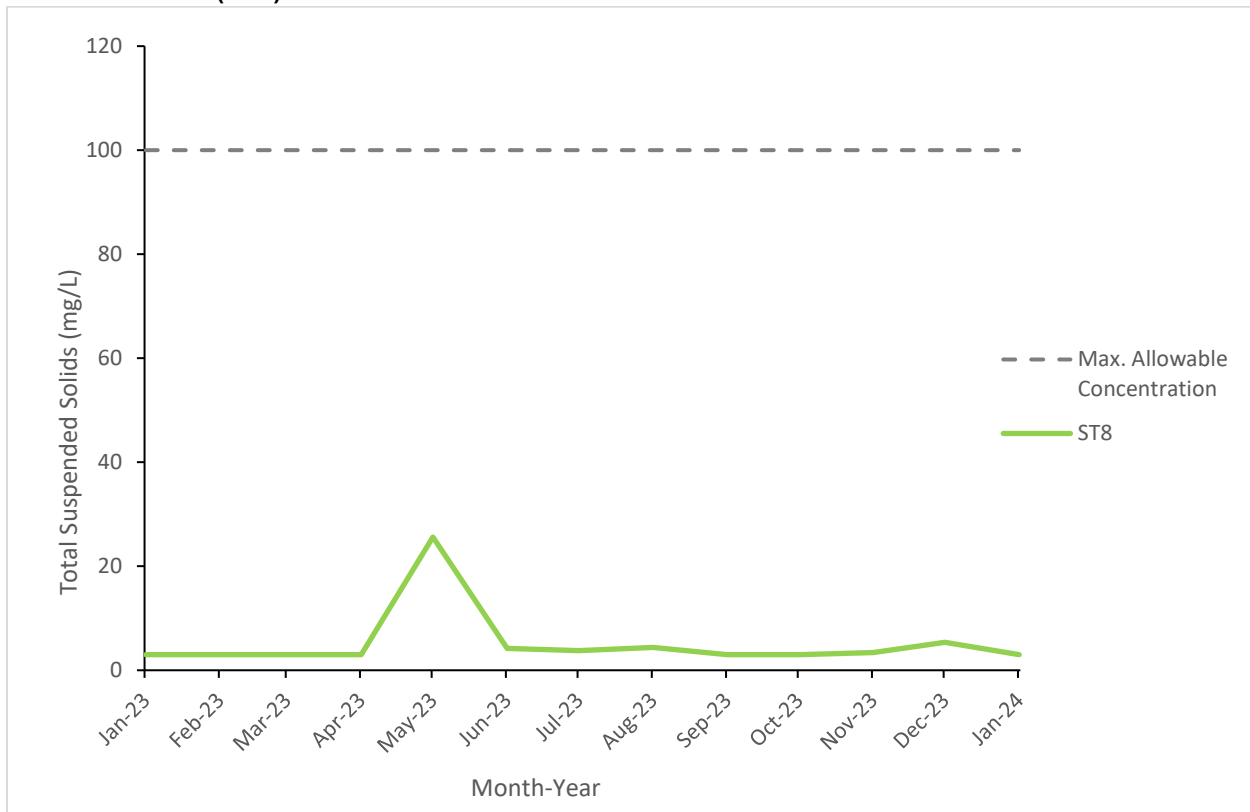
Figure 2. Total Suspended Solids Results Consistently Below Discharge Criteria for Wastewater Treatment Plant (ST8)

Note: Maximum Average Concentration as per Part F Item 4(b).

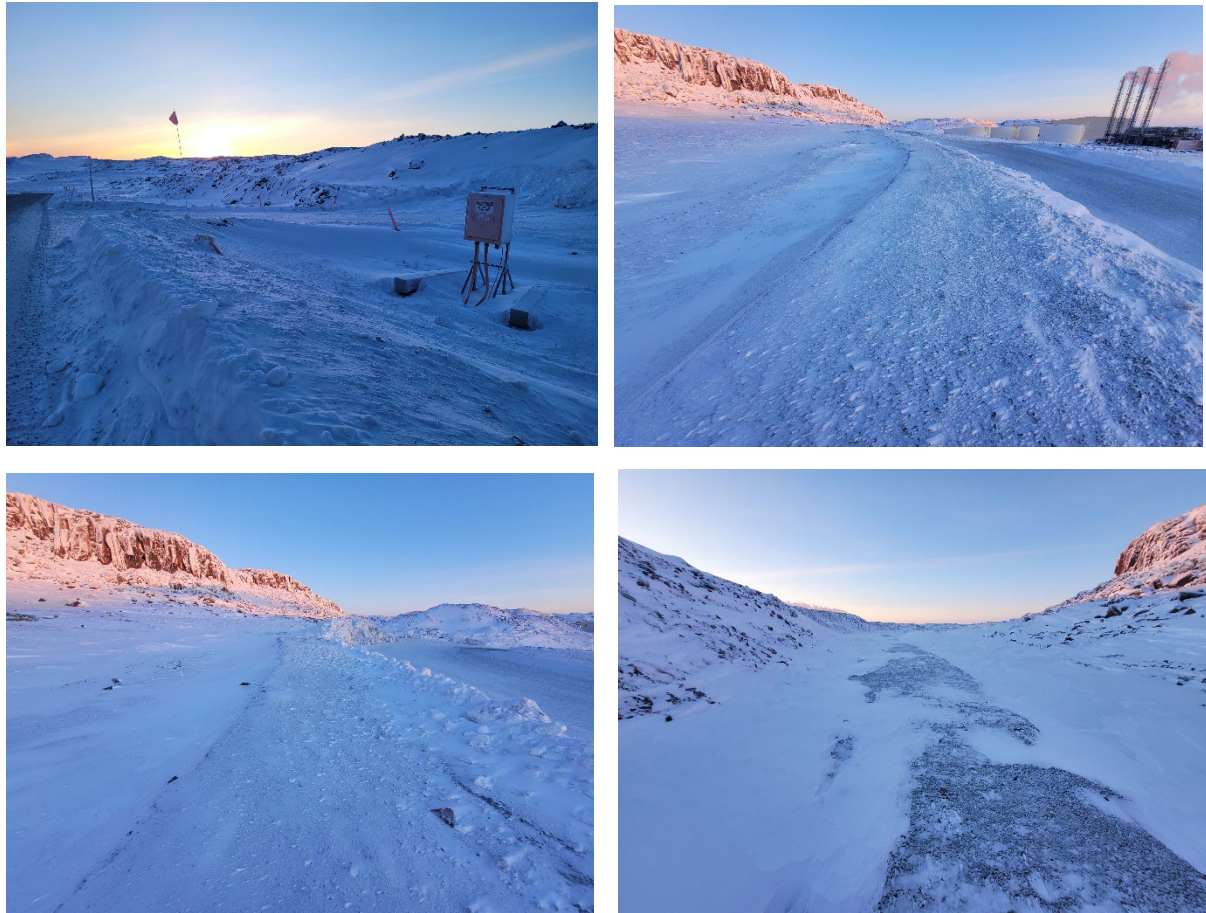
Figure 3. Diversion berm during January 2024

Visual monitoring was conducted at the Diversion Berm this month. No issues were identified at the Diversion Berm and associated check dam in January. Photos of this infrastructure are provided in Figure 3 below.
