**DORIS TIA**

| 2018 Annual Geotechnical Inspection | | |
| Station 0+60<br>Horizontal Ground Temperature<br>Cable Temperature Vs. Time | | |

2018 Annual Geotechnical Inspection

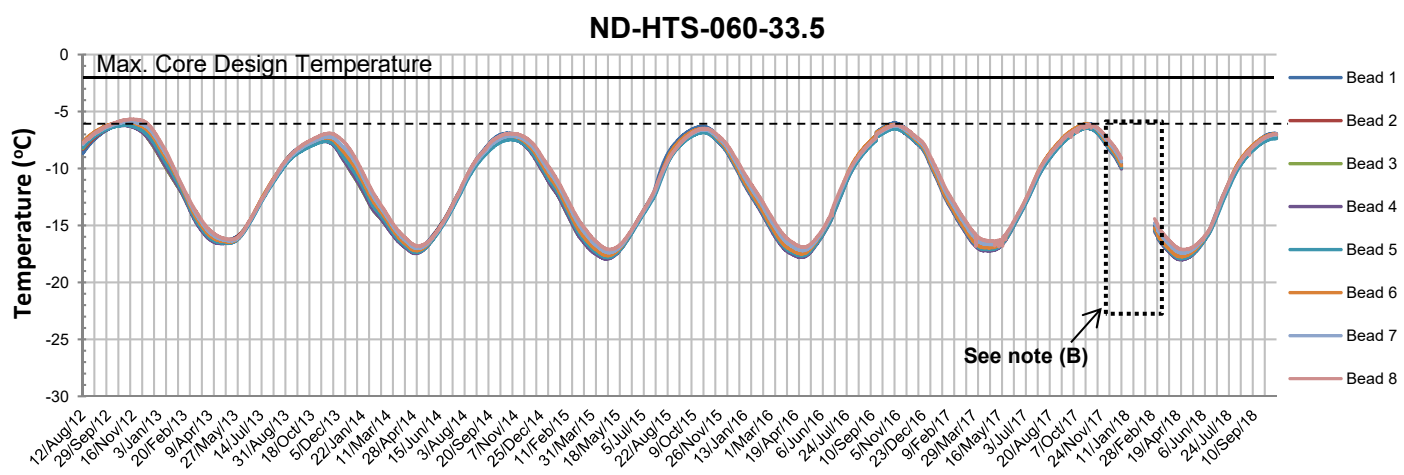
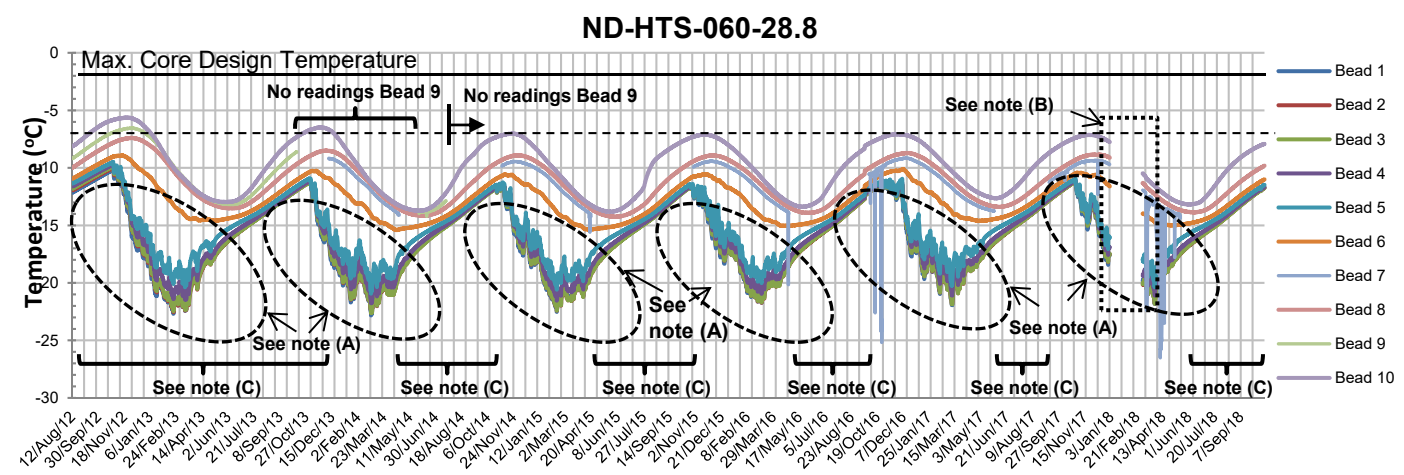
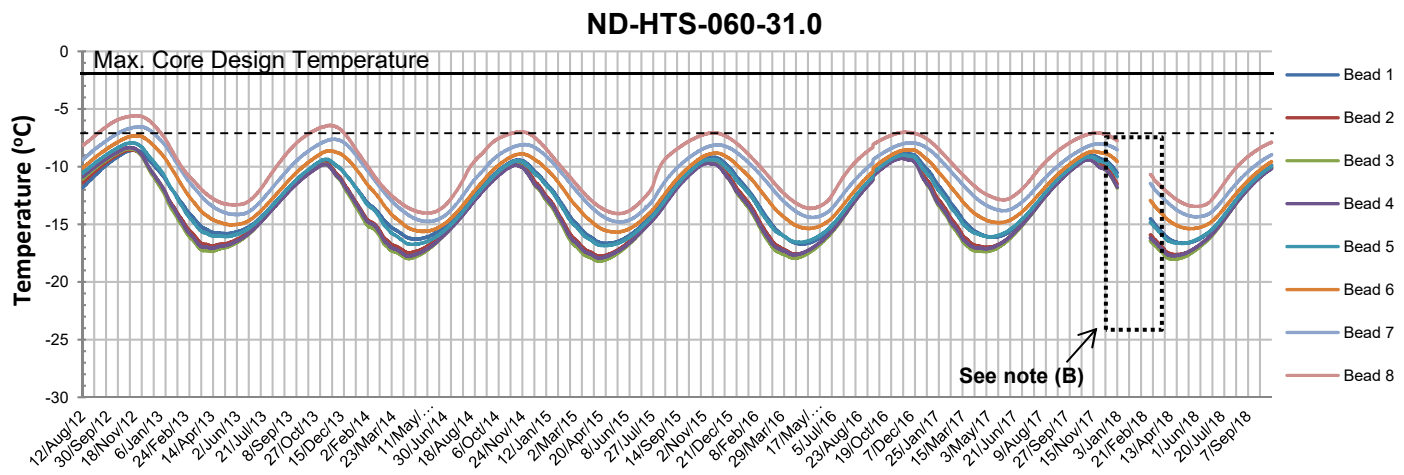
| Date:<br>Jan. 2019 | Approved:<br>PL | Figure:<br><b>B.3</b> |

- Notes:**
- Bead numbers increase from downstream to upstream (horizontal) and top to bottom (vertical)
  - **(A)** Variation in Ground Temperature Cable readings during winter months due to close proximity of Ground Temperature Cable beads to thermosyphon pipes.
  - **(B)** Data logger was disconnected from January 1, 2018 to March 3, 2018 for recalibration
  - **(C)** No readings from Bead 7

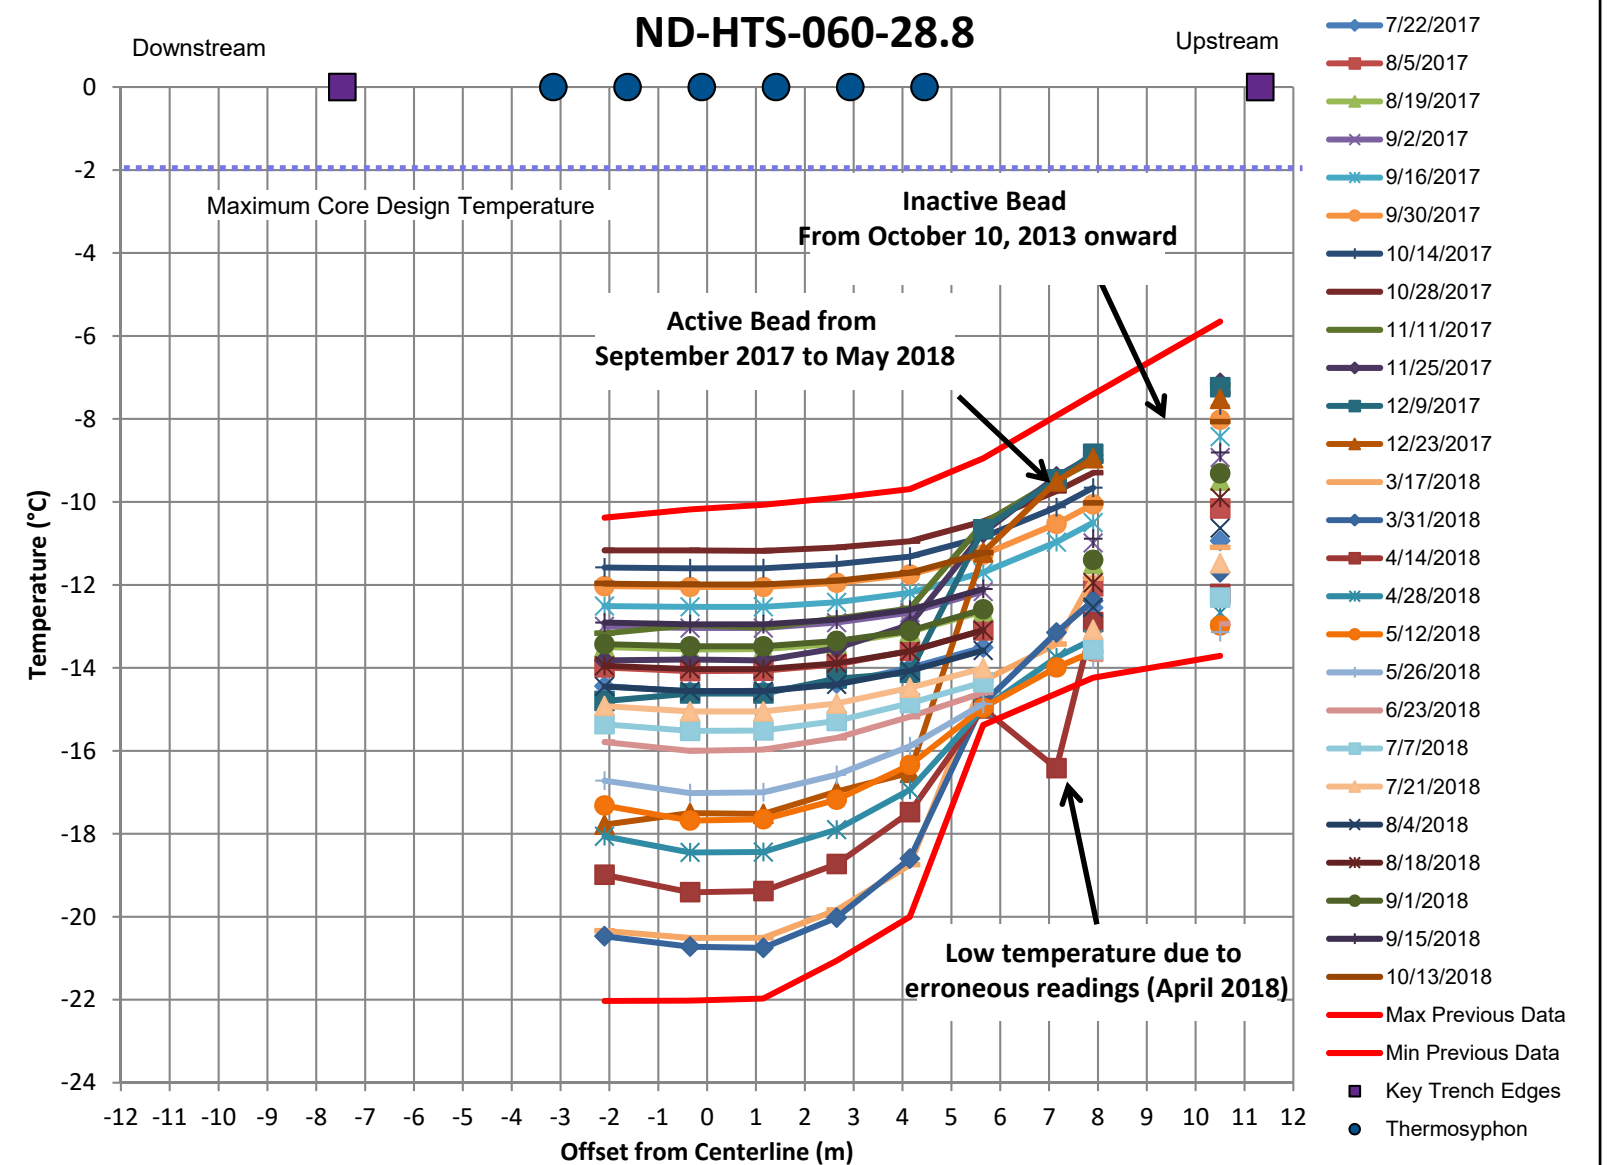
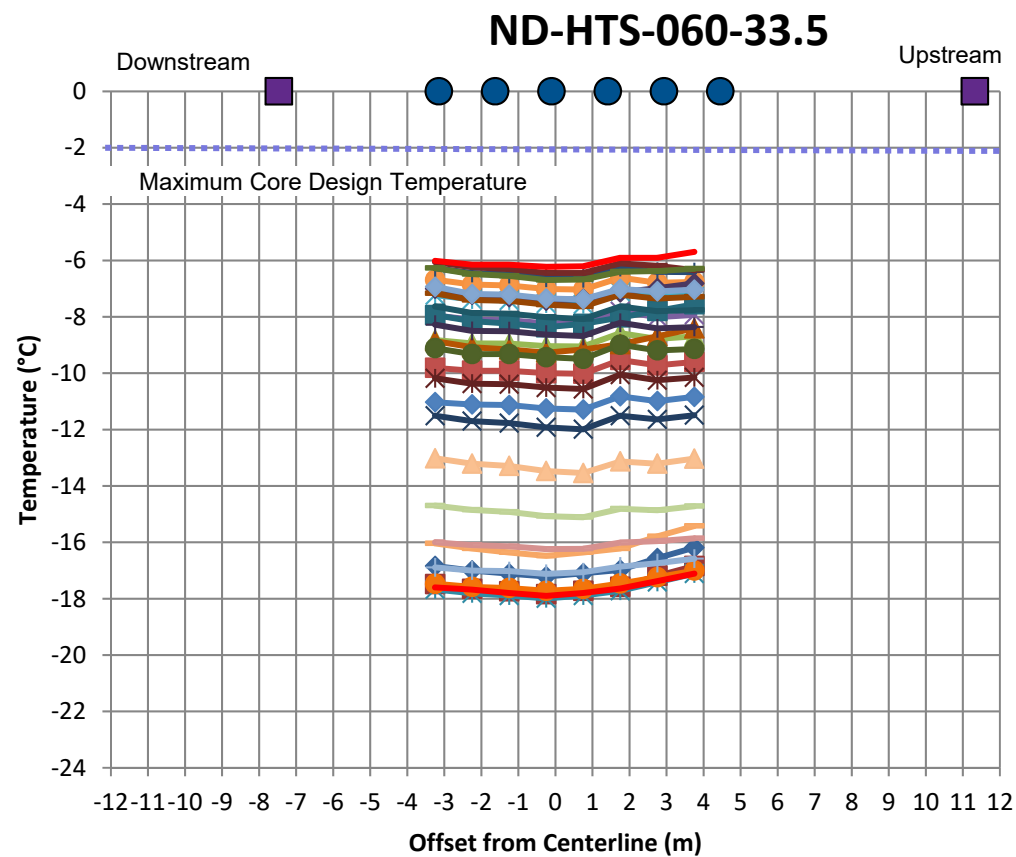
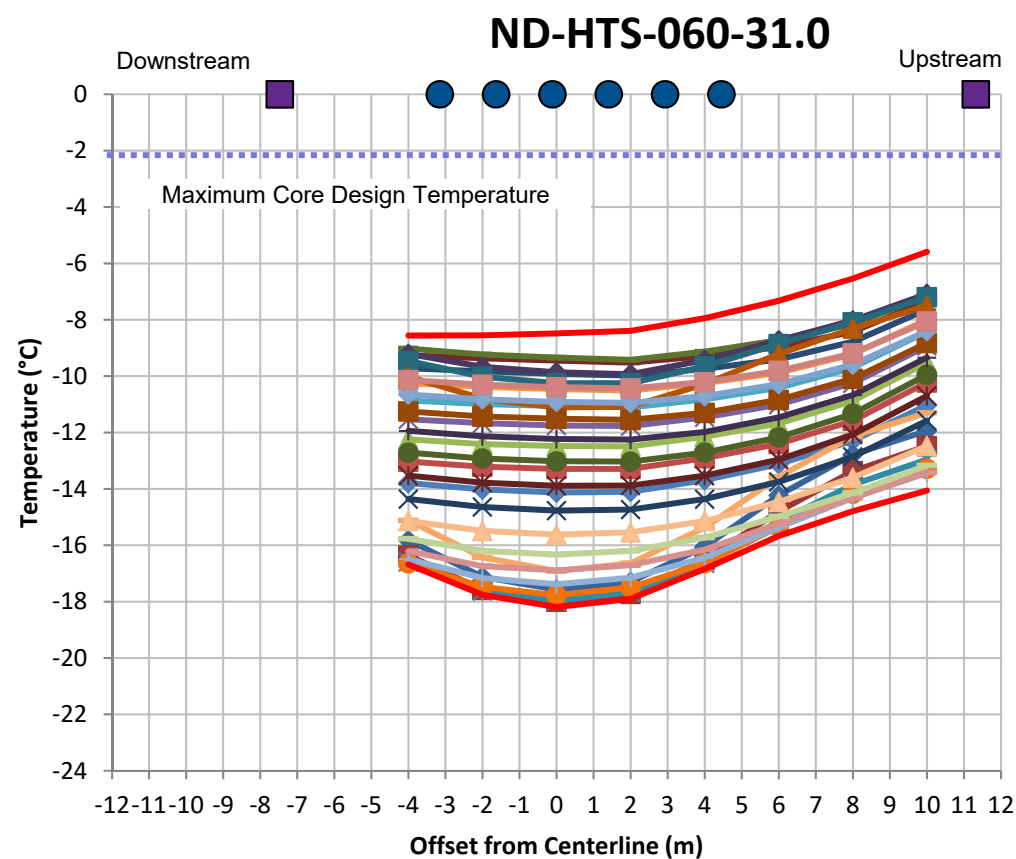
Date: Jan. 2019  
Approved: PL  
Figure: B.4

- Previous Data was recorded between August 2012 and July 2017
- Data logger was disconnected from January 1, 2018 to March 3, 2018 for recalibration
