DORIS TIA

2018 Annual Geotechnical Inspection

**Station 1+30**  
**Horizontal Ground Temperature**  
**Cable Temperature Vs. Time**

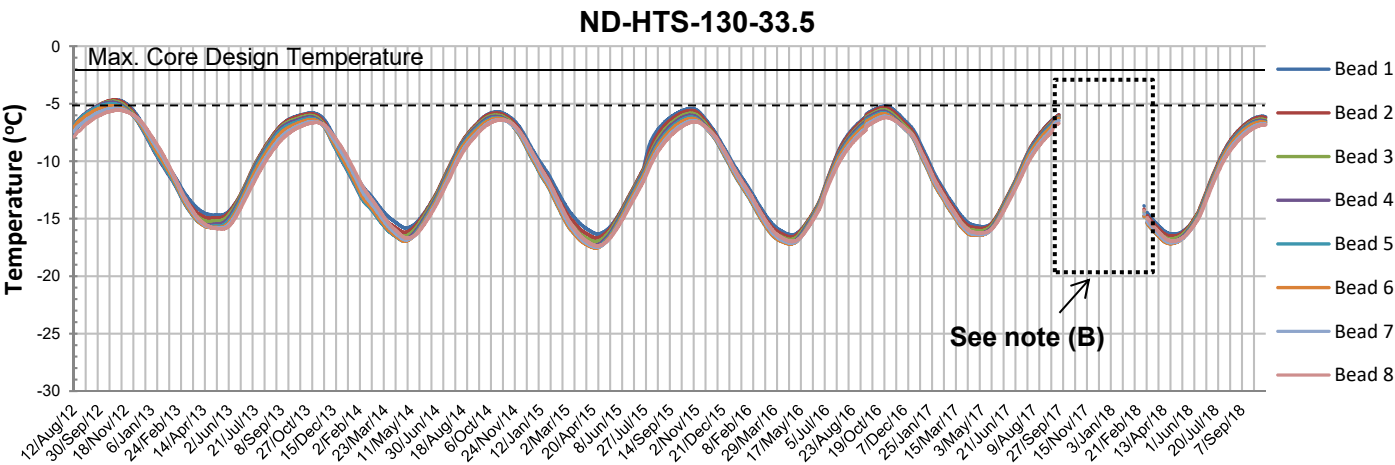
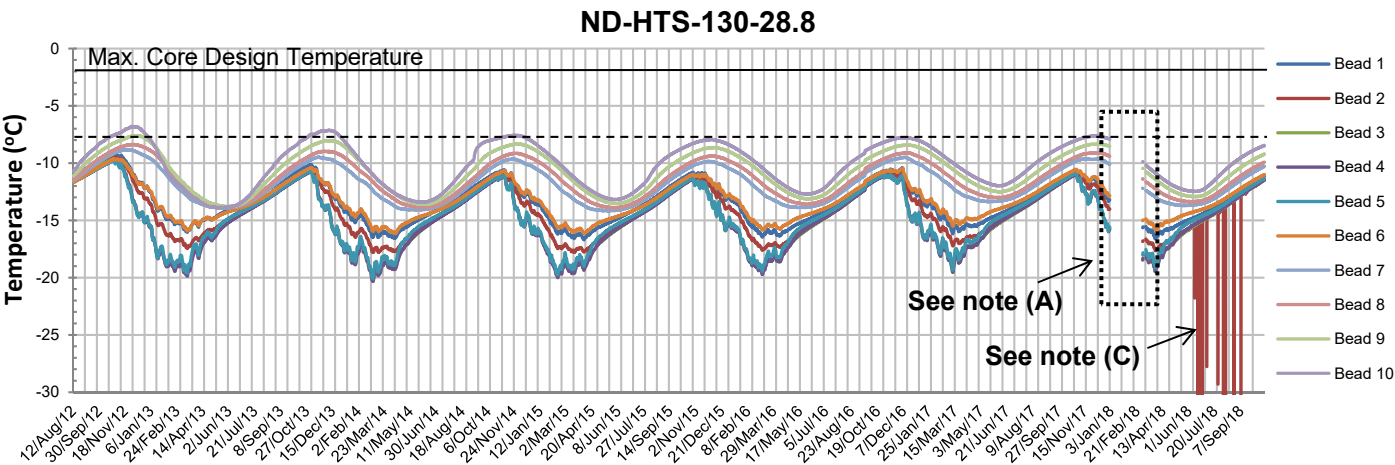
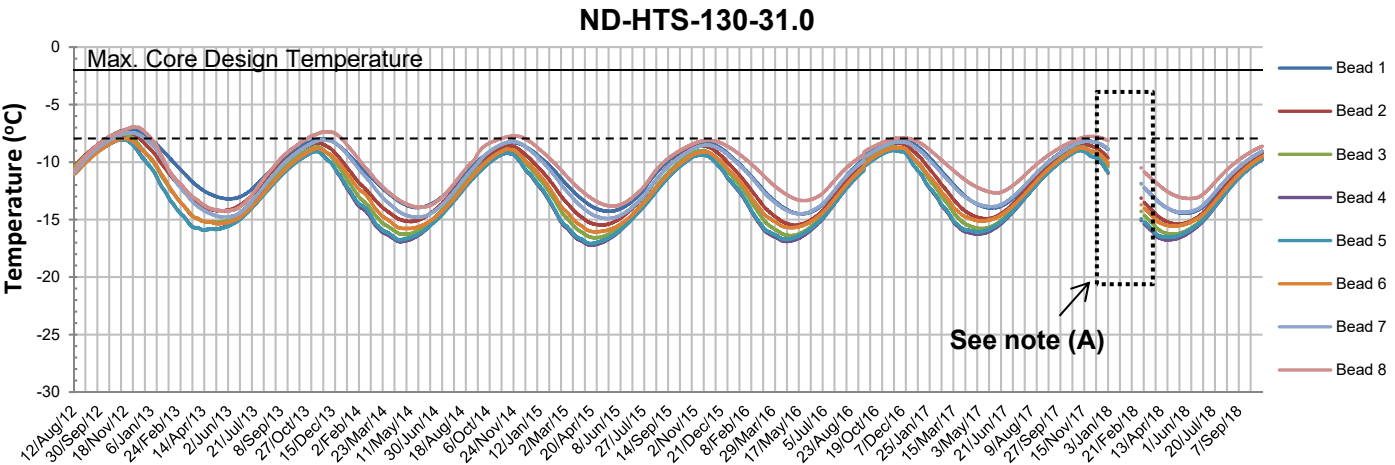
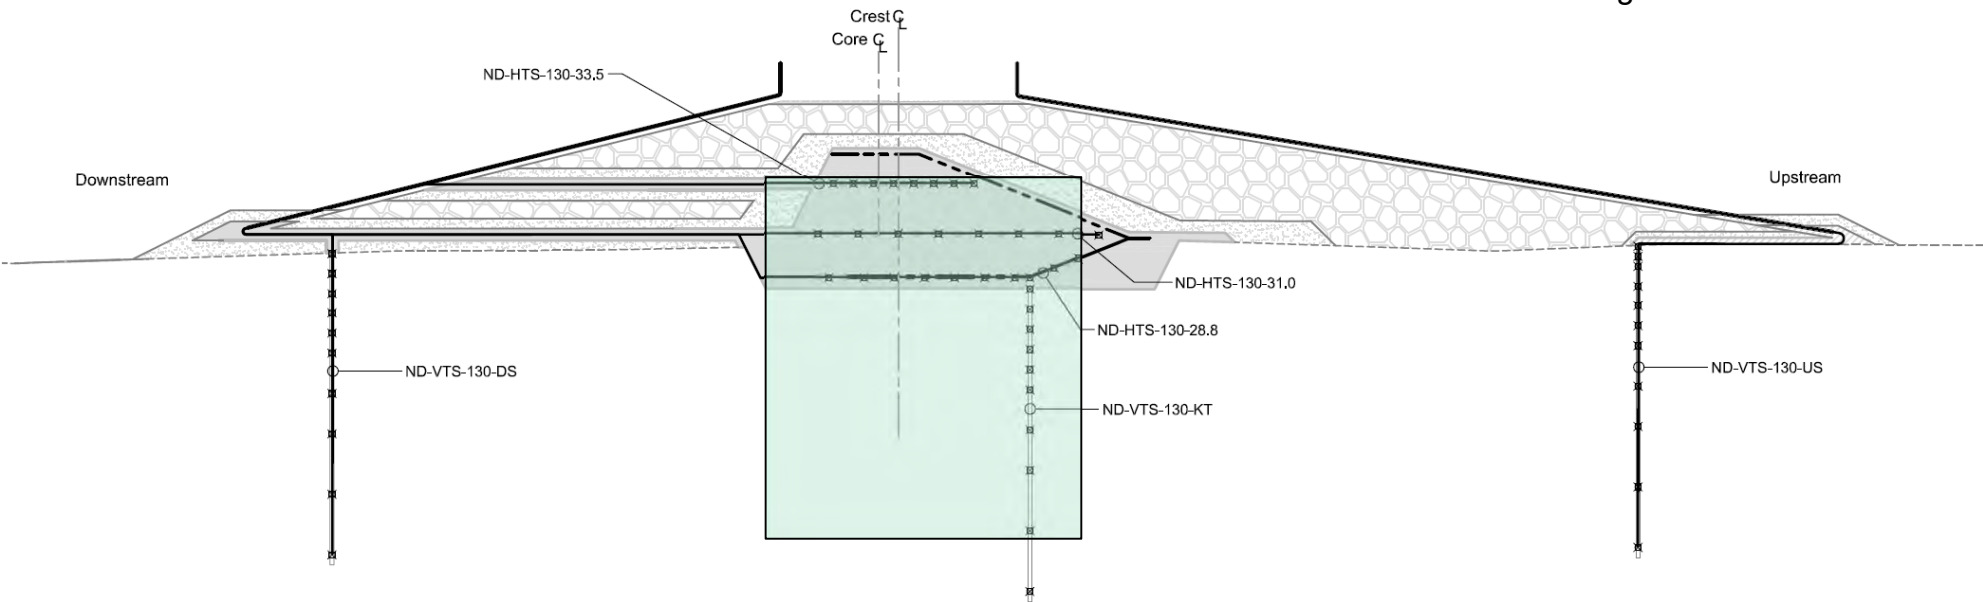
Date: Jan. 2019  
Approved: PL  
Figure: **B.11**

- Notes:**
- Bead numbers increase from downstream to upstream (horizontal) and top to bottom (vertical)
  - (A) Data logger was disconnected from January 1, 2018 to March 3, 2018 for recalibration
  - (B) ND-HTS-130-33.5 was disconnected from September 24, 2018 to March 3, 2018 due to damage of the cable lead at the datalogger housing. The lead was repaired prior to the reconnection of the datalogger.
  - (C) Low temperature spikes and intermittent data logging from Bead 2 of ND-HTS-130-28.8 were observed in the Summer of 2018. Likely a data logger issue, these spikes will be monitored.

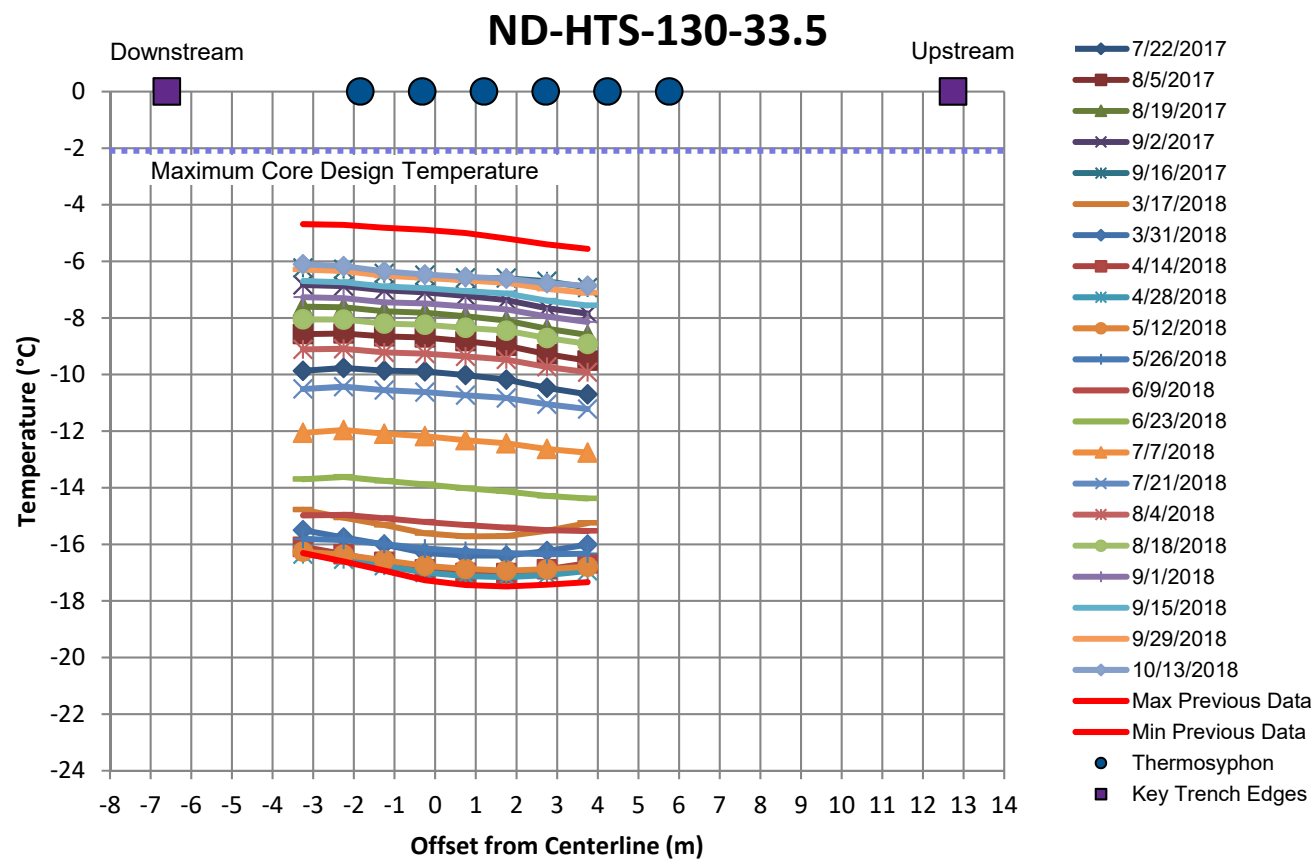
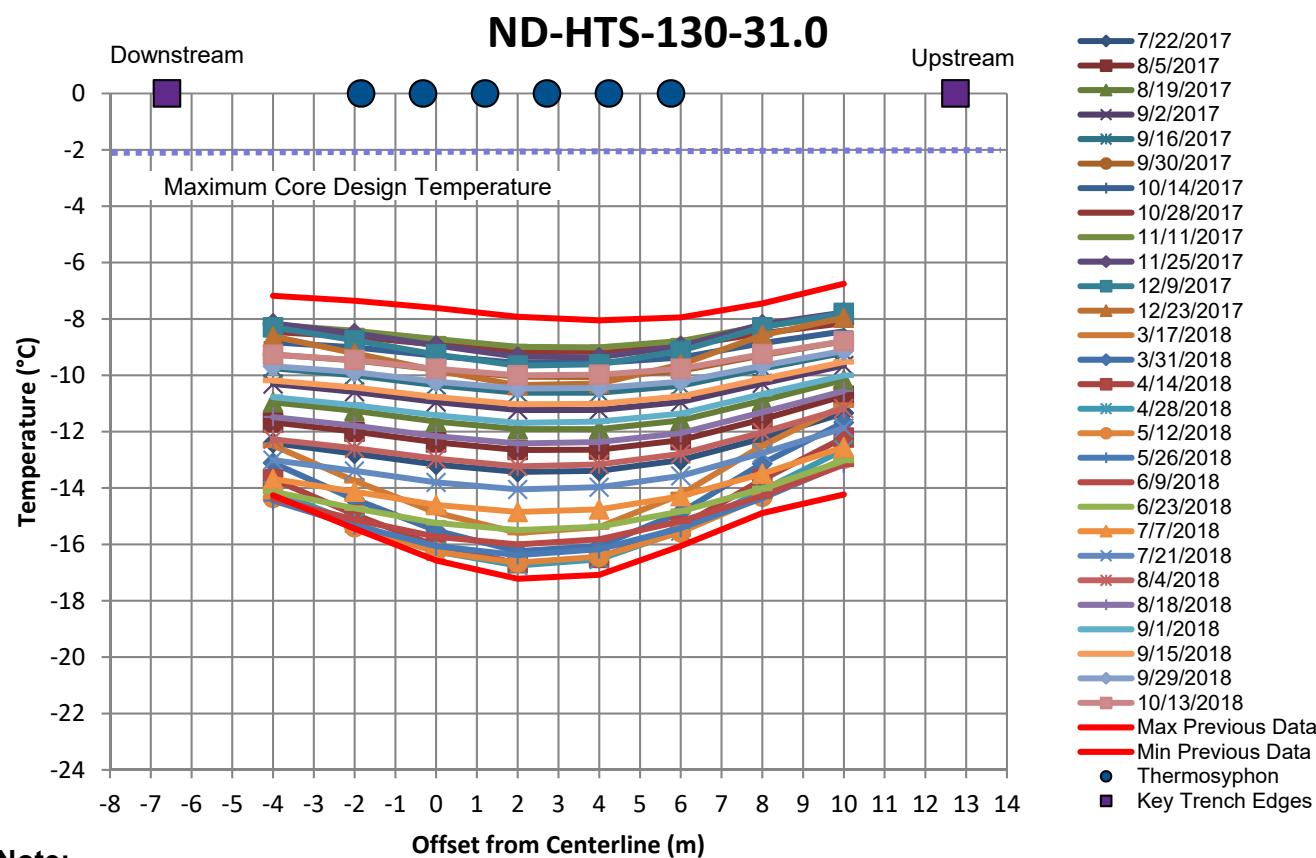
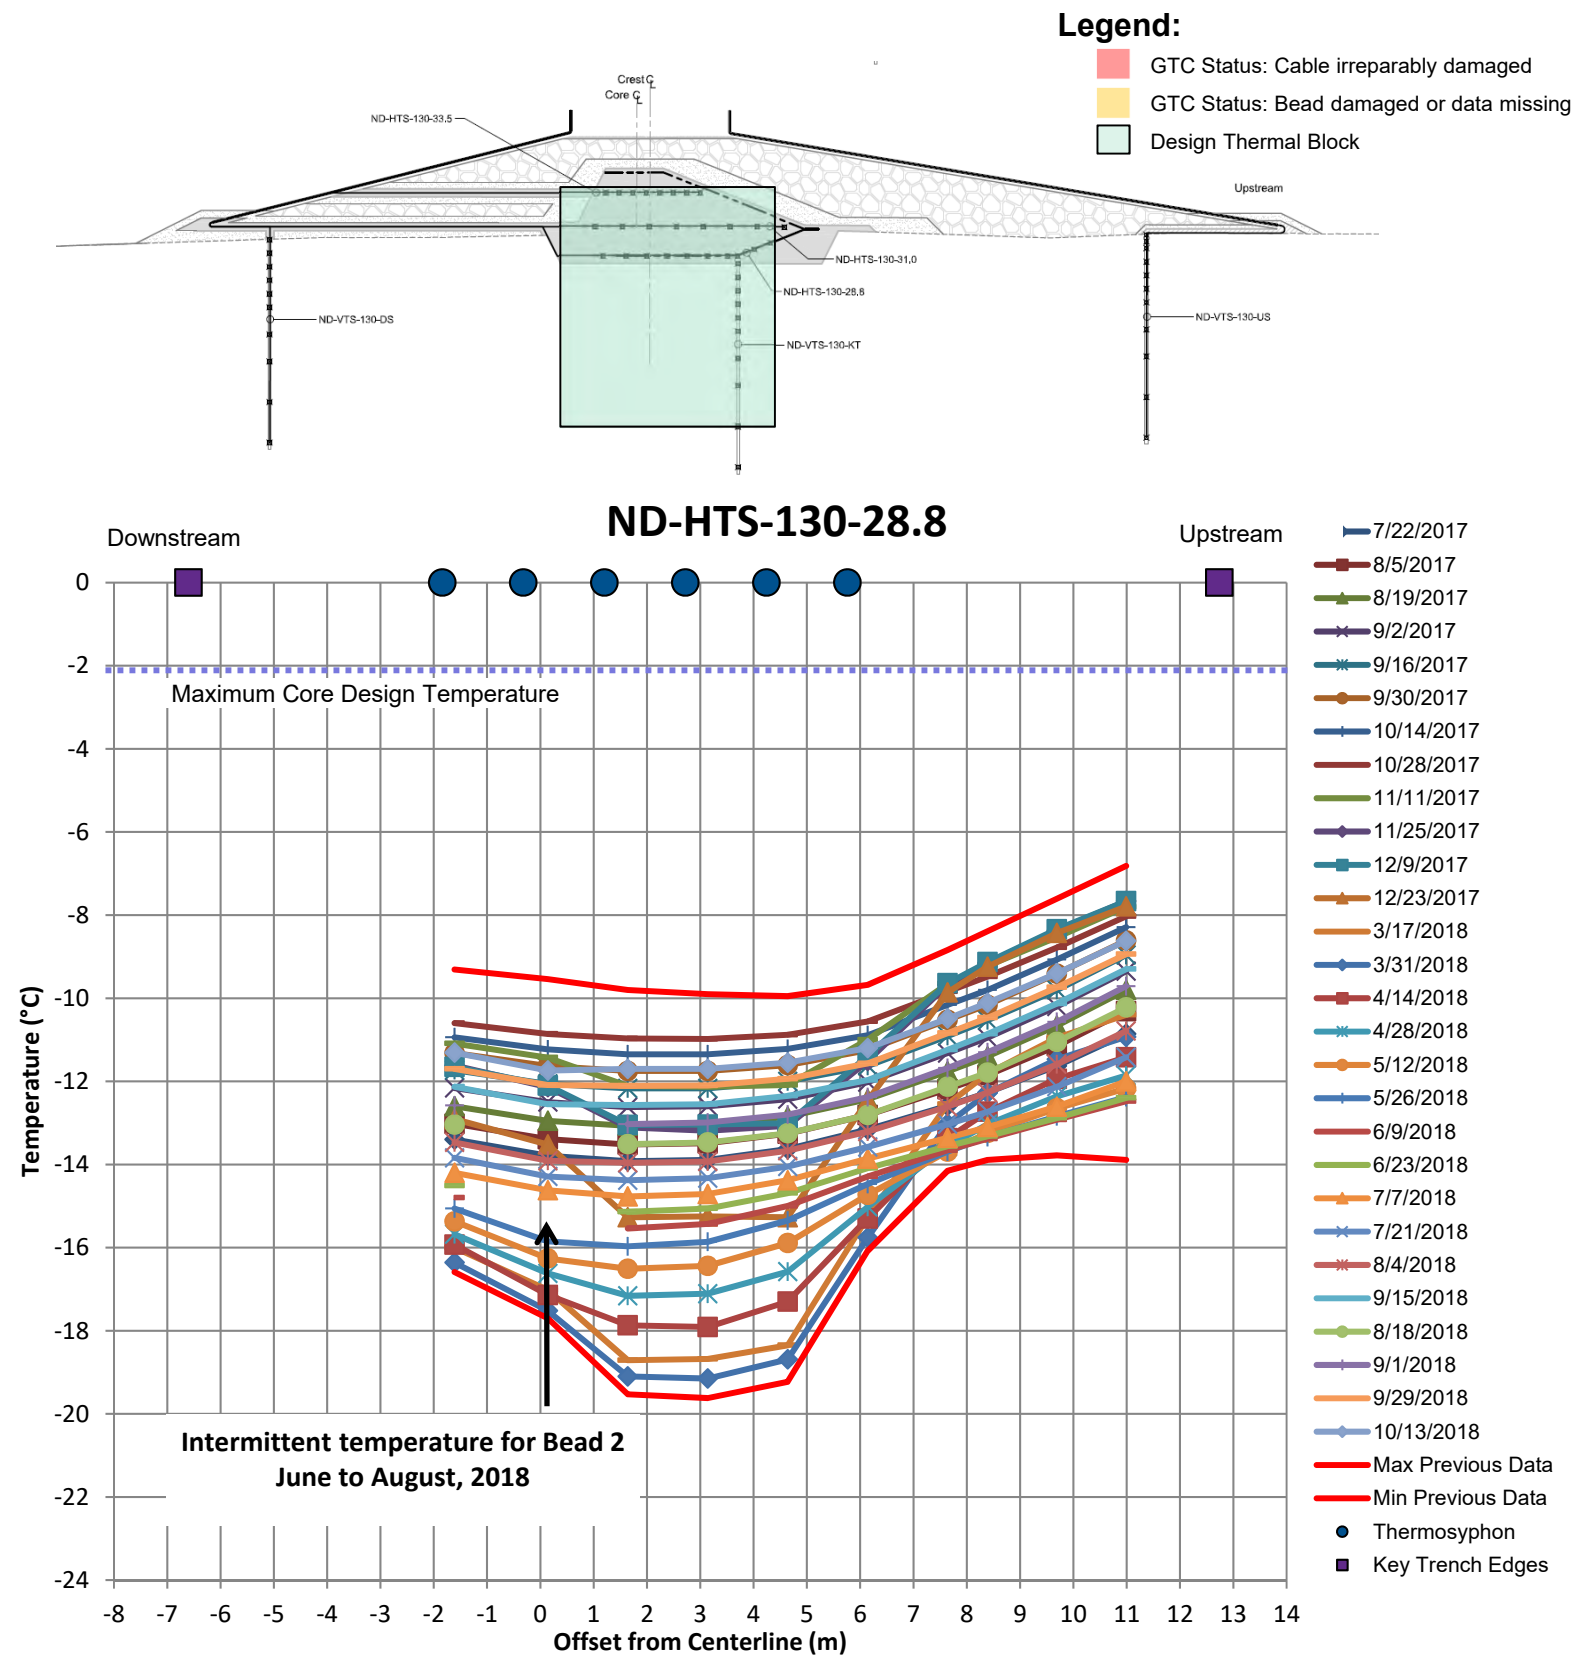
Date: Jan. 2019  
Approved: PL  
Figure: **B.12**

- Previous Data was recorded between August 2012 and July 2017
- Data logger was disconnected from January 1, 2018 to March 3, 2018 for recalibration
- The cable lead of ND-HTS-130-33.5 was damaged and repaired prior to the reconnection of the data logger following recalibration No readings recorded between September 24 and March 3, 2018
