2018 Annual Geotechnical Inspection

**DORIS TIA**

## Appendix G – Walk Over Surveys

# North Dam Weekly Walkover Survey Report

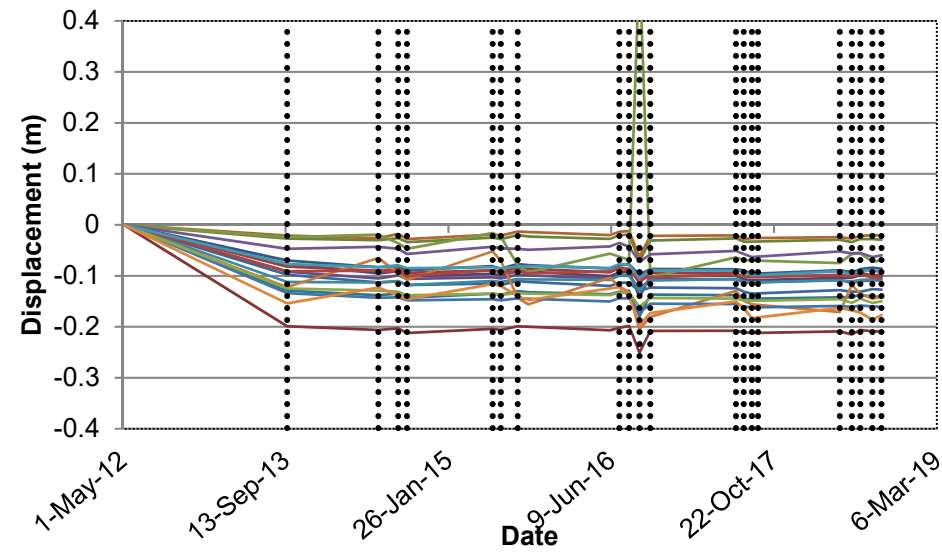
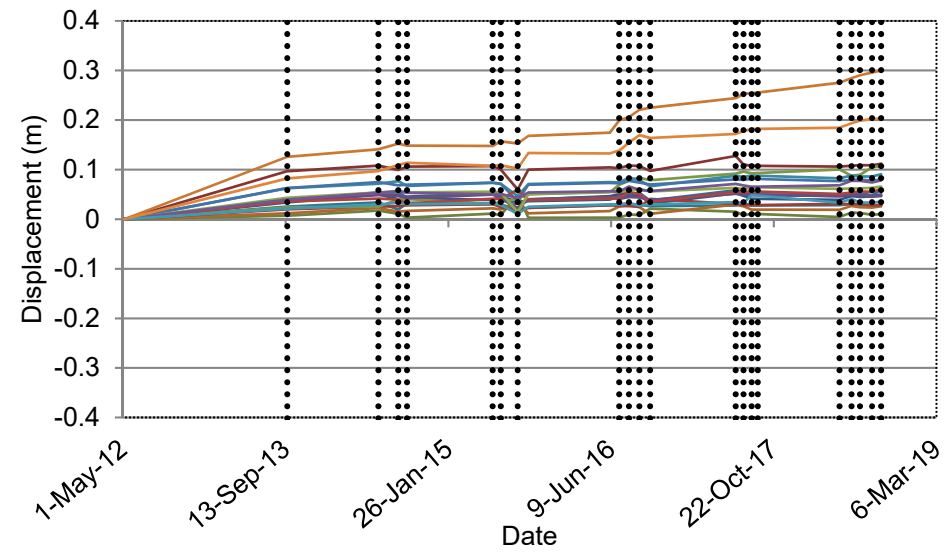
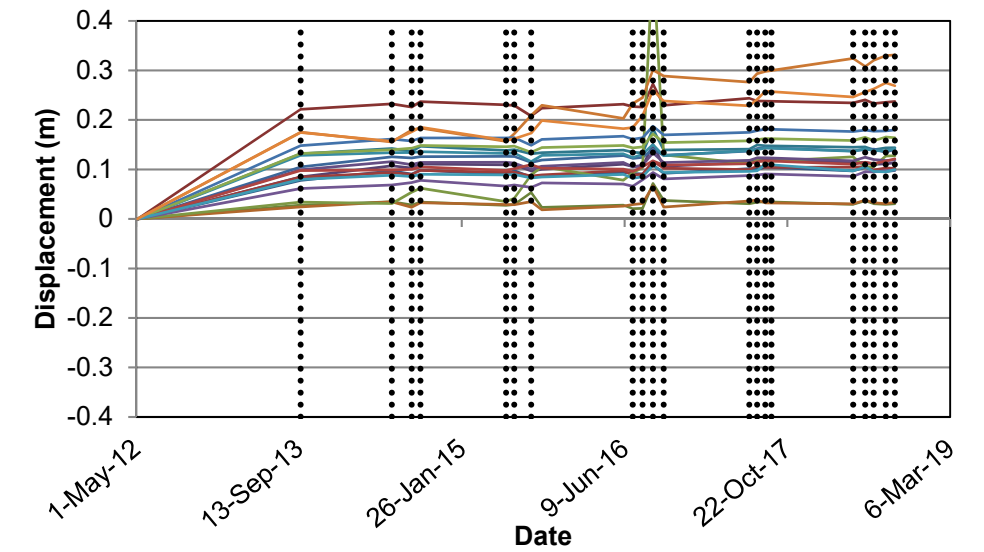
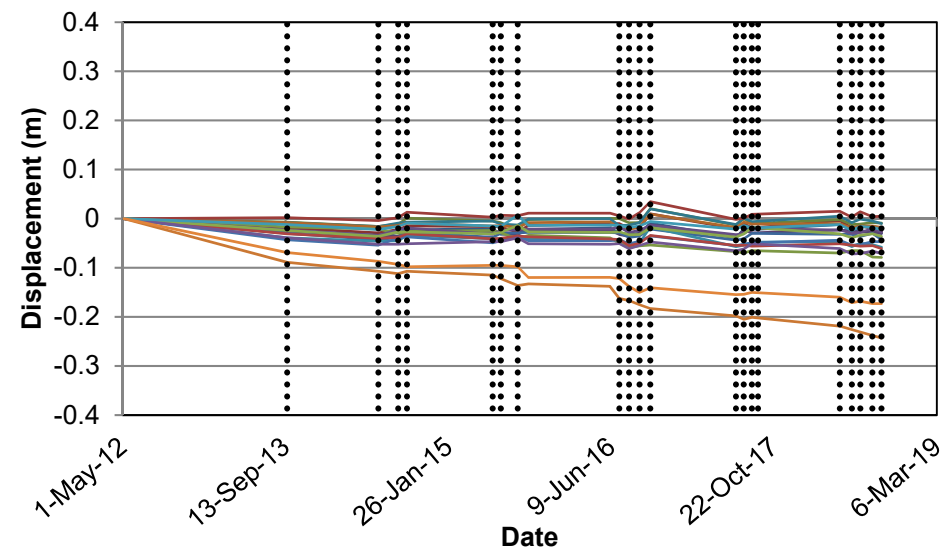
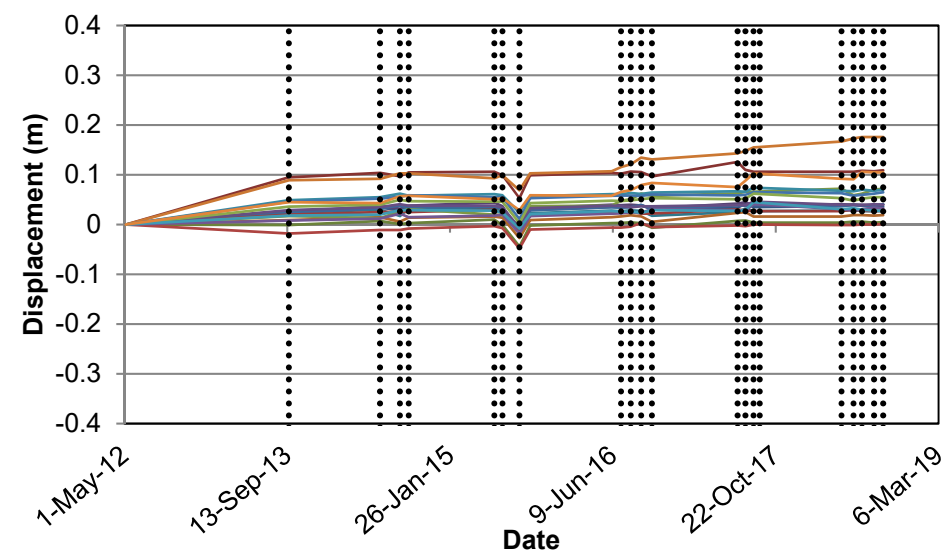
Surface Survey Monitoring Points  
Displacement Timeseries

1. The anomolous horizontal displacement observed are Settlement point ND-SSP-110-3 and ND-SSP-155-2 near the downstream toe of the dam.

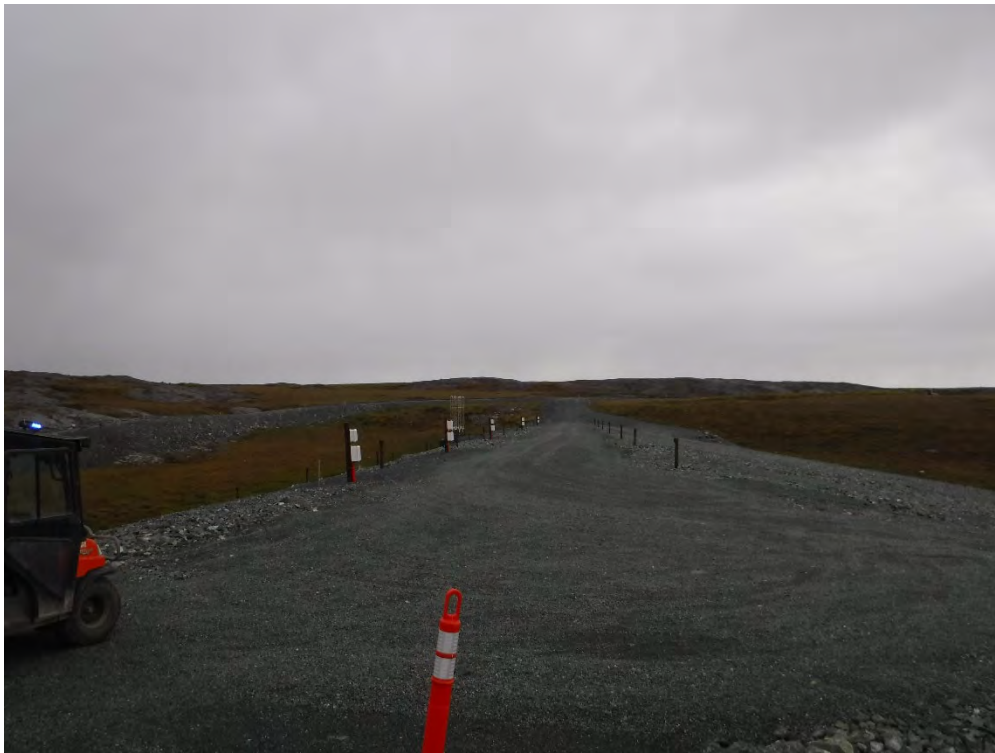
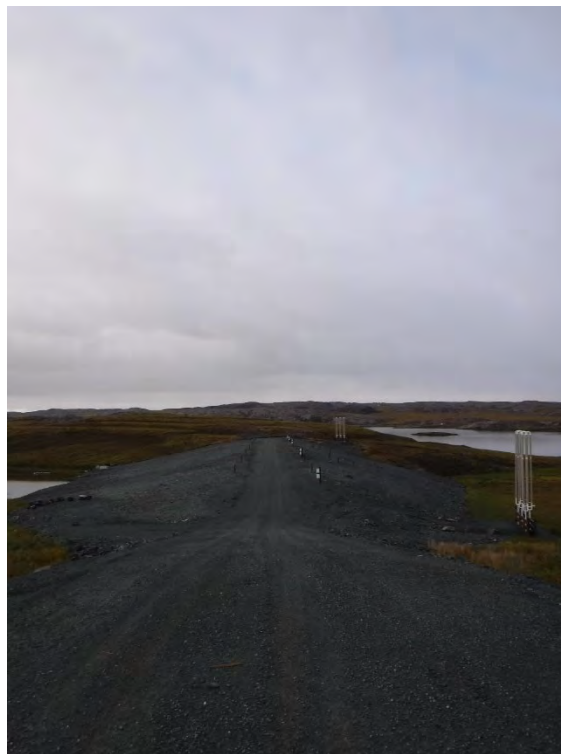
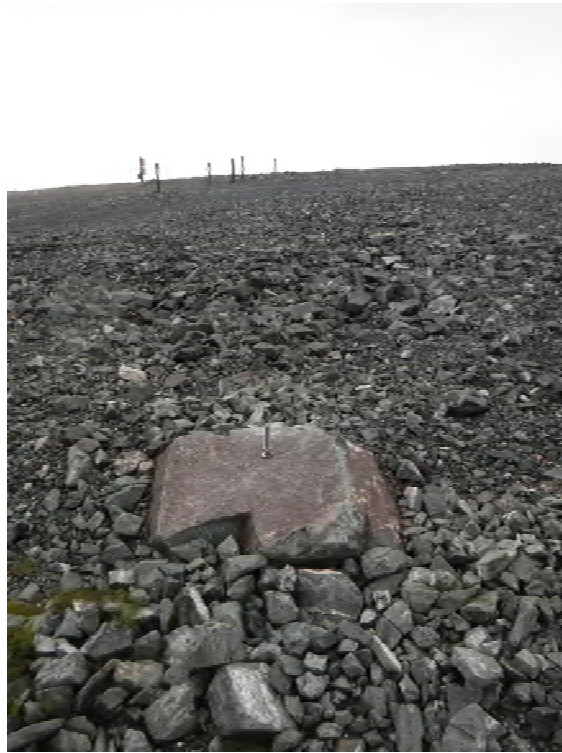
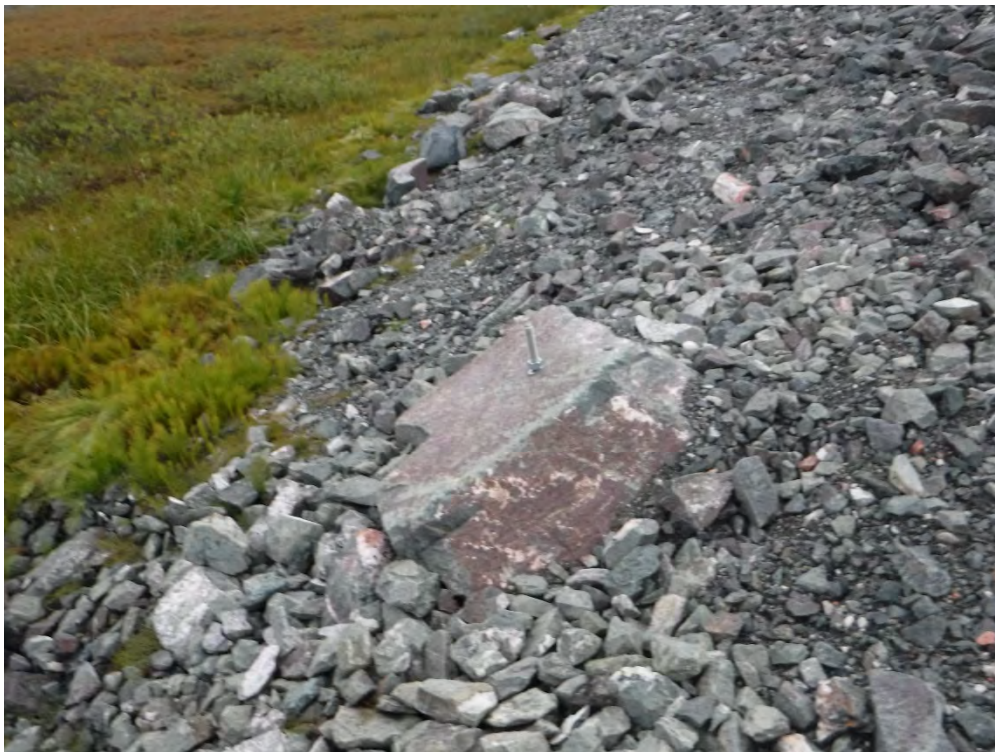
cracks @ upstream part near road  
 pictures of ND-SSP-110-3 & ND-SSP-155-2
