# North Dam Weekly Walkover Survey Report

2018 Annual Geotechnical Inspection

## Memo

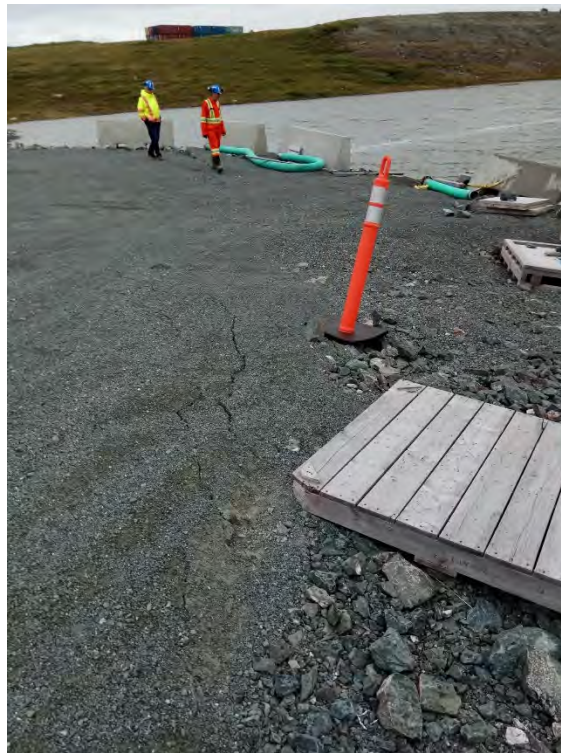
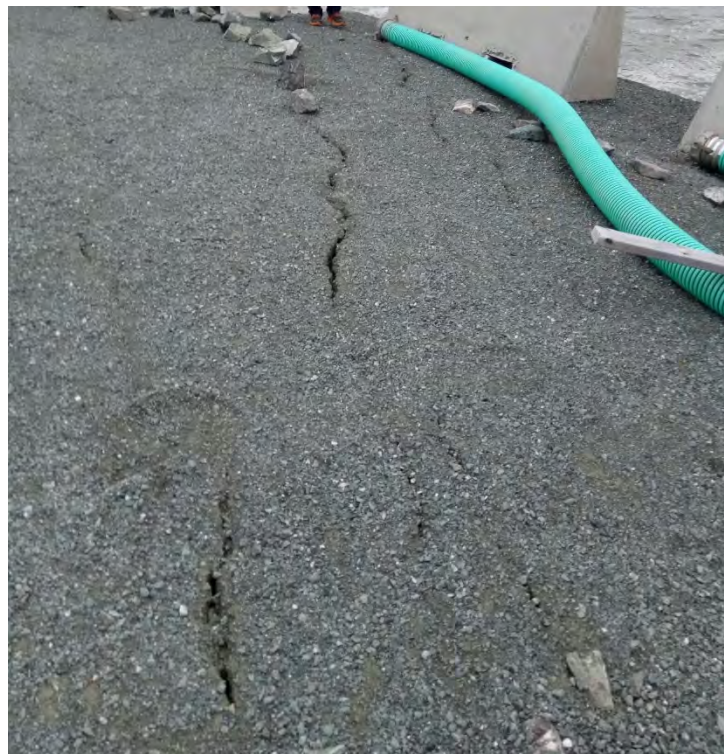
Small crack at the fine gravel close to the water. It might exist long time. We have not done the inspection for a while not sure this exists before. It's very minor.

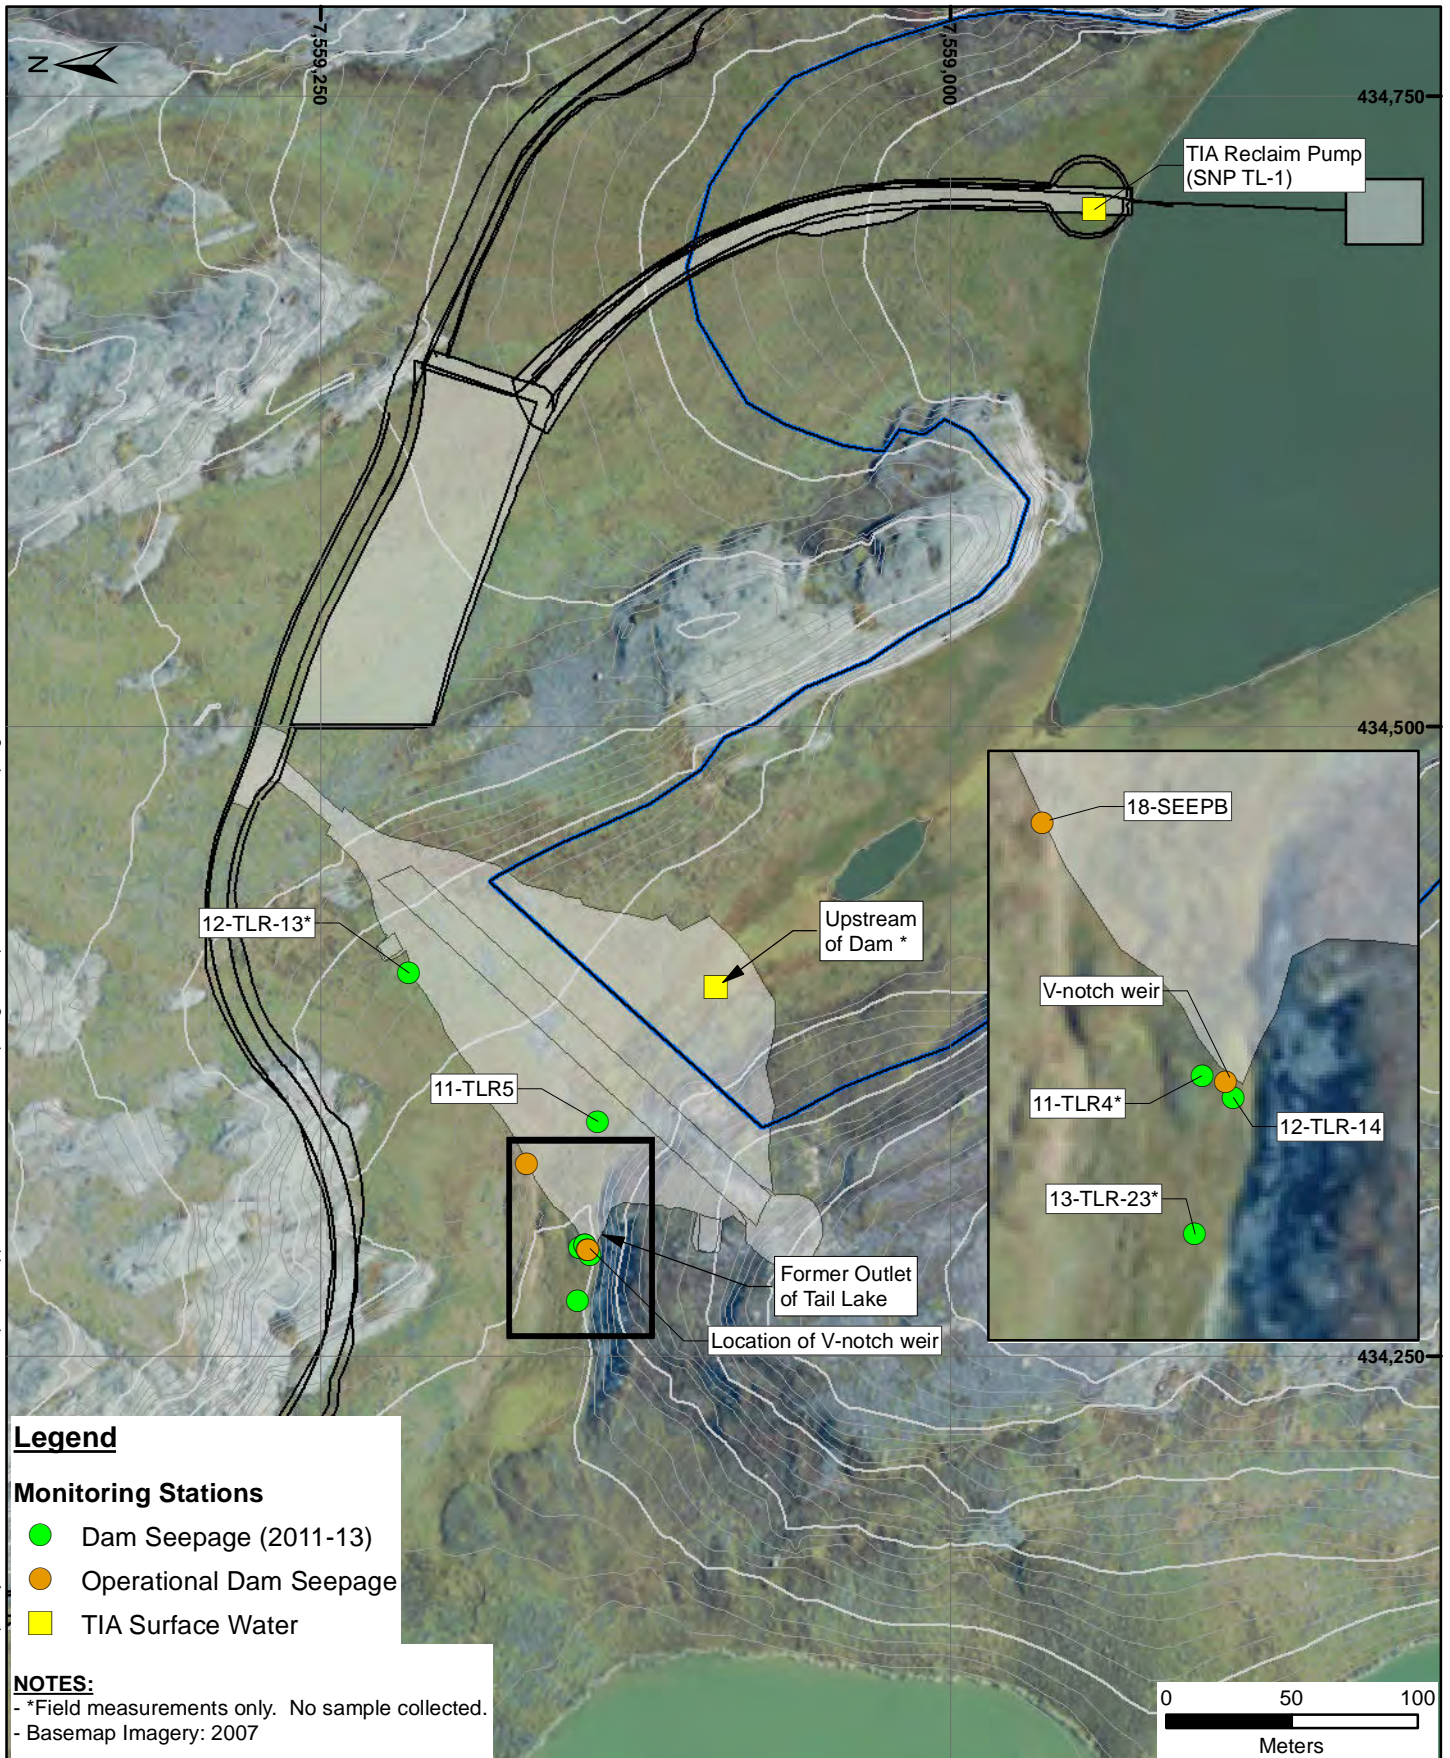
2-1

SRK Consulting (Canada) Inc. (2018a) outlines the North Dam toe seepage inspection and water quality monitoring program. In summary, TMAC conducts weekly inspections of the dam toe. If seepage is observed flowing at the dam toe, TMAC collects the following samples at a maximum frequency of once per week (Figure 2-1):
