Appendix L – 2018 AGI Inspection Feedback Presentation

Hope Bay Project 2018 Annual Geotechnical Inspection: On Site Feedback

Maritz Rykaart, PhD, PEng, Doris Camp, Nunavut, August 2-7, 2018

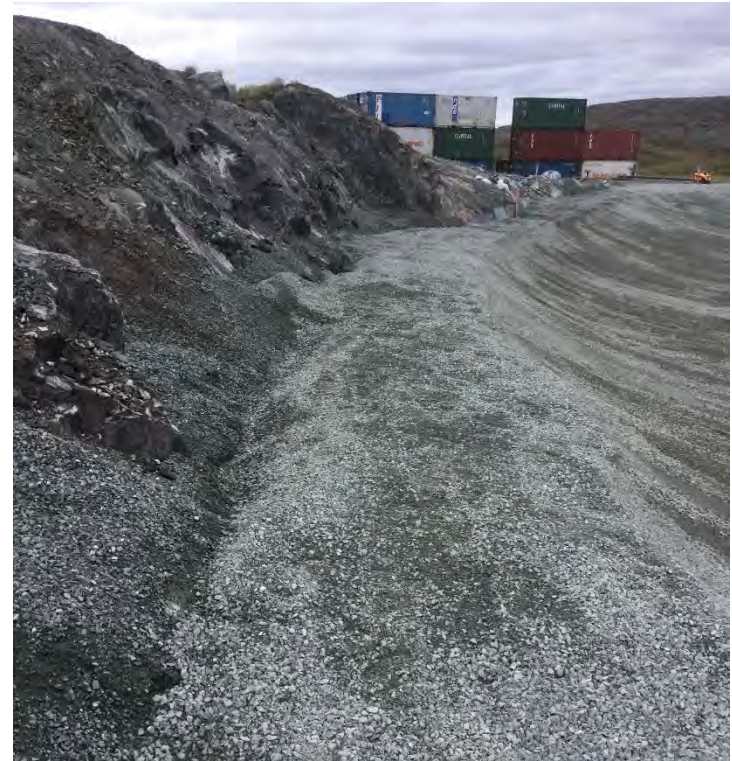
Construction Concern: Lack of Compaction

- Increased risk of liner sloughing because anchoring is not secured
- Increased risk of liner puncture damage because vehicle load distribution is concentrated
- Not possible to discern when real problems occur
- Increased maintenance requirement

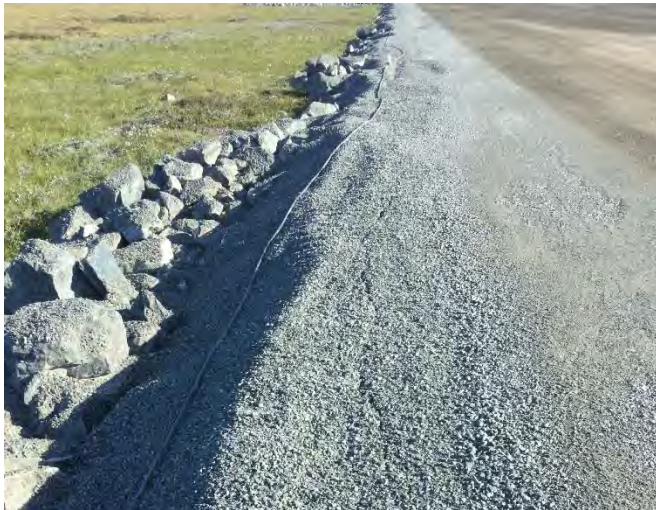
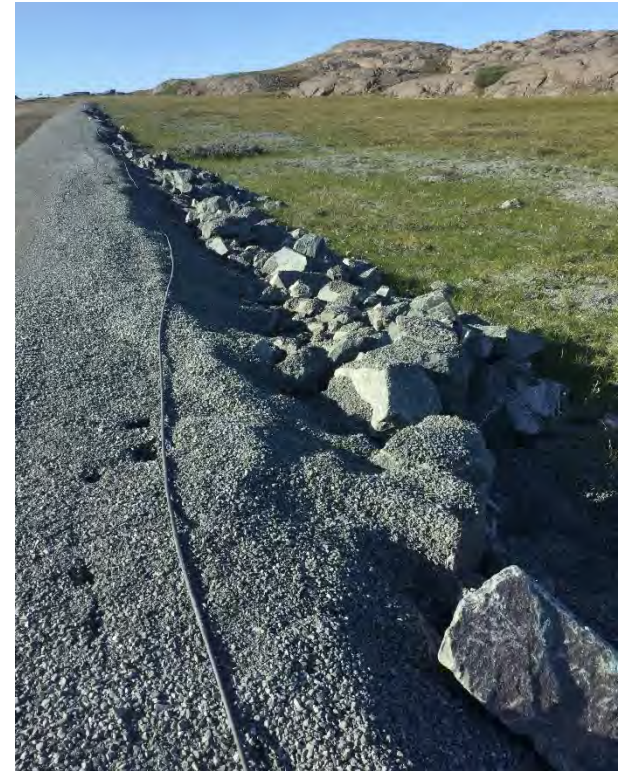
Construction Concern: Poor Slope Finishing

- Shoulder damage/risk gets masked
- Increased risk of localized ponding which increases risk of shoulder damage

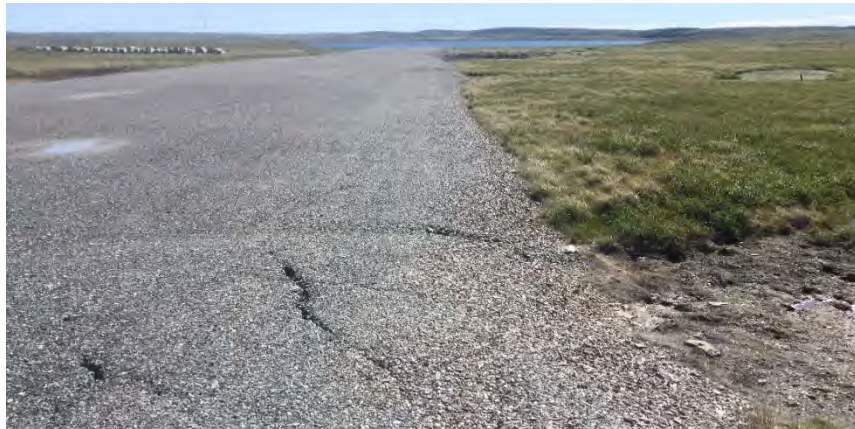
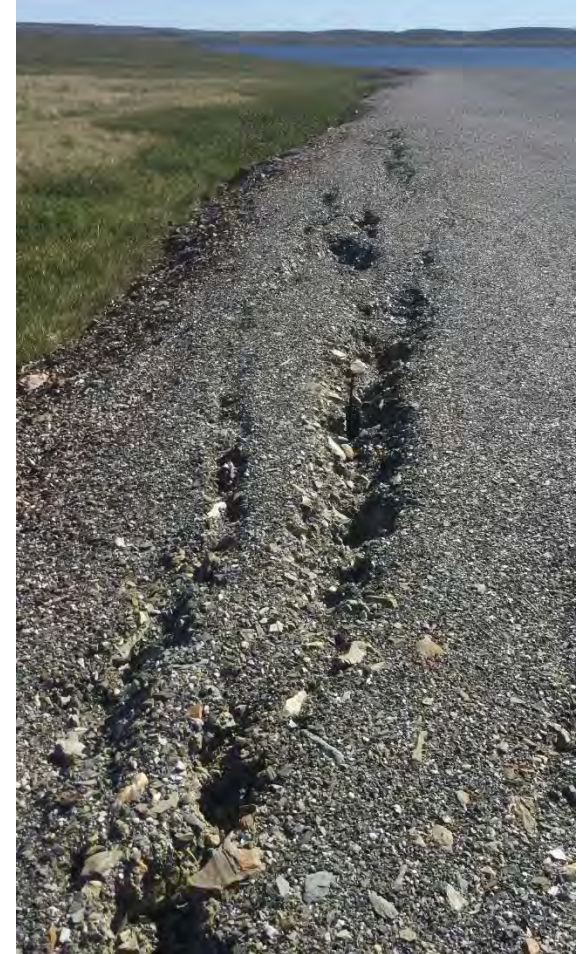
★ Airstrip

- Extensive tension cracking on shoulders but some are 5+ m from crest which is less common (and more dangerous)
- Significant undulations and local depressions
- Will likely need charter company to review airstrip before landing aircraft

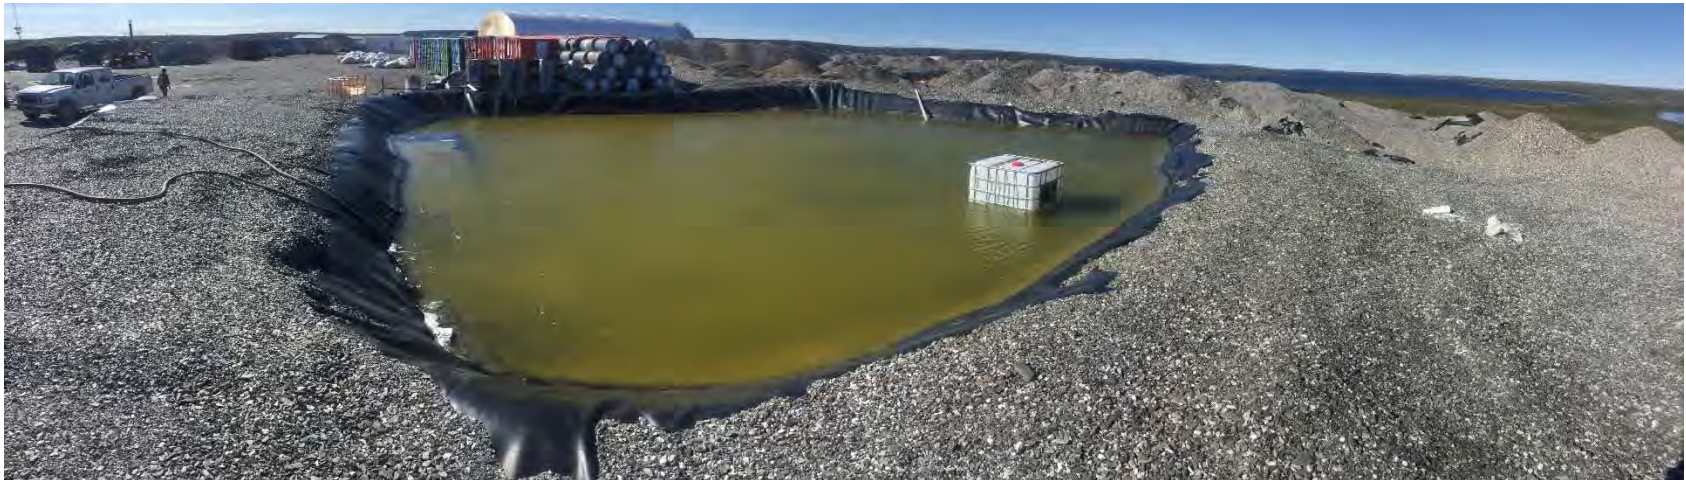
Lined Pond

- New pond not compacted and slopes over-steepened
- Pond will not perform well over long-term and liner slippage will occur
- Use of ore for construction could impact water quality and prevent ability to discharge

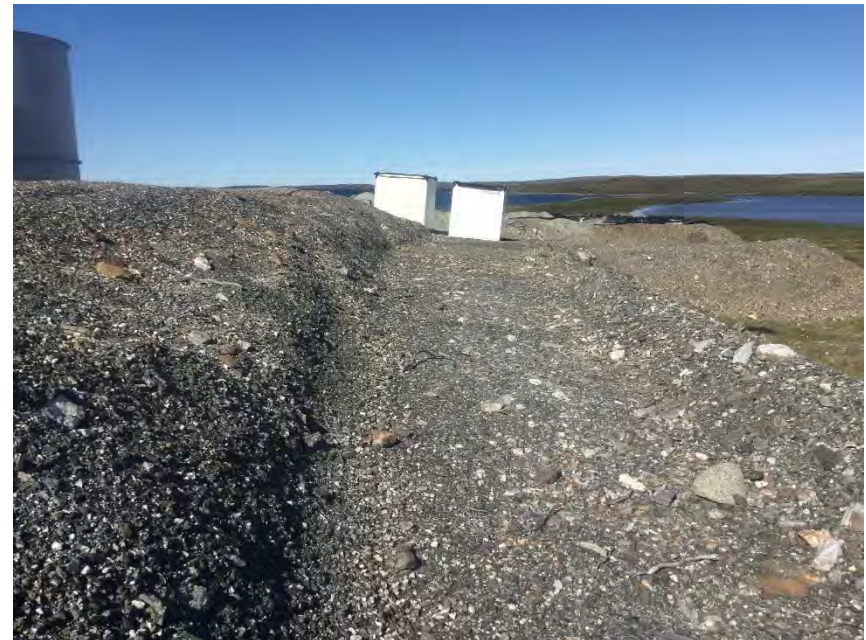
★ Tank Farm

- Both north and eastern berm has extensive tension cracking which is not stability induced but liner induced
- Likely good to operate provided no tension placed on inside berms (i.e. equipment traffic)
- Downstream slope of eastern berm has been cut due to road access and over-steepened. Needs to be remediated to avoid berm failure

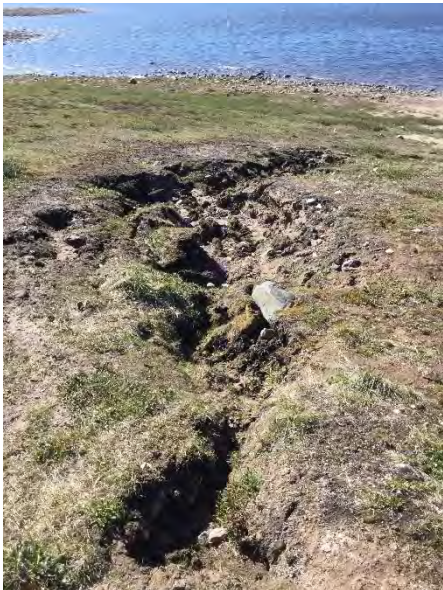
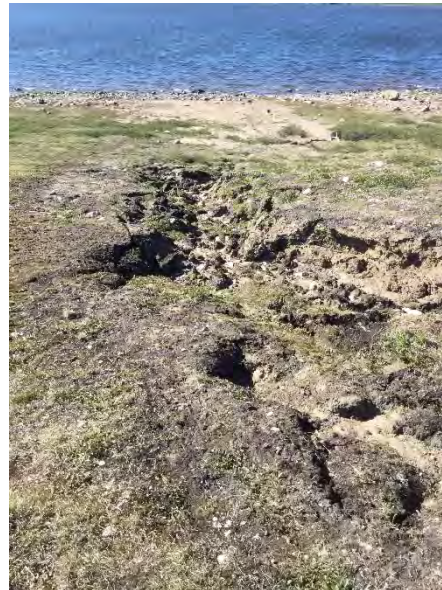
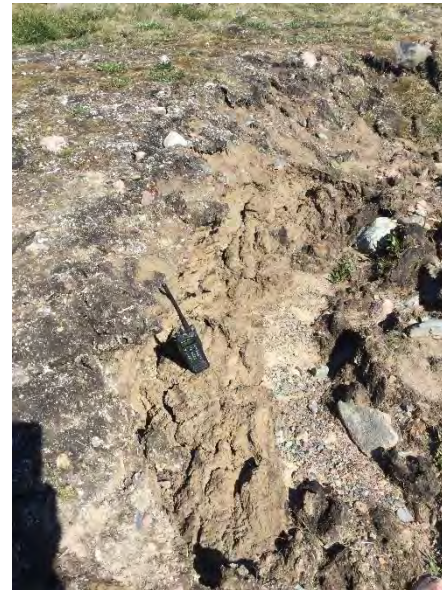
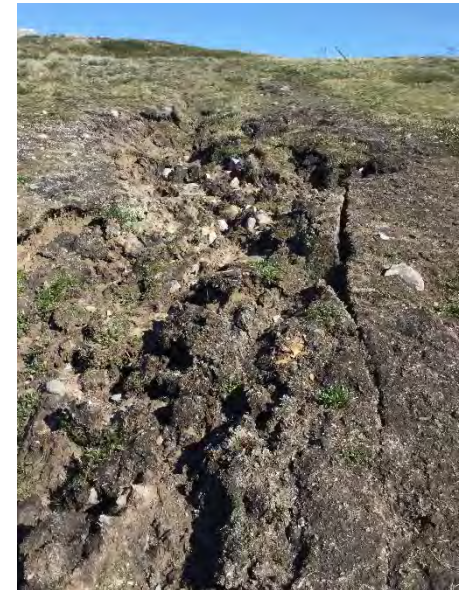
Erosion Gulley

- Initiated by erosion; growing rapidly due to permafrost degradation
- Requires remediation to avoid progression

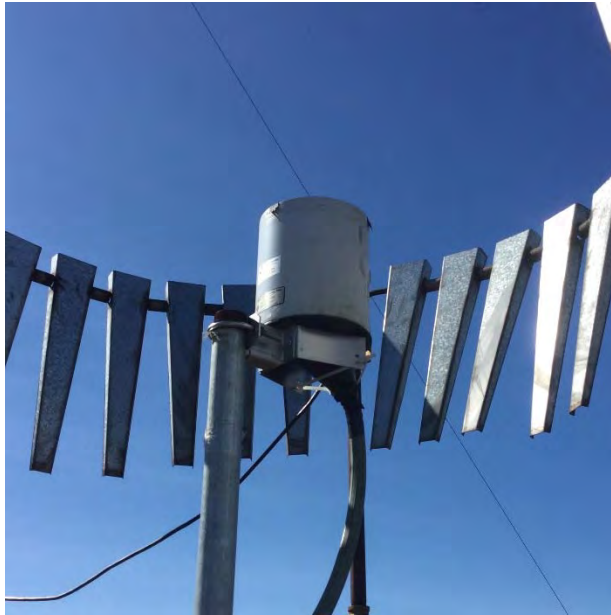
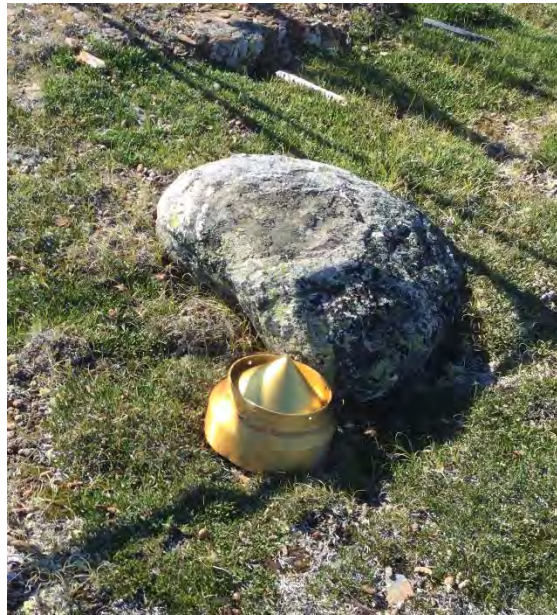
Weather Station

- Top rain catcher ring has blown off

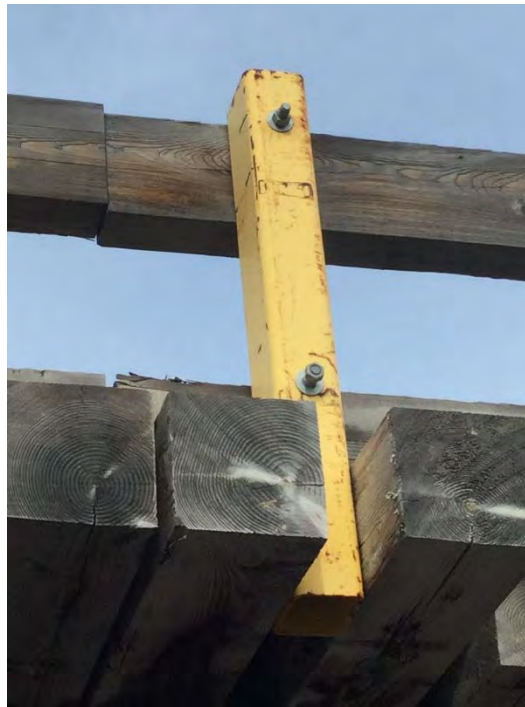
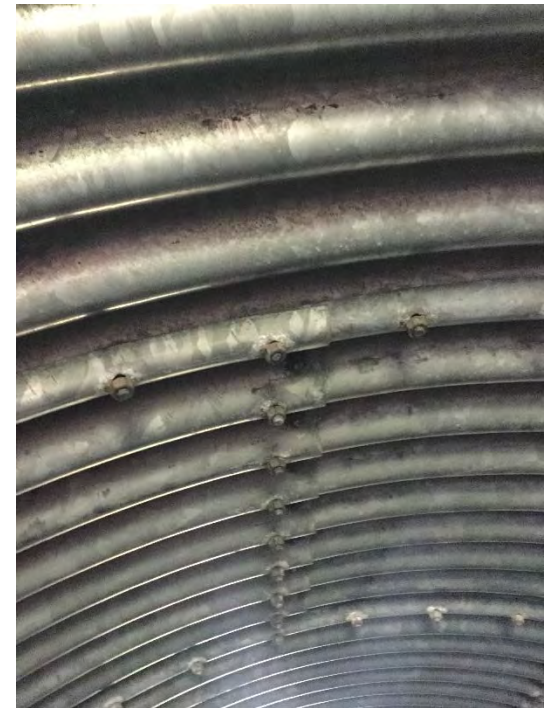
Windy Road Arch Culvert & Single Bridge

- Loose bolts on arch culvert
- Loose bolts on bridge railing

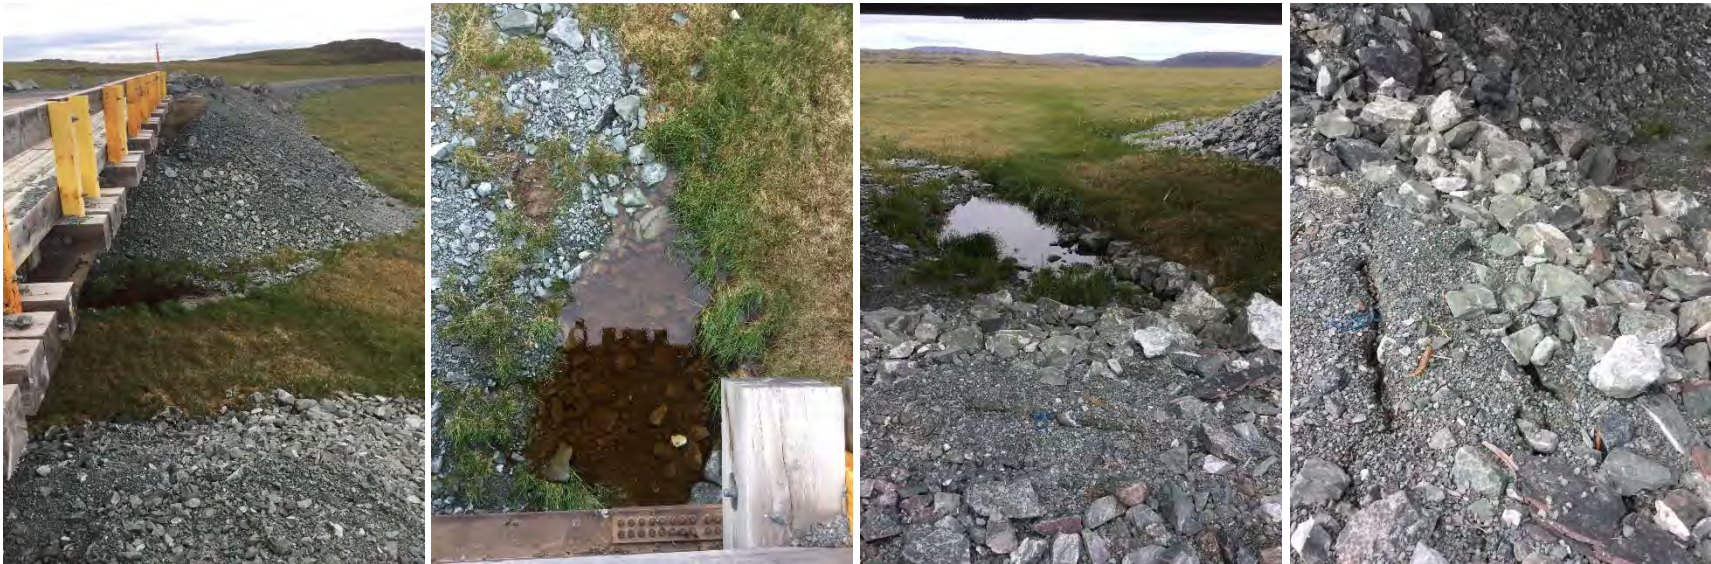
Windy Road Double Bridge

- Loose bolts on bridge railing
- ★ • Pond on south abutment is starting to cause some instability. It should be backfilled with overburden, at least 1 m thick and compacted

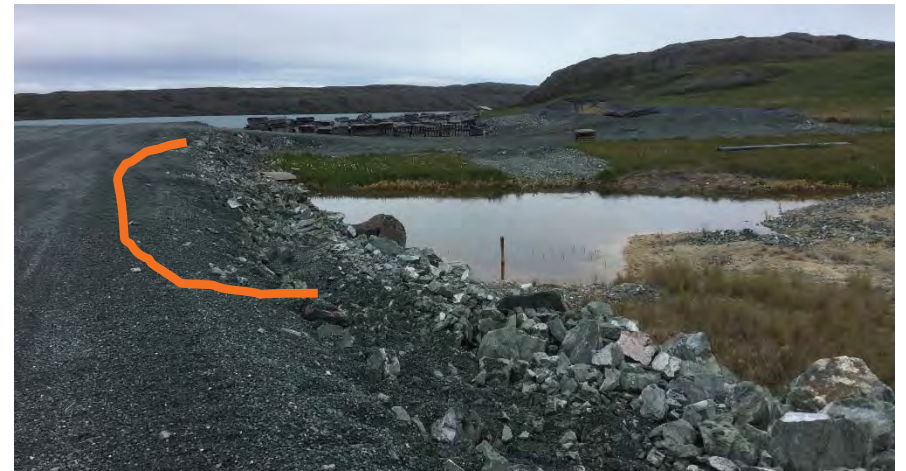
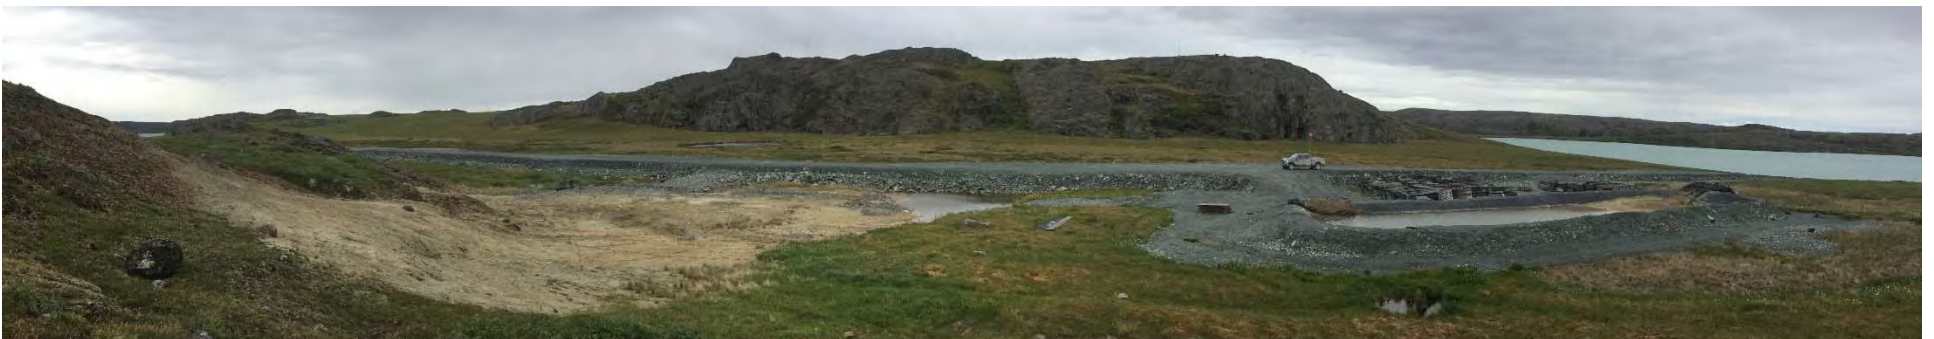
Windy Exploration Trench

- Some signs of road shoulder instability; small tension cracks
- Cause likely permafrost melt induced by large shoulder pond
- Keep observing for further progression

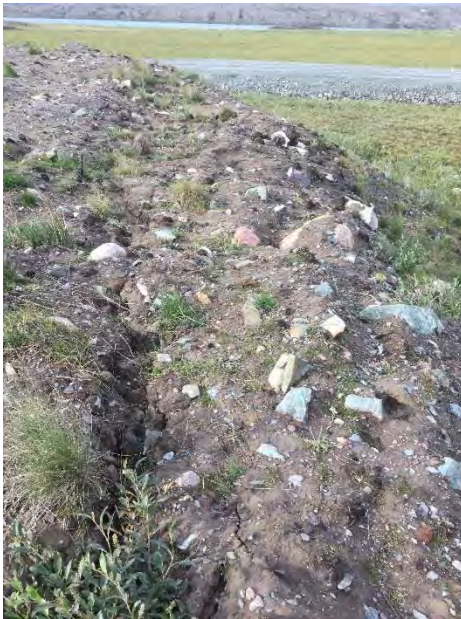
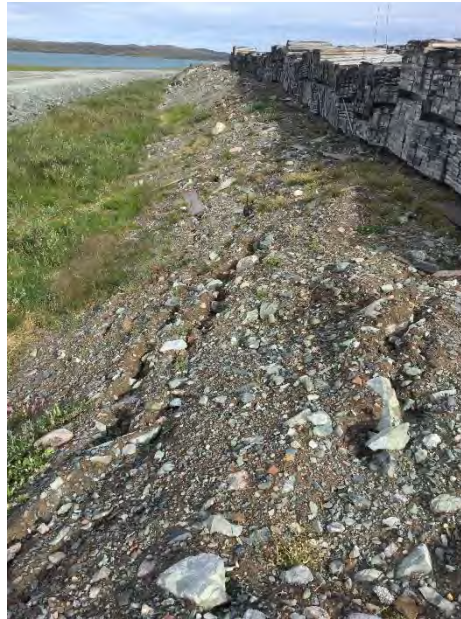
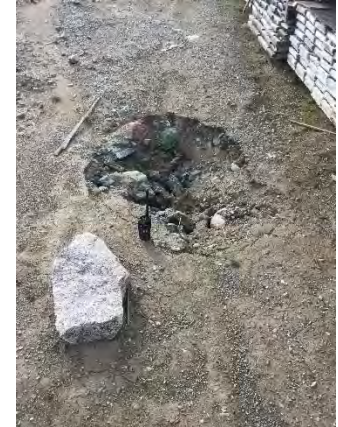
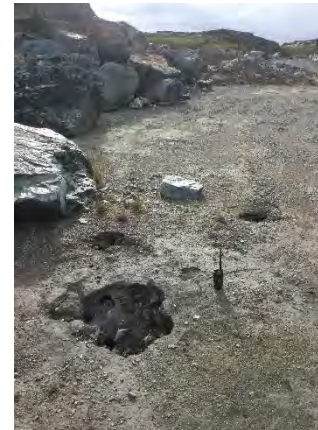
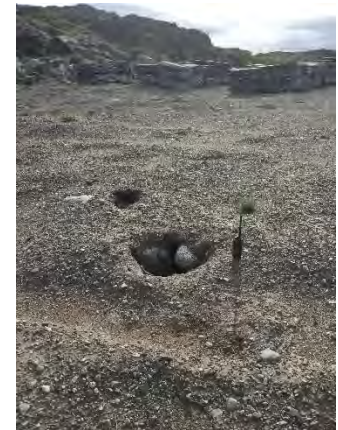
Quarry D Core Storage Pad

- Perimeter slope instability
- Multiple smaller sinkholes
- Make people aware of risks if area is to be used

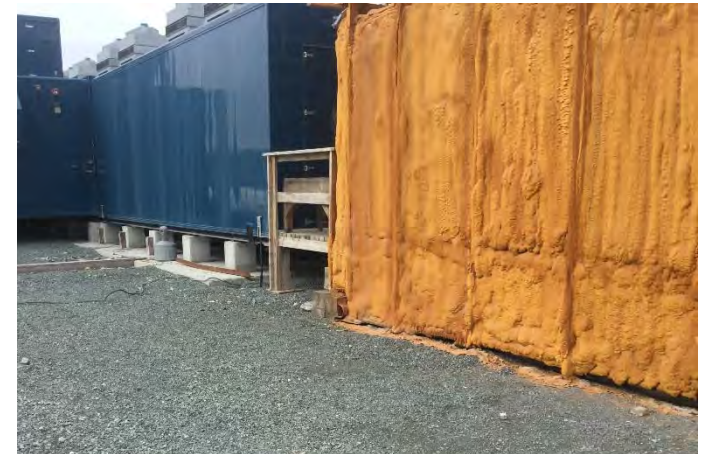
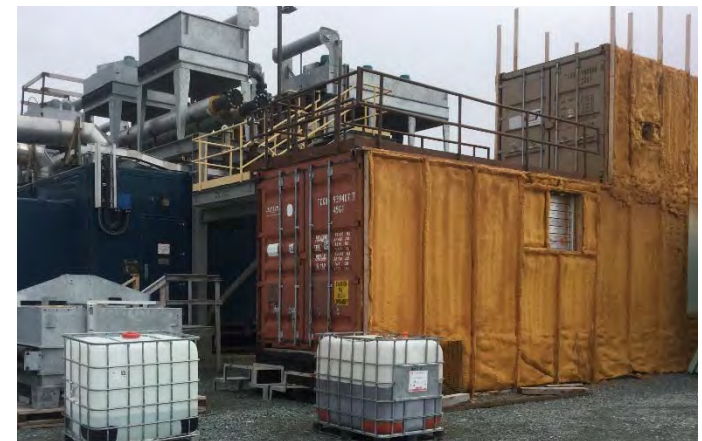
Pad B – Power House

- Need to be careful not to construct heated buildings on this pad where airflow under the building is hindered
- This pad is constructed on very thick ice rich material and given the height and location of the pad, plus the weight of the genset, there can be no tolerance for anything that may compromise the foundation
- Monitoring to date does not suggest any issues at this point, but a precautionary approach is advised

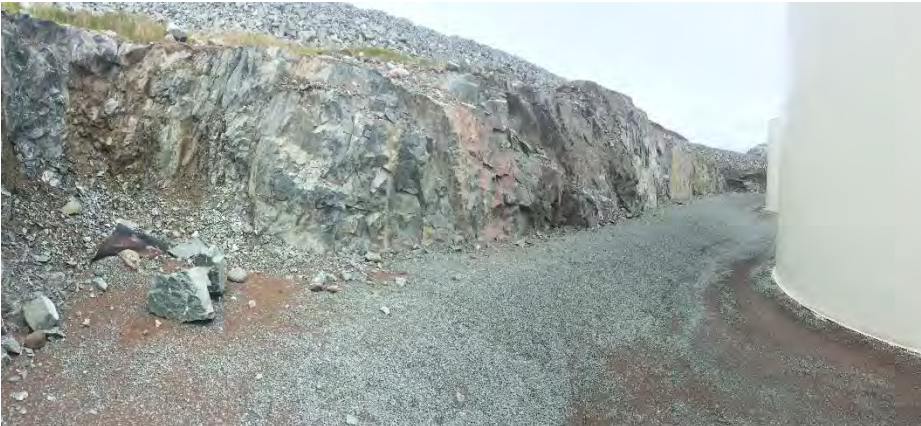
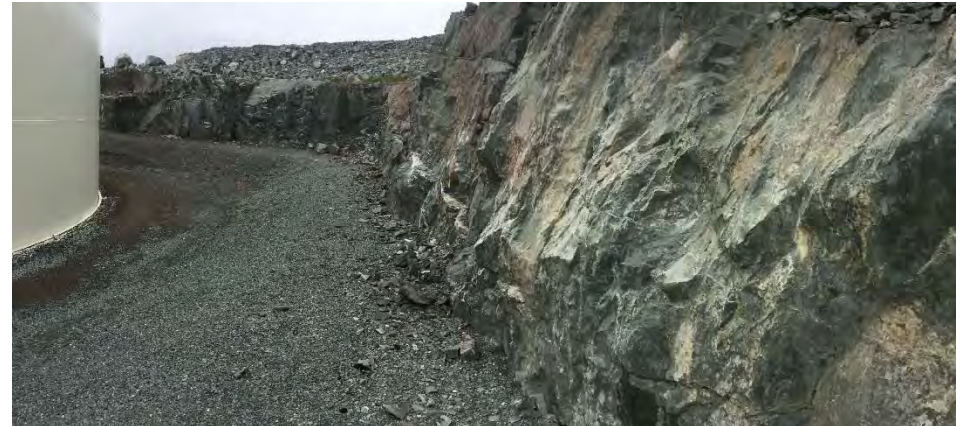
7.5 ML Tank Farm

- Spalling rock continues and wedges are starting to be pushed out - risk profile increasing
- Smaller rocks likely won't damage liner or tanks, but can harm personnel
- Larger rocks or wedges can damage the liner or tanks
- ★ • As a minimum warning signs be posted against the falling hazard
- Larger issue should however be addressed:
 - Implement IFC rock bolting and mesh design, or
 - Establish frequent inspection of high walls by qualified rock mechanics engineer (TMAC mine engineer)

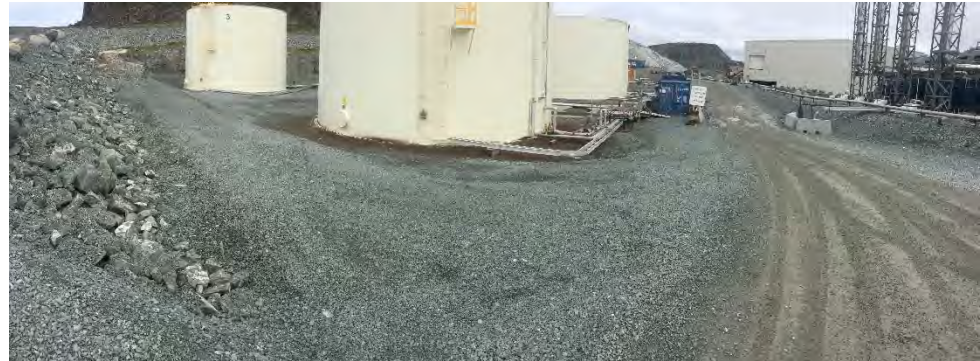
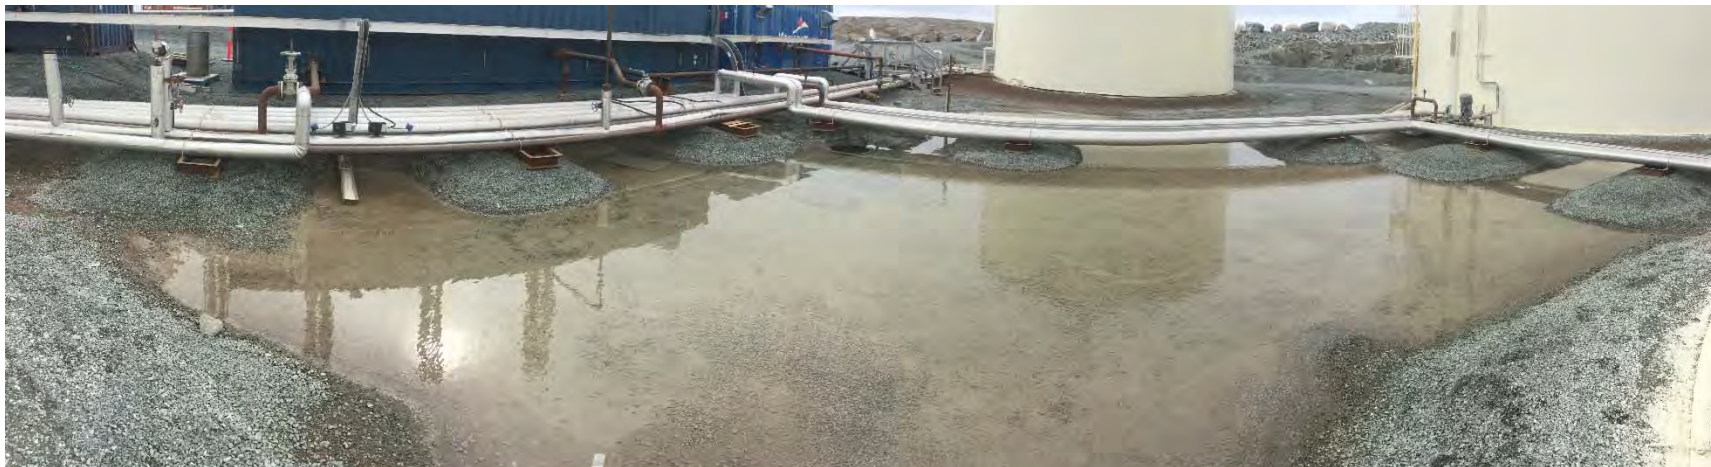
7.5 ML Tank Farm

- Be cautious about containment capacity
- Facility to be kept drained
- Don't construct unplanned ramps

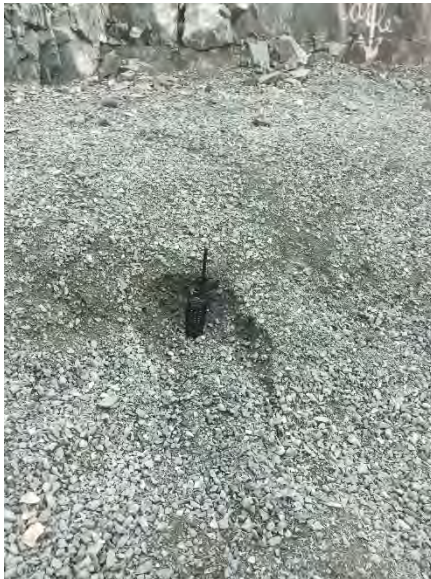
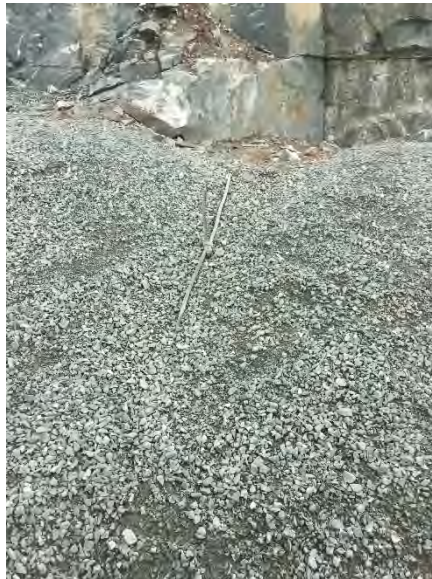
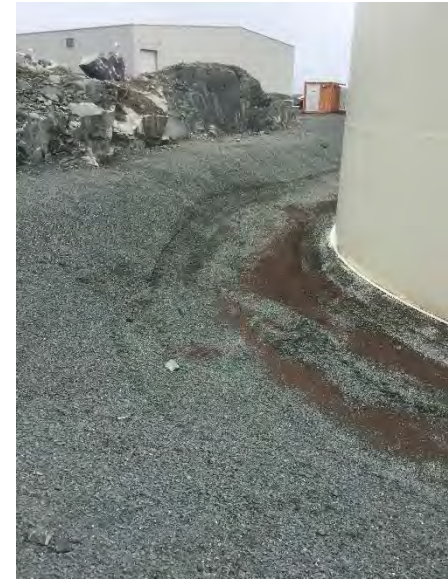
7.5 ML Tank Farm

- Some damage affecting the cover; small slough and grounding cable excavation
- Need to be cautious of vehicle traffic damage

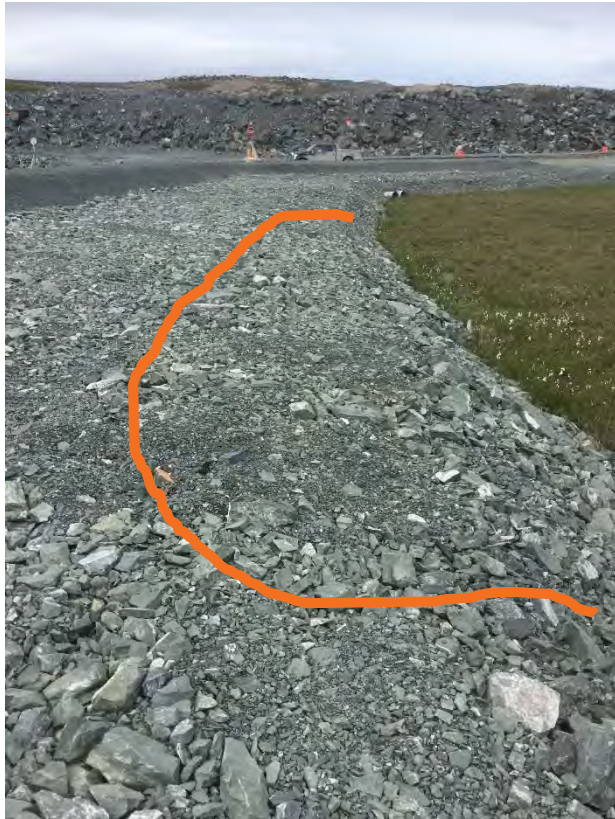
Doris Camp Diversion

- Fairly large tension crack with toe ponding – approximately 15 m in length
- Could be sign of melting ground ice
- Keep eye on it and if extensive localized ponding occurs remedial work may be required

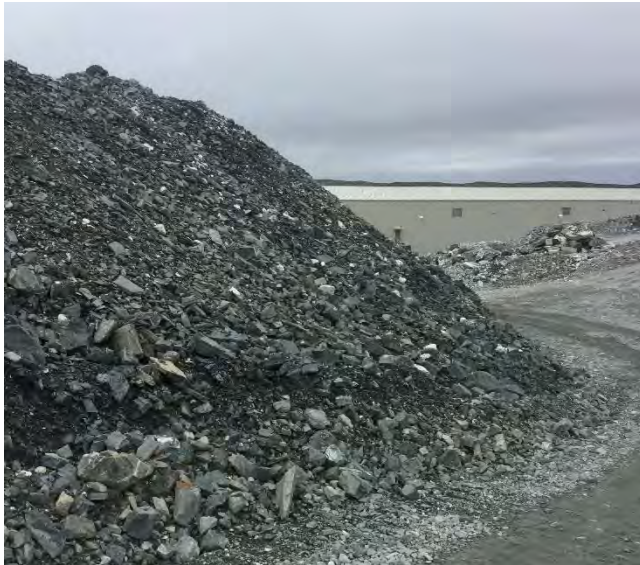
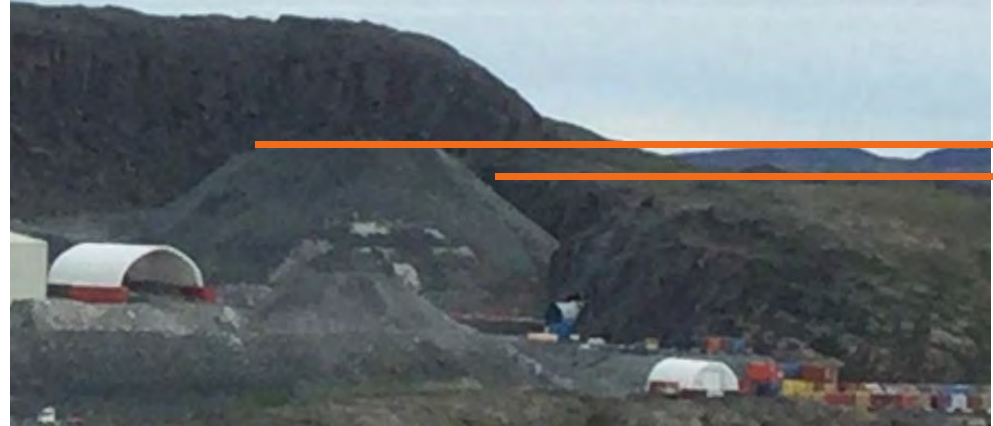
★ Pad T – Waste Rock & Ore Stockpiles

- Waste Rock Pile appears to be above (?) maximum design crest elevation of 75 m (rock outcrop above portal around same elevation)
- Design slope = 1H:2.5V; Current slope = angle of repose 1H:1V
- Minimum required design FOS likely not met; should be checked
