Pad I – Waste Rock & Ore Stockpiles

Roberts Bay Observations

TIA Observations

Closing

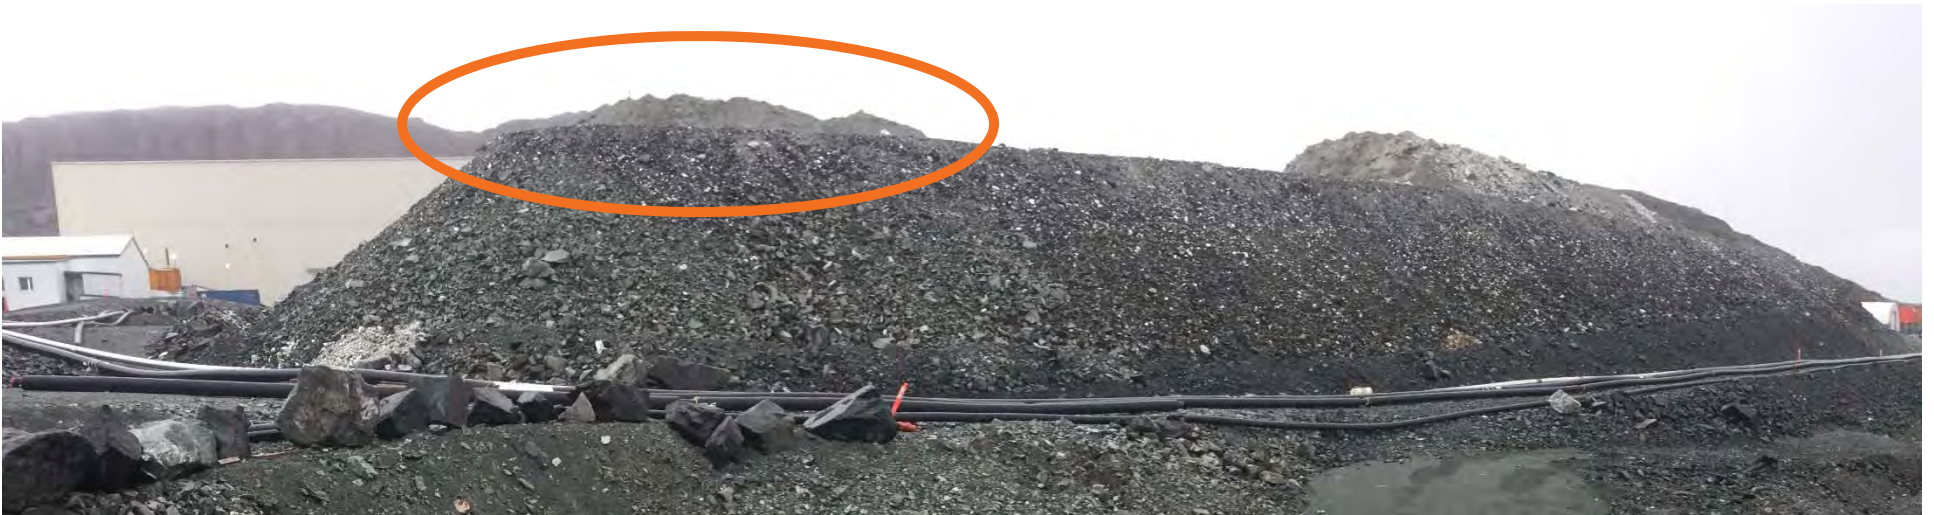
- Is DETOX tailings being stored on Waste Rock Pile?
- OK as long as it is tracked

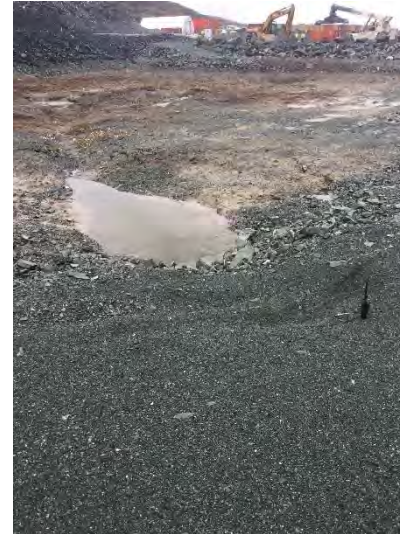
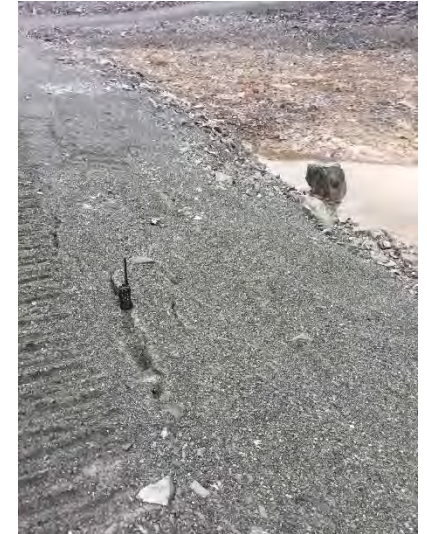
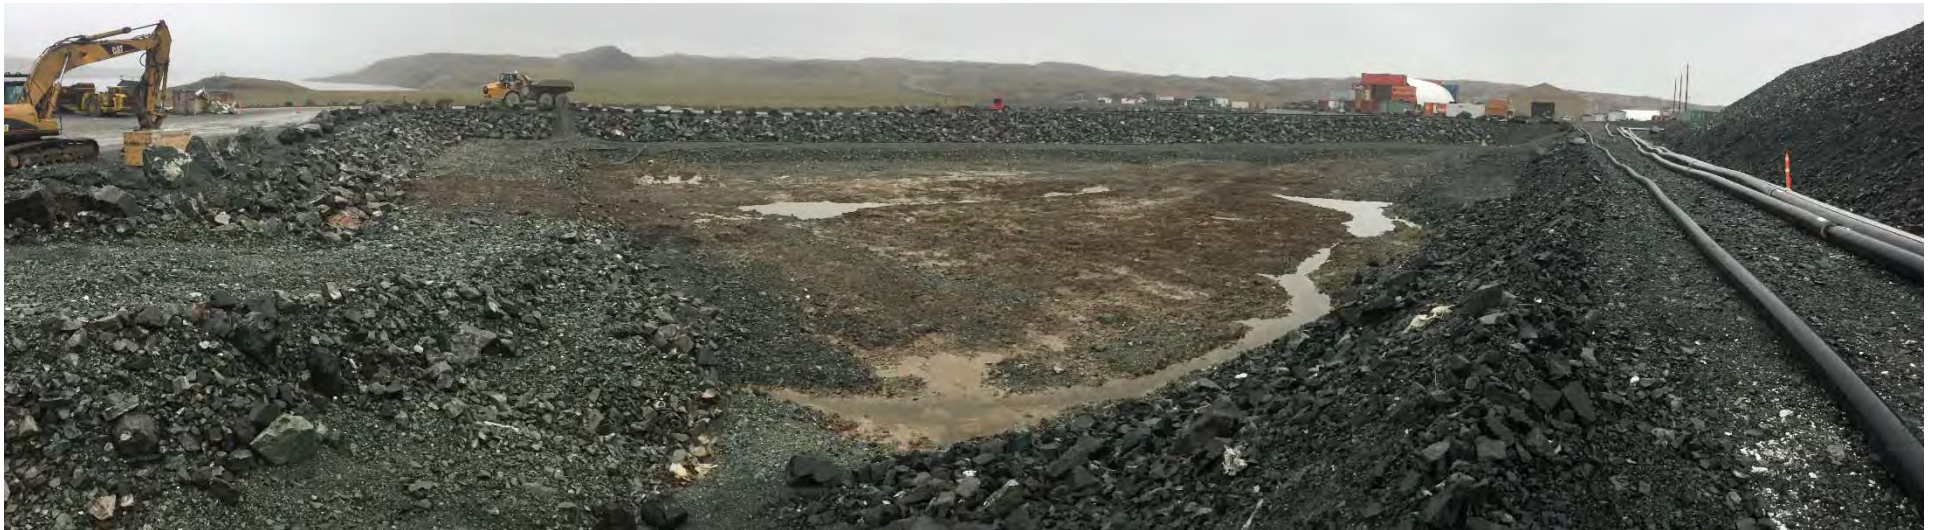
Pollution Control Pond

- Need to infill to large ponds with overburden soils; this is carry over recommendation from 2017
- Will reduce risk of larger sinkholes developing and prolong life of facility – now is best time to do it

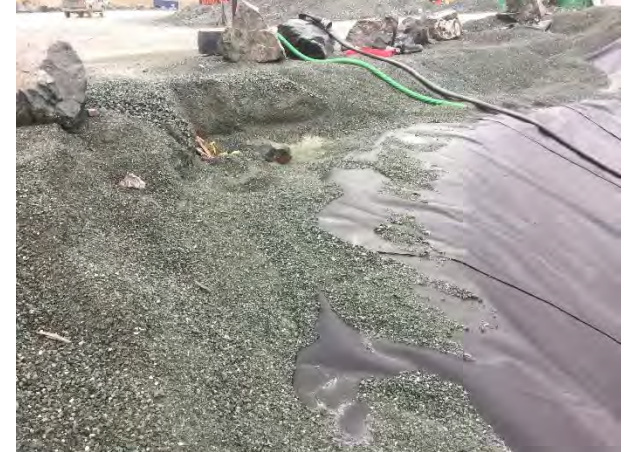
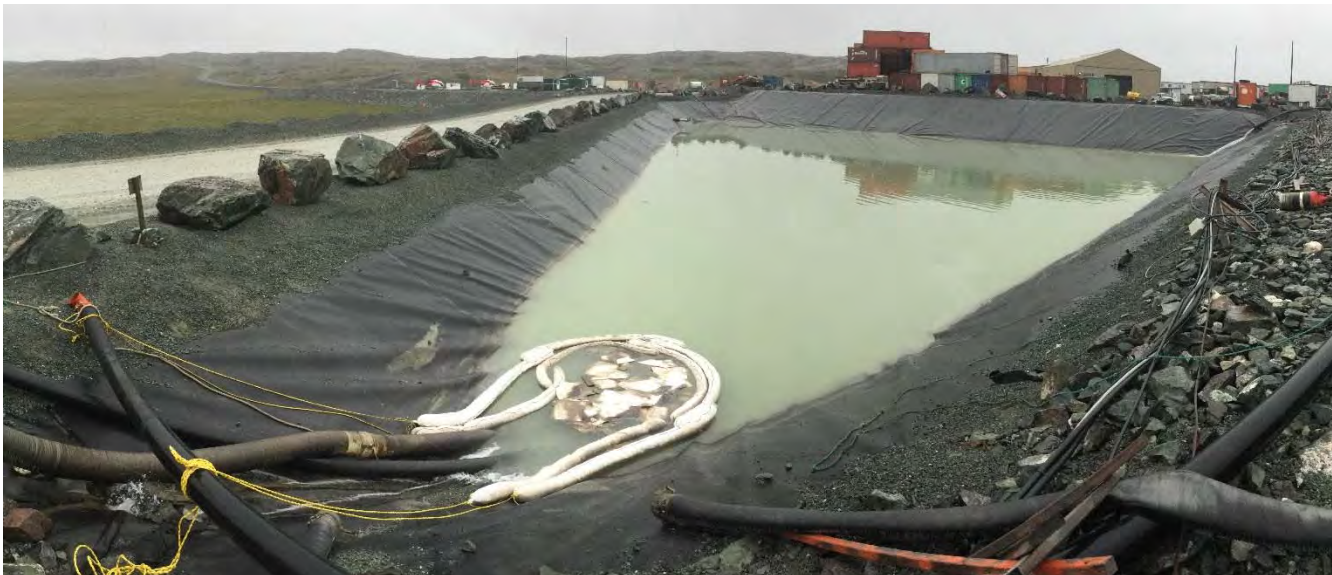
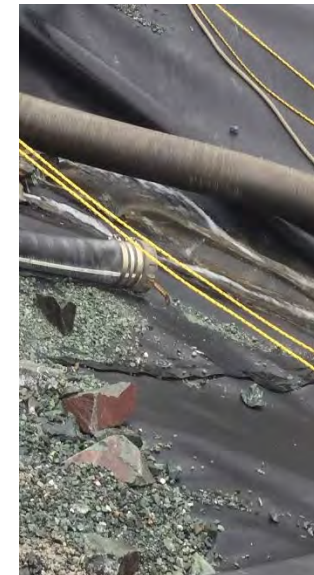
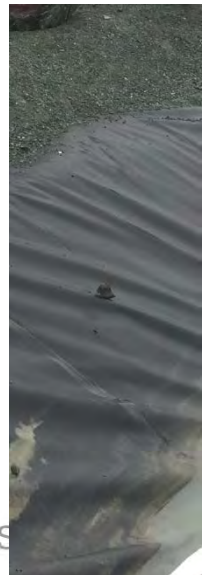
★ Sedimentation Pond

- Should do general cleanup of all rocks and gravel on liner slopes
- Fix the excavation on the south-west corner

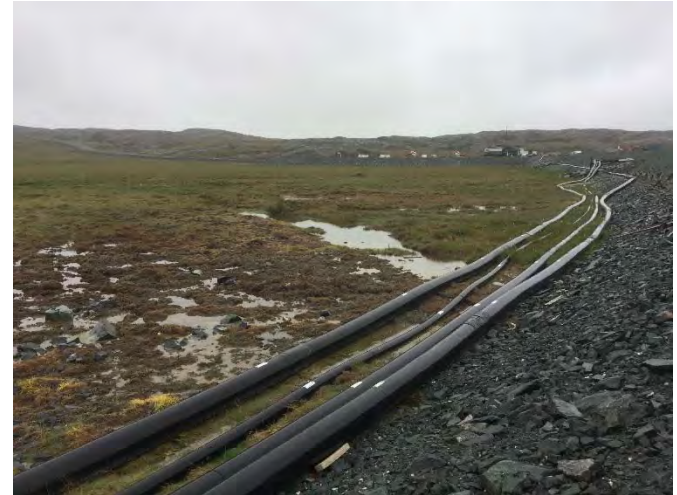
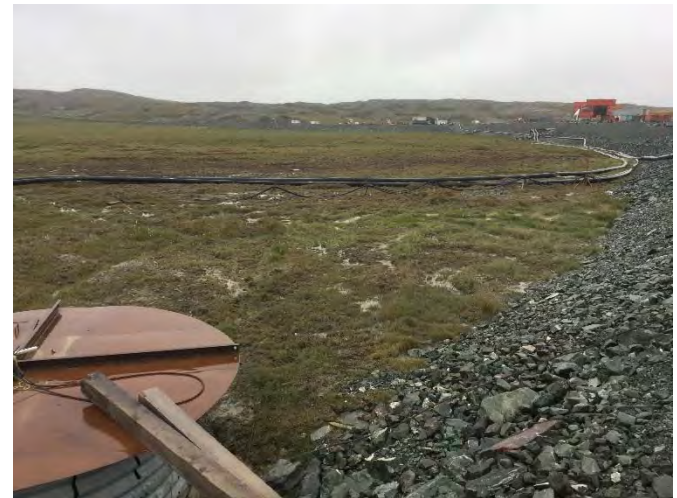
Sump #1

- Flows appear to be bypassing the sump
- Need to confirm based on water quality sampling whether the bypassed water exceeds discharge quality
- Need to consider options to direct flow to the sump, or capture water elsewhere

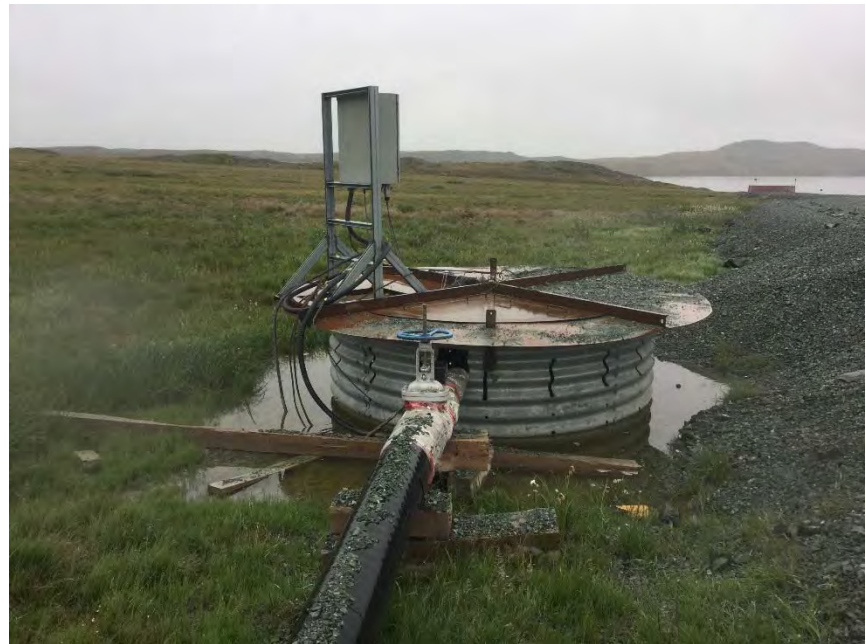
Sump #2

- Automatic float switches appear to have been removed, so is pump now operated manually?
- Need to prevent permanent ponding around the sump

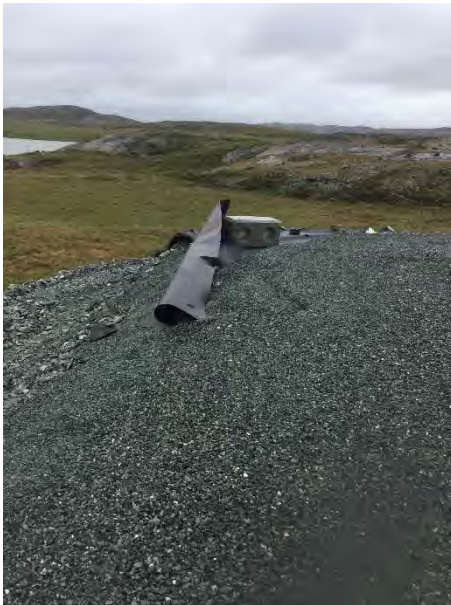
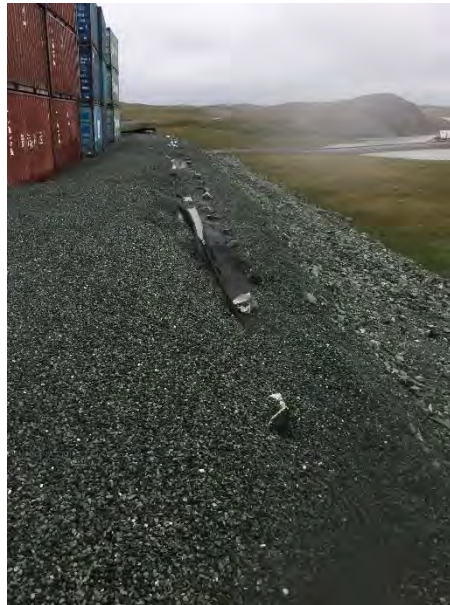
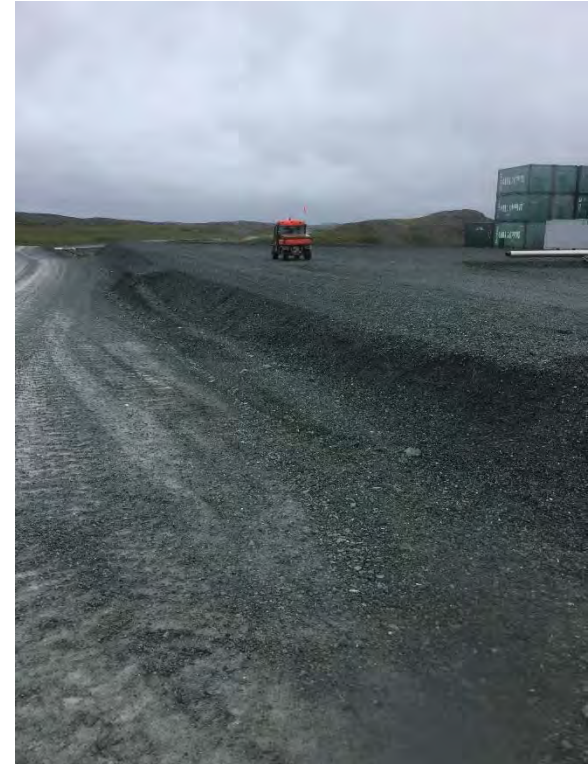
Reagent Pad

- Over steepened slope on north
- Exposed liner on south

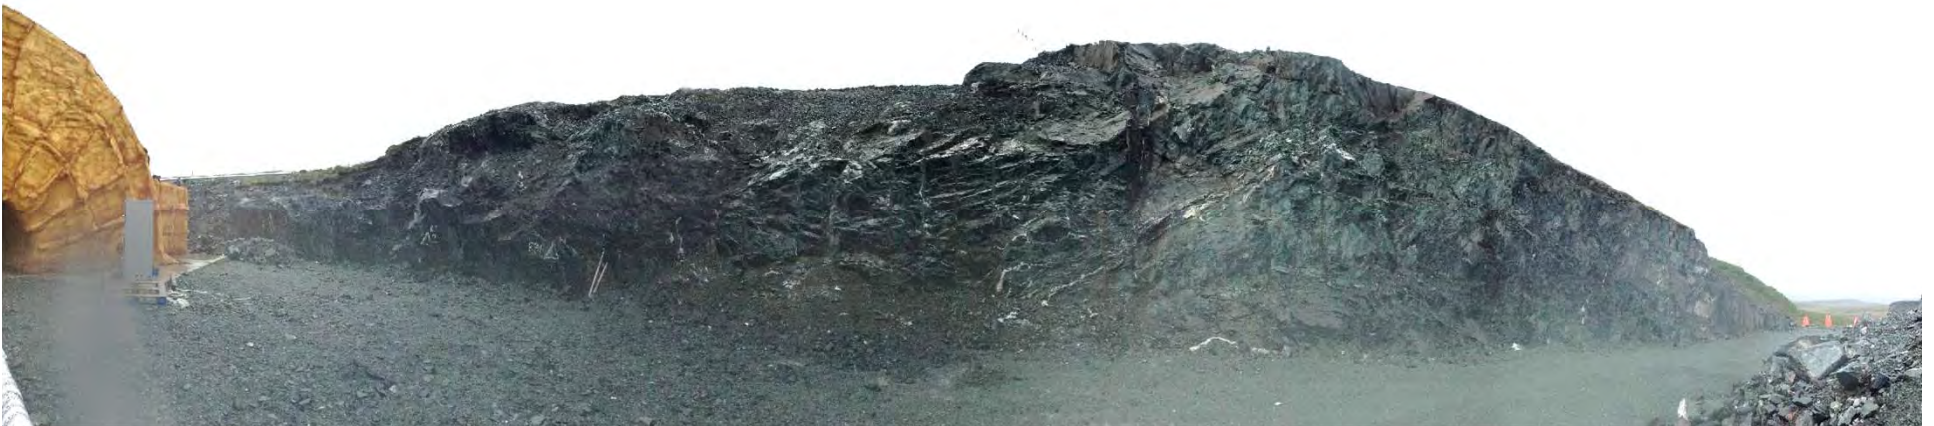
Vent Raise

- Rockfall hazard
- ★ • At minimum post warning signs
- If space permits consider constructing catch berm

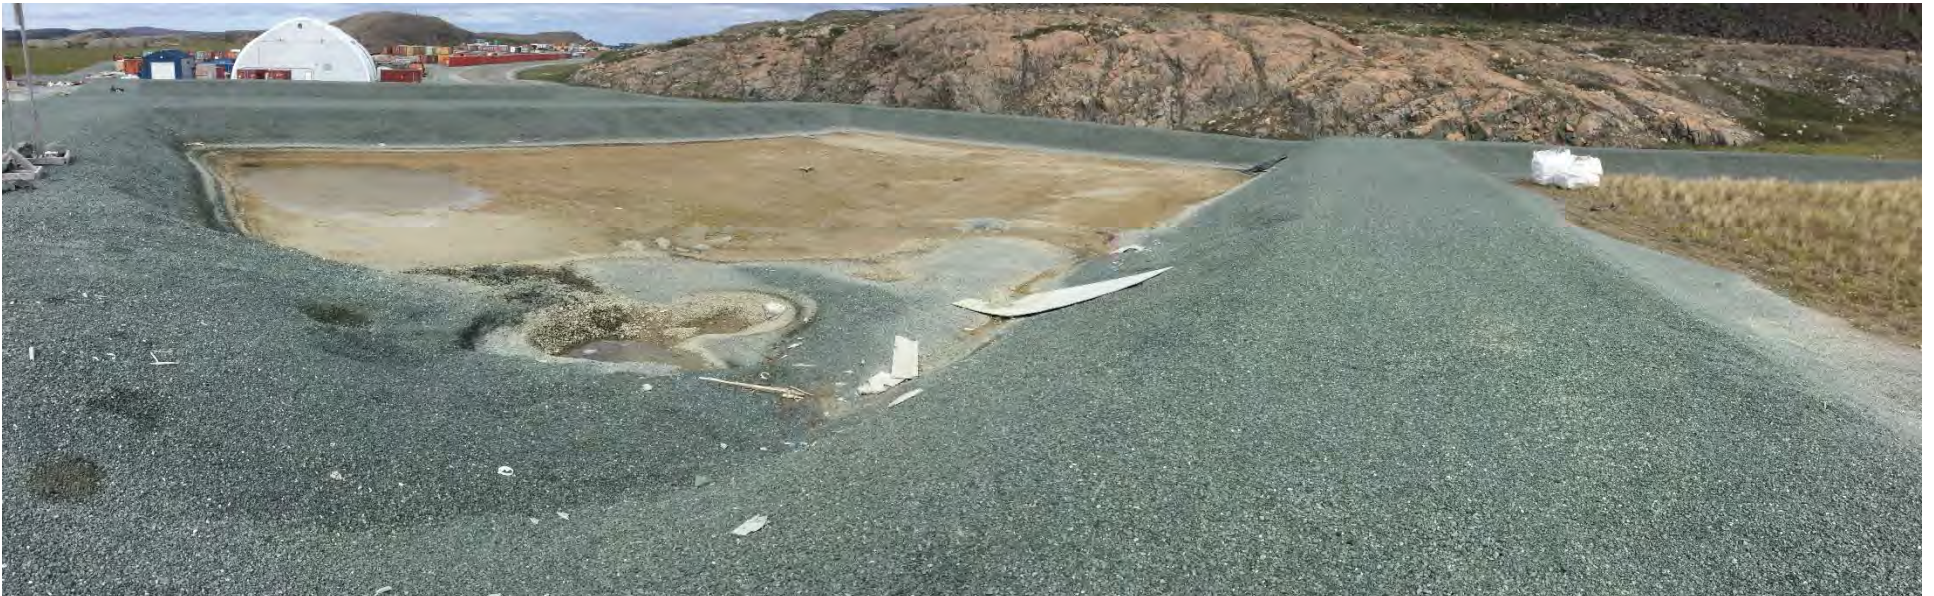
Landfarm

- Be careful when excavating to not dig deeper than the design invert; it can compromise the liner

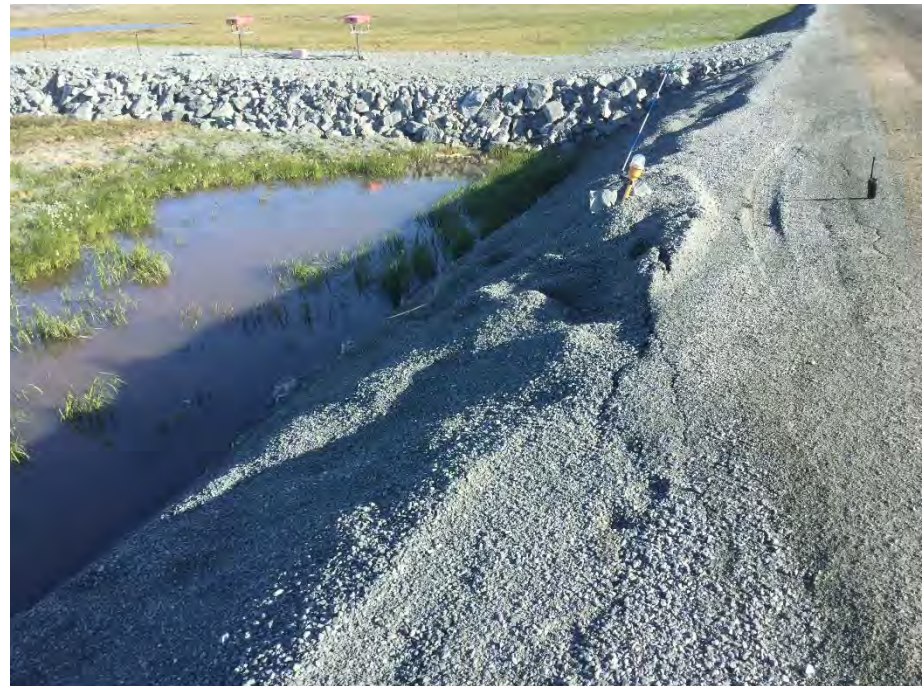
Airstrip & De-Icing Apron

- West shoulder has series of tension cracks; keep monitoring
- Consider backfilling the large pond at the north airstrip light island with overburden; fill to proud of surface and compact
- De-icing apron needs to be properly compacted
- ★ • De-icing apron grading towards sump does not seem right; confirm and fix

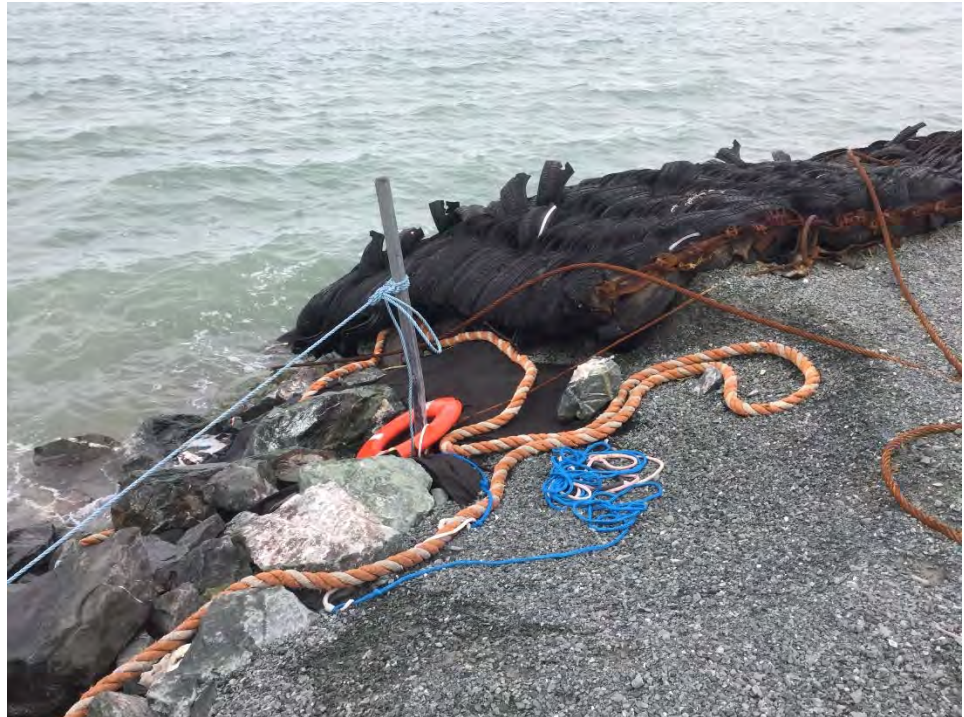
Jetty

- Consider additional Riprap at the jetty head

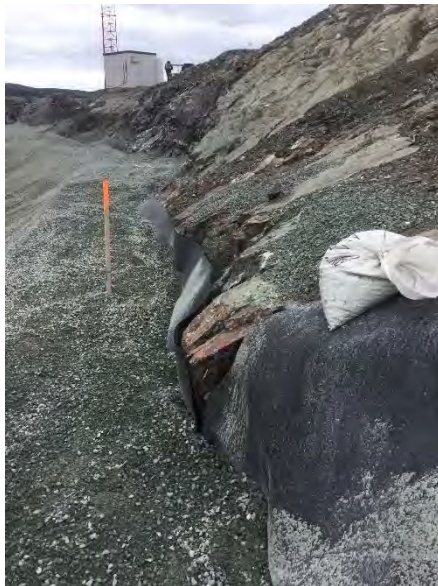
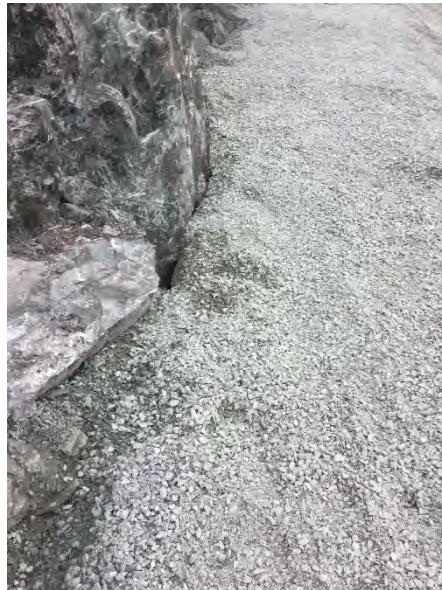
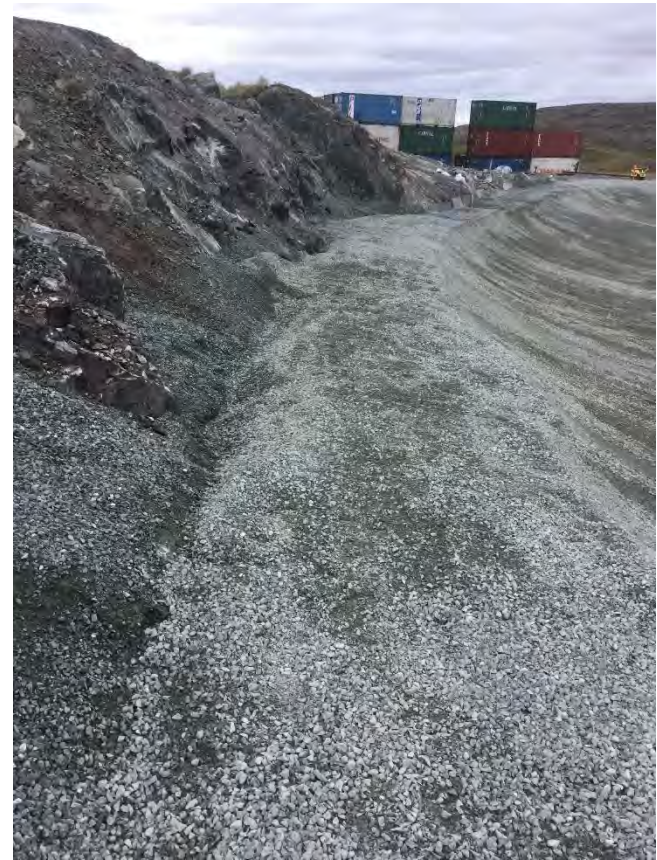
Rob Bay 5ML Tank Farm

- Cut exposed liner
- Fill in void space behind liner
- Compact berms and slopes

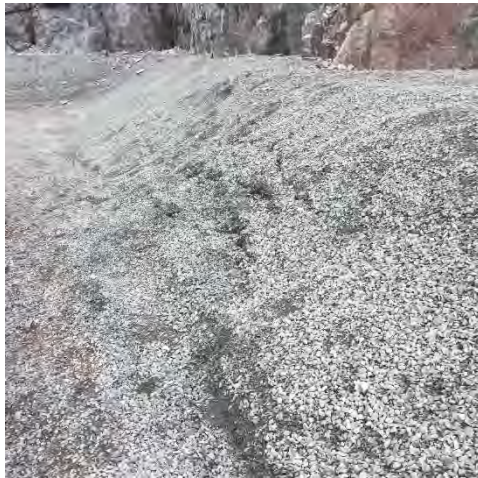
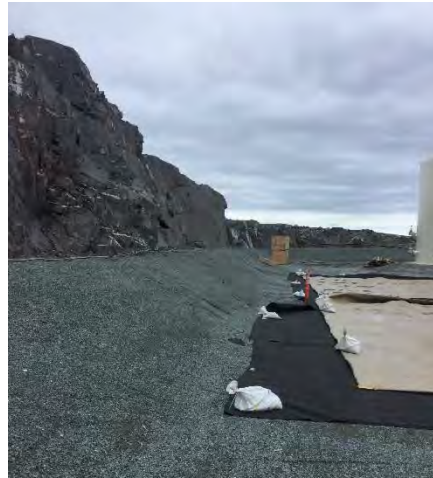
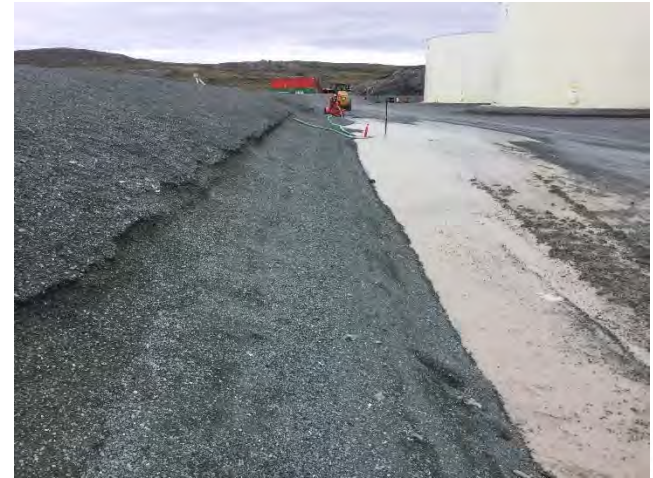
Rob Bay 20ML Tank Farm

- Monitor falling rocks carefully, especially above bladders
- Some fill sloughing occurring on south berm due to equipment traffic on berm
- ★ • Over-steepened north slope due to erosion need to be reconstructed (including compaction)

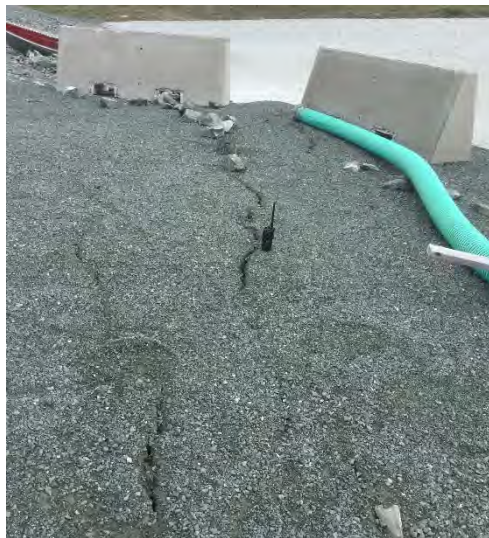
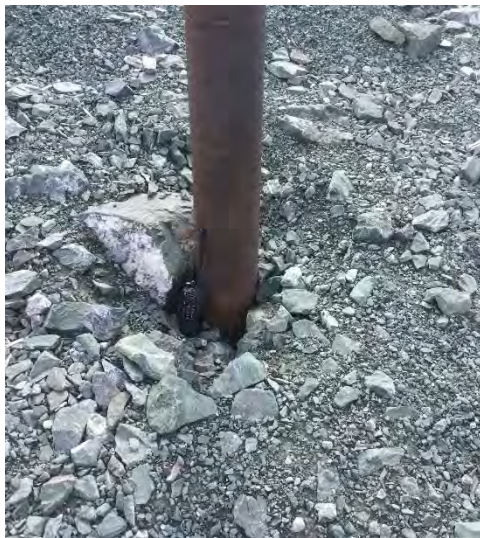
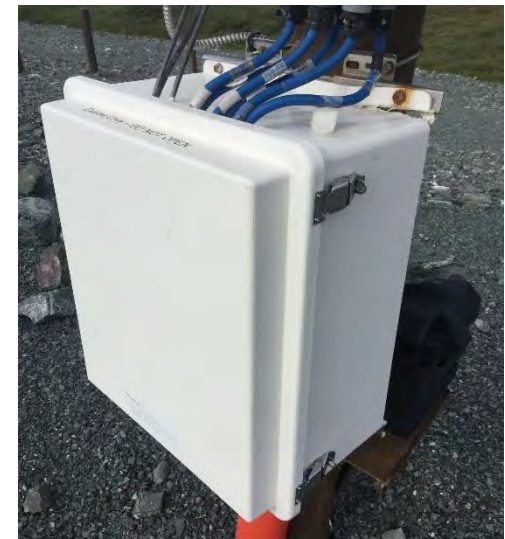
★ North Dam

- Watch tension cracks on upstream slope near shoreline
- Backfill with crush around inclinometer housing of Station 0+130 m
- Replace bottom weatherproof housing for node D

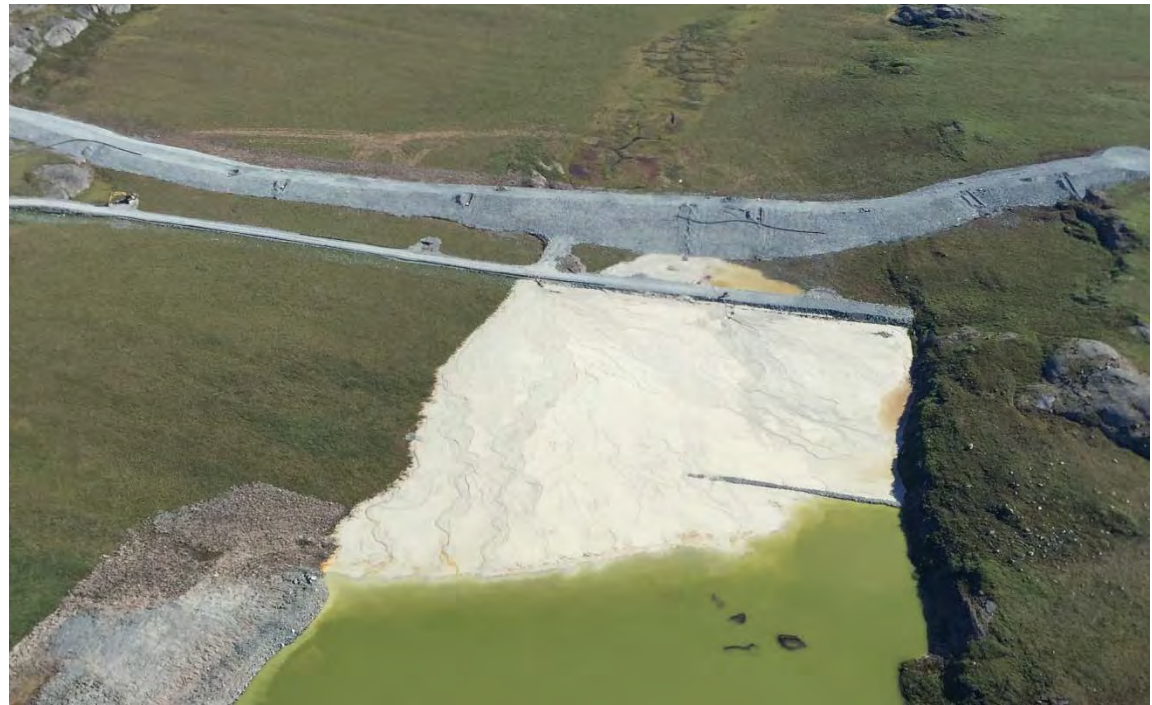
★ South Dam

- Small construction completion tasks to final signoff
- Some instrumentation to be completed
- Monitoring SOP to be updated
- Watch for ponding at back of dam
- Start beach development immediately

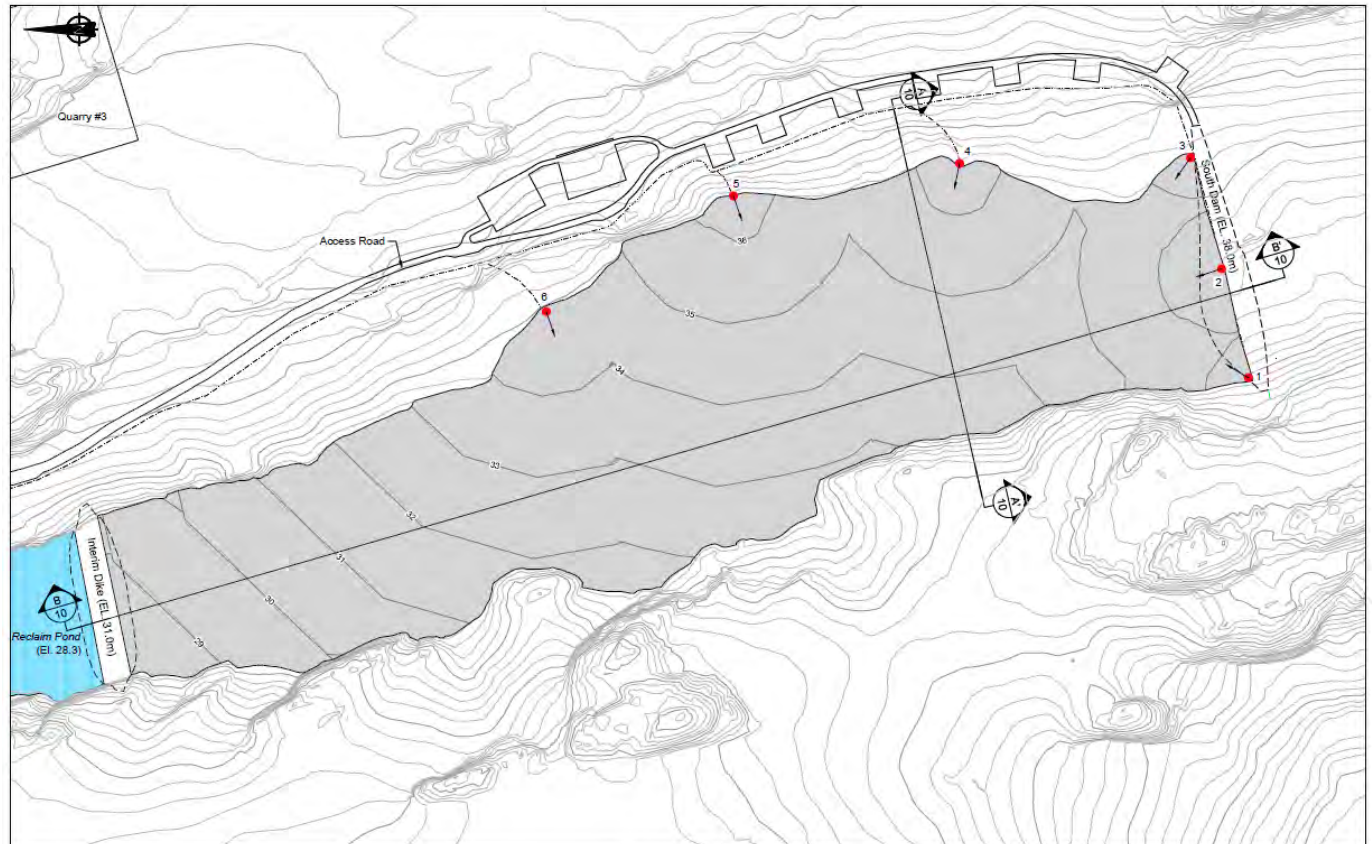
★ Tailings Deposition

- Develop minimum 100 m beach from South Dam asap!
- Single point discharge (3 spigot locations)
- Implement diversion protocol for low solids content tailings near Dam
- No saline water (or other non tailings water) to be discharged with tailings

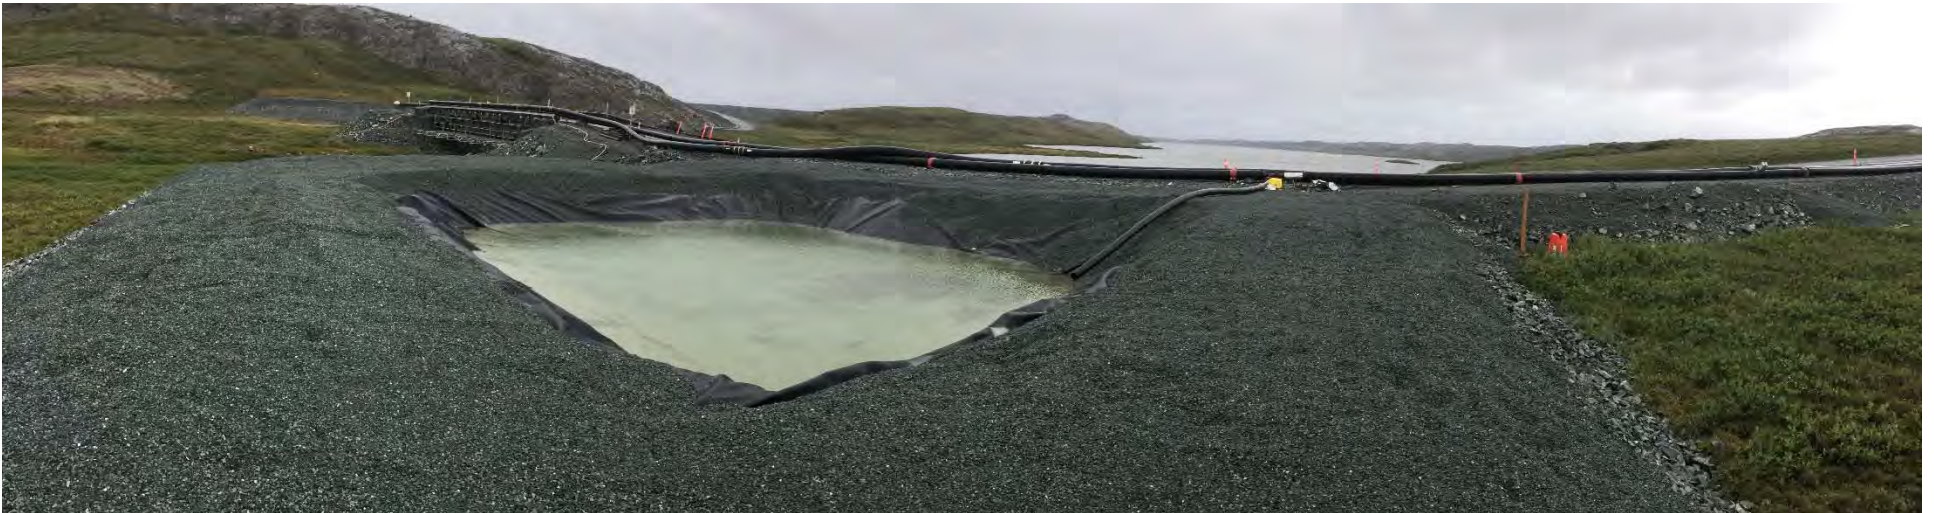
Emergency Dump Ponds

- ★ • Ponds need to be kept empty
- West pond not properly constructed: (1) Not compacted, (2) Liner sloughing
- Pond will require excessive maintenance and should not be relied upon
- Undermines credibility with KIA and INAC

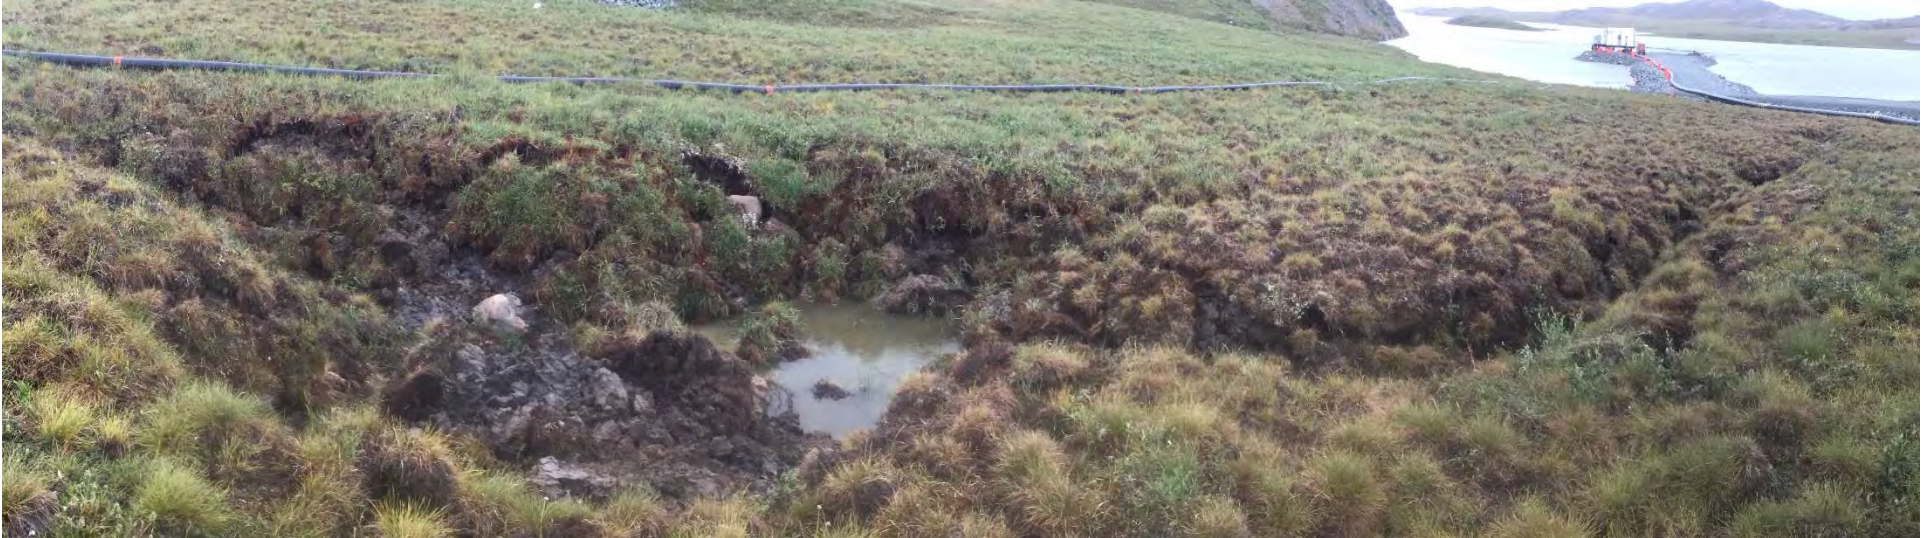
★ Tundra Hole

- Need to backfill as damage will progress
- Suggest backfill with tailings, or overburden slurry mixture
- Needs to be high solids content, preferably lower water temperature than tailings; could we use concrete mix trucks?
