2018 Annual Geotechnical Inspection		
		North Dam Upstream Face		
Job No: 1CT022.028	Doris TIA	Date: January 2019	Approved: PL	Photolog: 1
Filename: 2018NDGeotechInsp_Rev1_sw.pptx

2018 Annual Geotechnical Inspection		
		North Dam Downstream Face		
Job No: 1CT022.028	Doris TIA	Date: January 2019	Approved: PL	Photolog: 2
Filename: 2018NDGeotechInsp_Rev1_sw.pptx

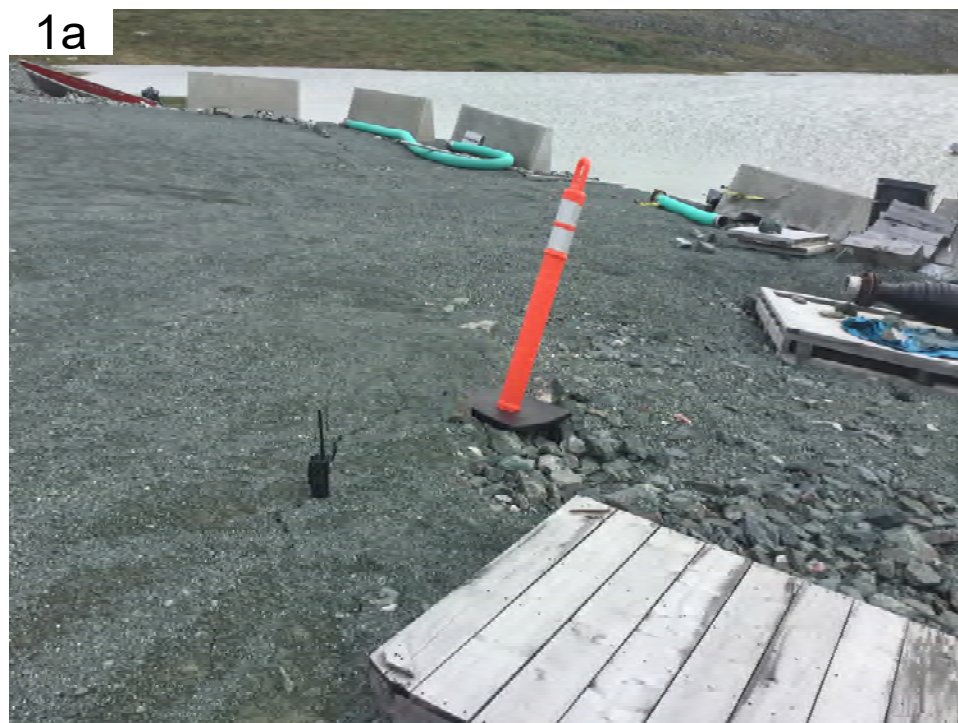
Photo 1a: View of the cracking observed on the upstream face pumping pad, looking east

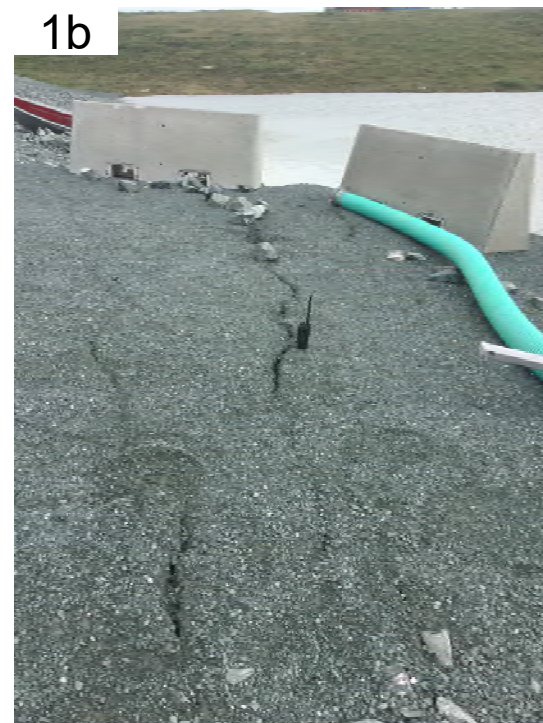
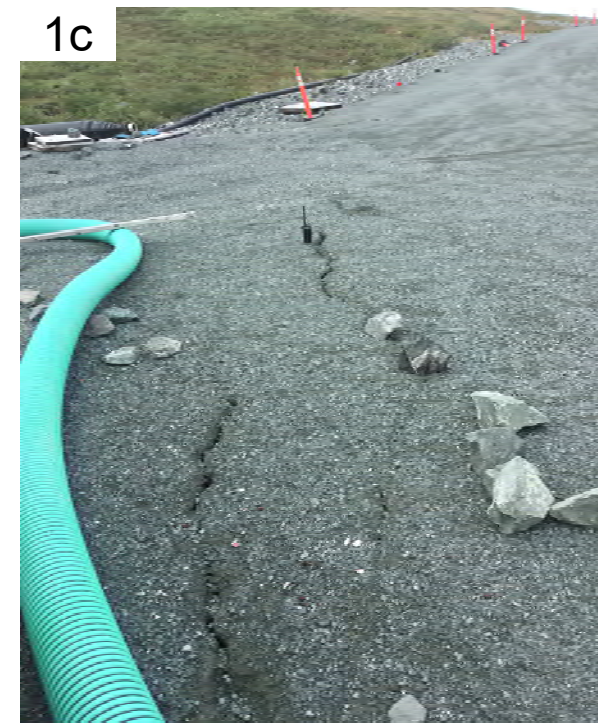
Photo 1b, 1c: Two alternative photos of the cracking observed on the pumping pad

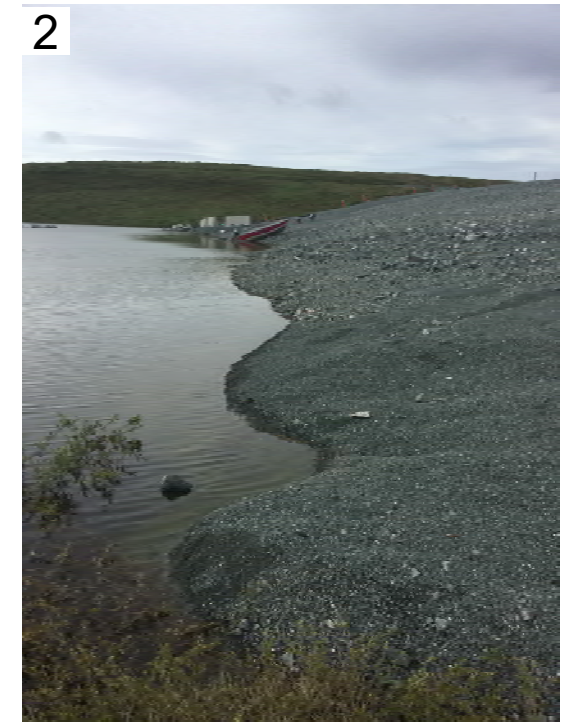
Photo 2: upstream face of the North Dam, looking west

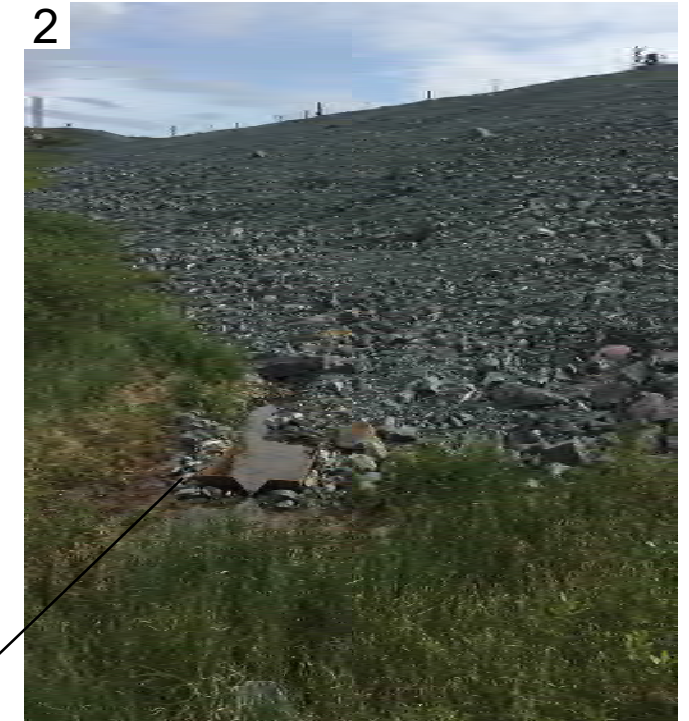
Photos:  
 Photo 1: View of the North Dam crest, looking east  
 Photo 2: Views of the V-notch weir installed at the downstream toe of the North Dam in 2018  
 Photo 3: Close-up of the V-notch weir installed at the downstream toe  
 Middle: Aerial photo of the North Dam
