2018 Annual Geotechnical Inspection		
		TIA Shoreline and Tailings Deposition (South End)		
Job No: 1CT022.028	Doris TIA	Date: January 2019	Approved: PL	Photolog: 6
Filename: 2018NDGeotechInsp_Rev1_sw.pptx

2018 Annual Geotechnical Inspection		
		Emergency Dump Catch Basins		
Job No: 1CT022.028 Filename: 2018NDGeotechInsp_Rev1_sw.pptx	Doris TIA	Date: January 2019	Approved: PL	Photolog: 7

2018 Annual Geotechnical Inspection		
		Tailings Discharge and Reclaim Pipeline (Near TIA)		
Job No: 1CT022.028	Doris TIA	Date: January 2019	Approved: PL	Photolog: 8
Filename: 2018NDGeotechInsp_Rev1_sw.pptx

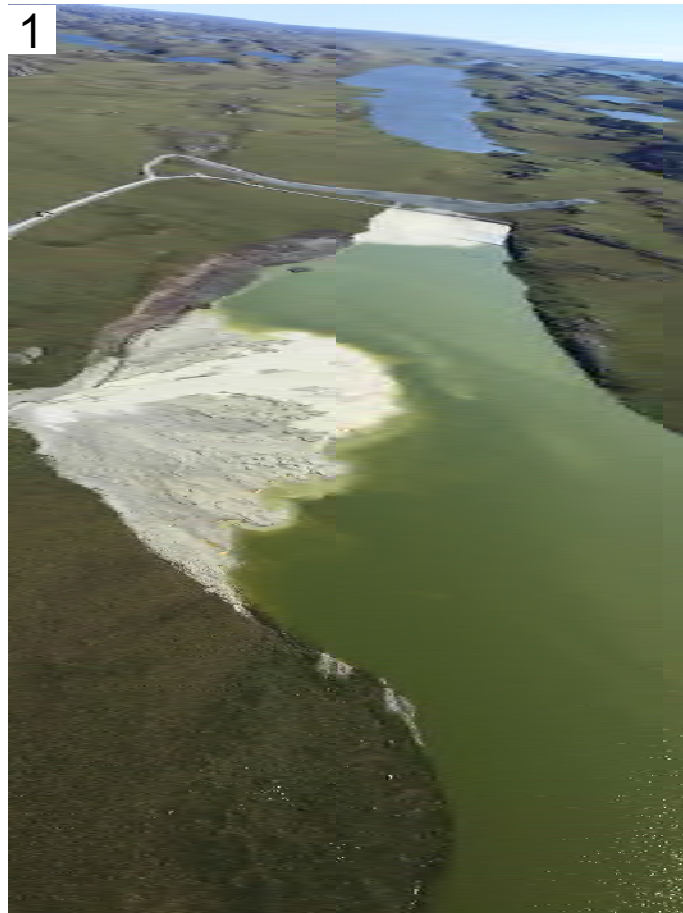
- Photo 1: Photo of the TIA with the primary spigot points and the overburden dump
- Photo 2: East shoreline of the TIA in 2017, prior to the construction of the South Dam
- Photo 3: Northern spigot point on the east side of the TIA
- Photo 4: View of the South Dam and southern shoreline looking north

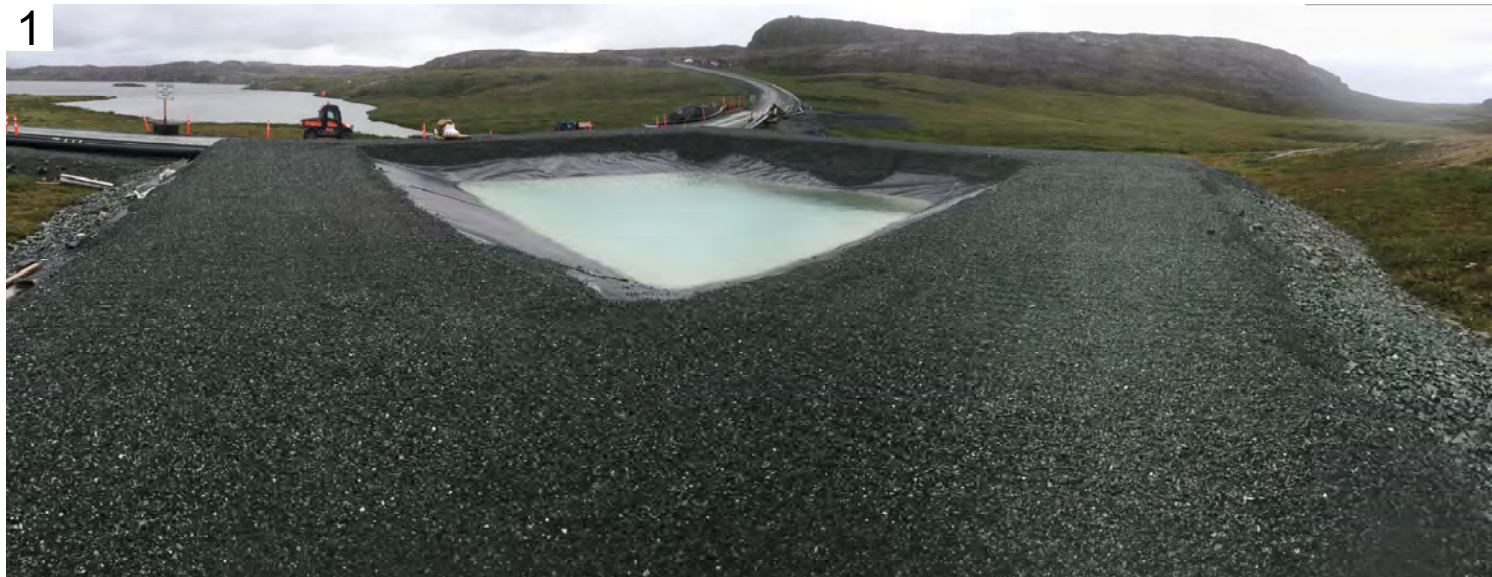
Photos:
 Photo 1: Photo of North EDCB looking south
 Photo 2: Photo of the North EDCB looking NE
 Photo 3: South EDCB looking south,
 Photo 4: South EDCB looking SE
 Photo 5: South EDCB looking east over Doris Lake

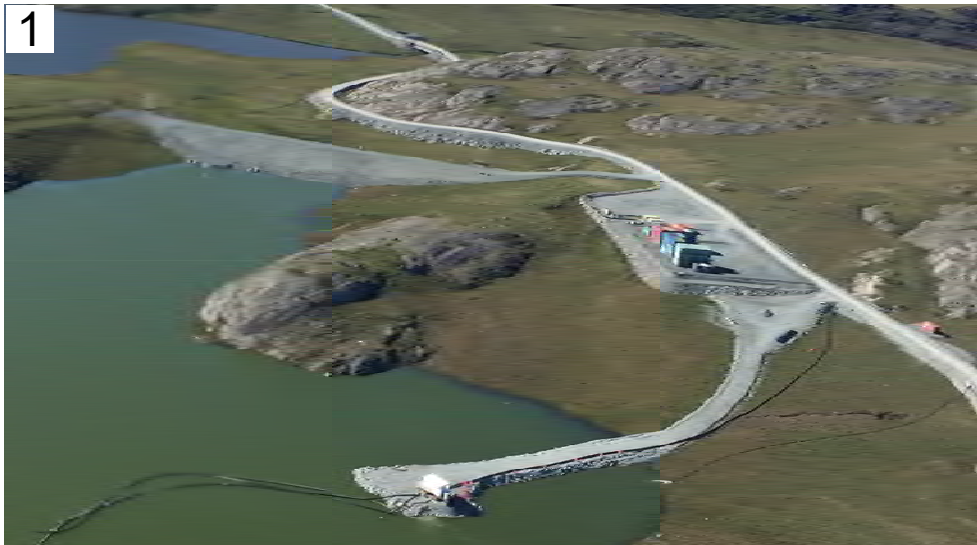
Photo 1: TIA Reclaim pipeline

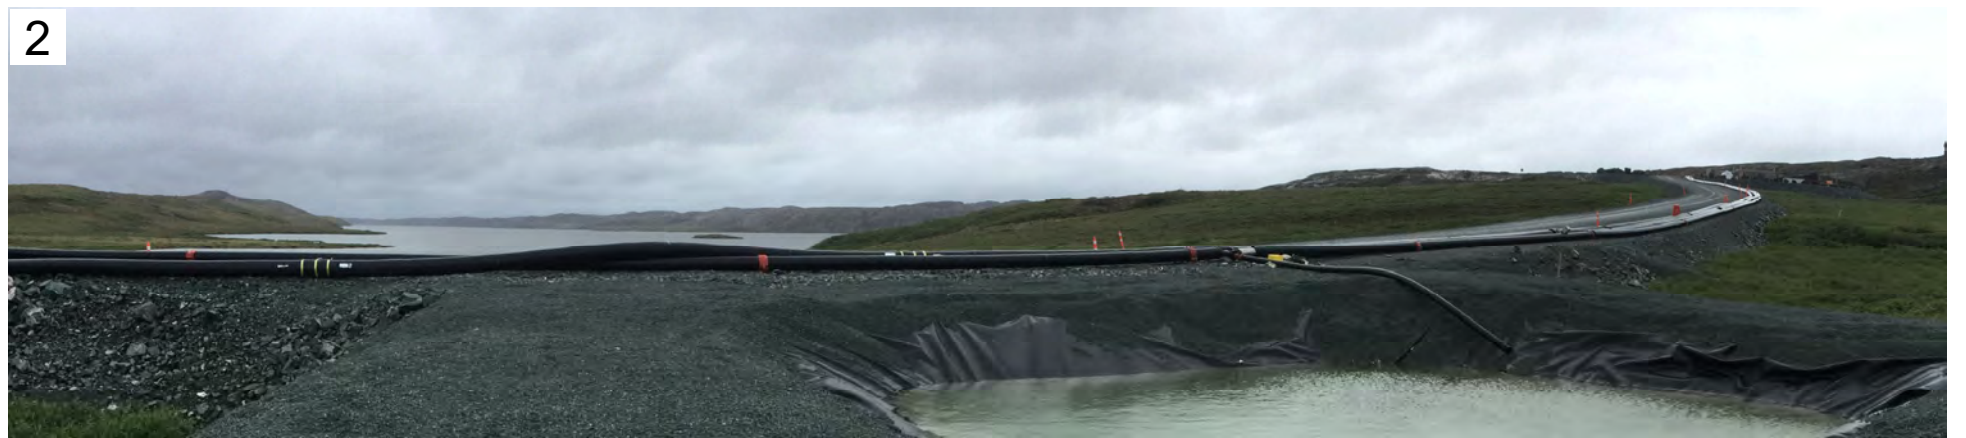
Photo 2: Tailings discharge and reclaim pipeline passing the South Emergency Dump Catch Basin (EDCB)

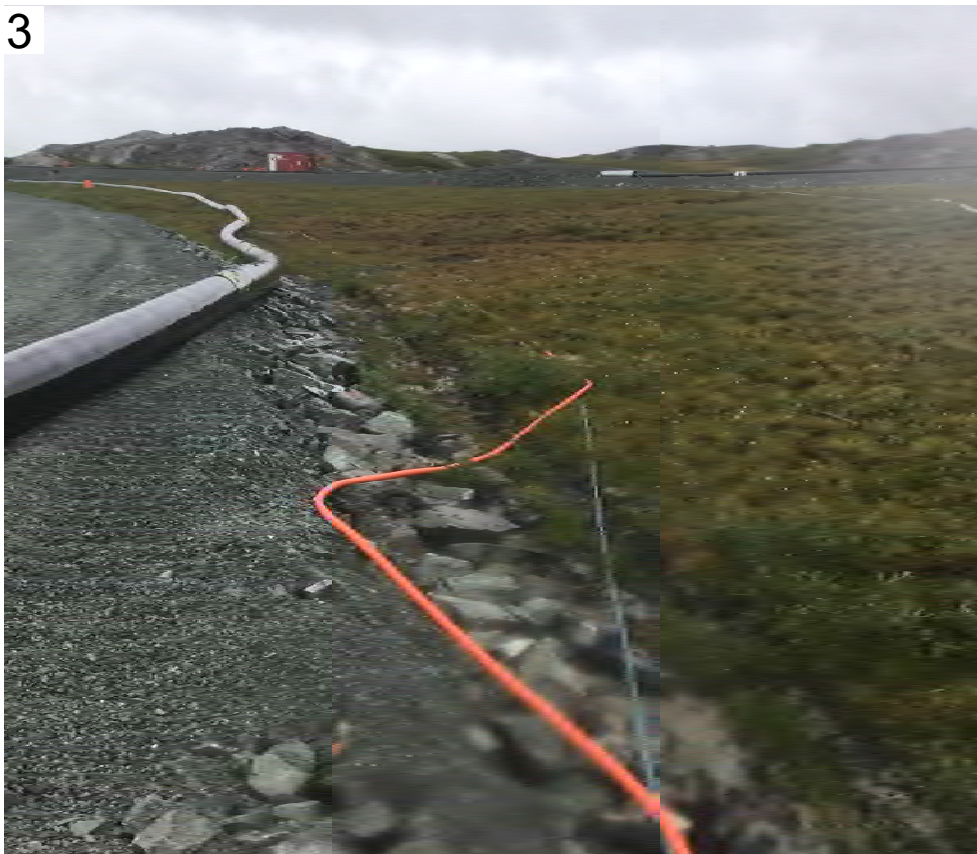
Photo 3: Tailings pipeline and electrical cable on tundra between Doris Camp and the TIA

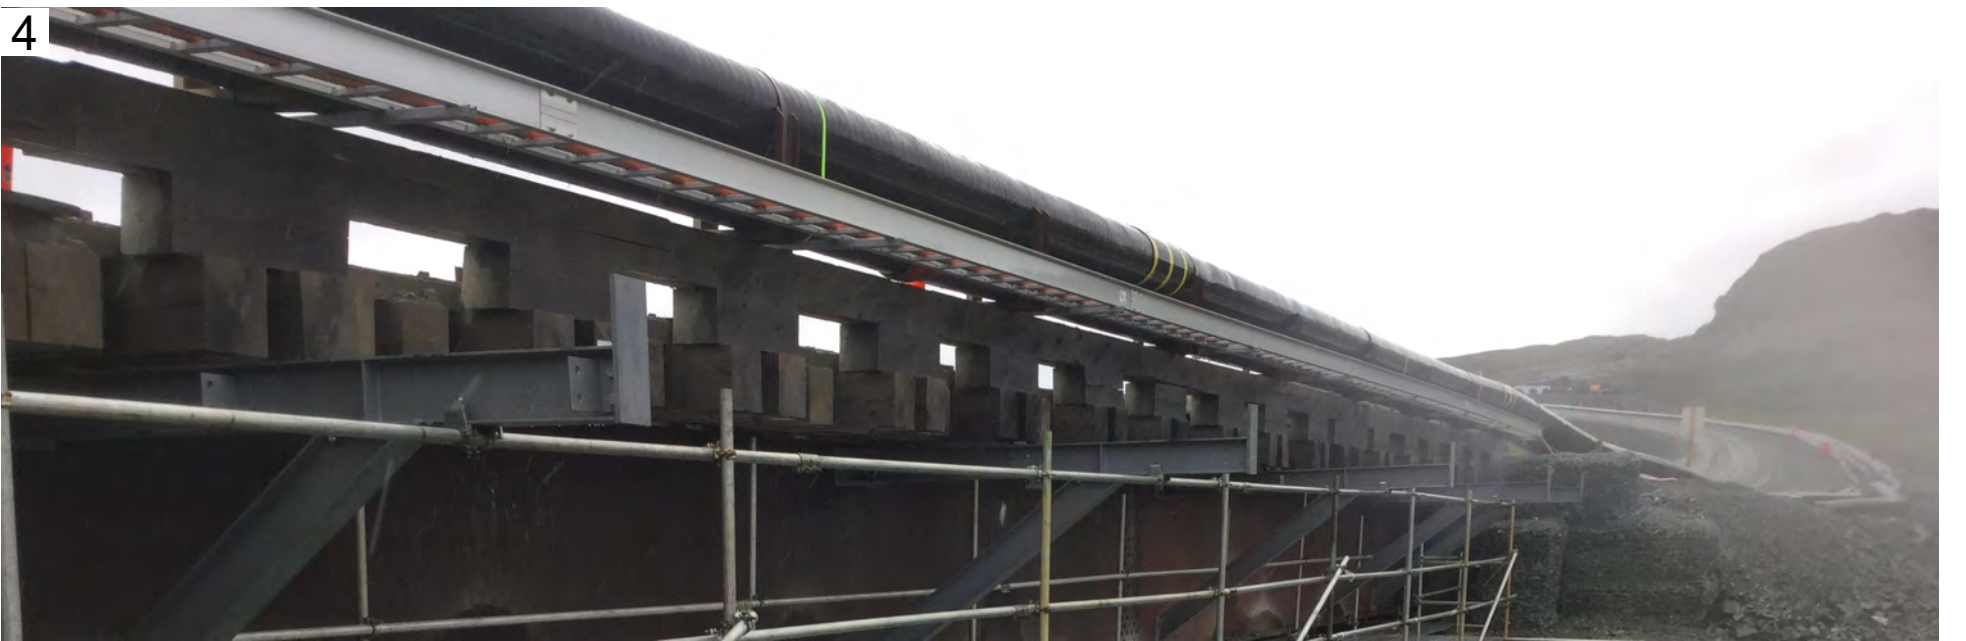
Photo 4: Tailings pipeline crossing the Doris Creek Bridge
