Appendix A – Arctic Foundations of Canada Inspection Report

Doris North Dam

Inspection of Thermosyphon System

April 10-11, 2018

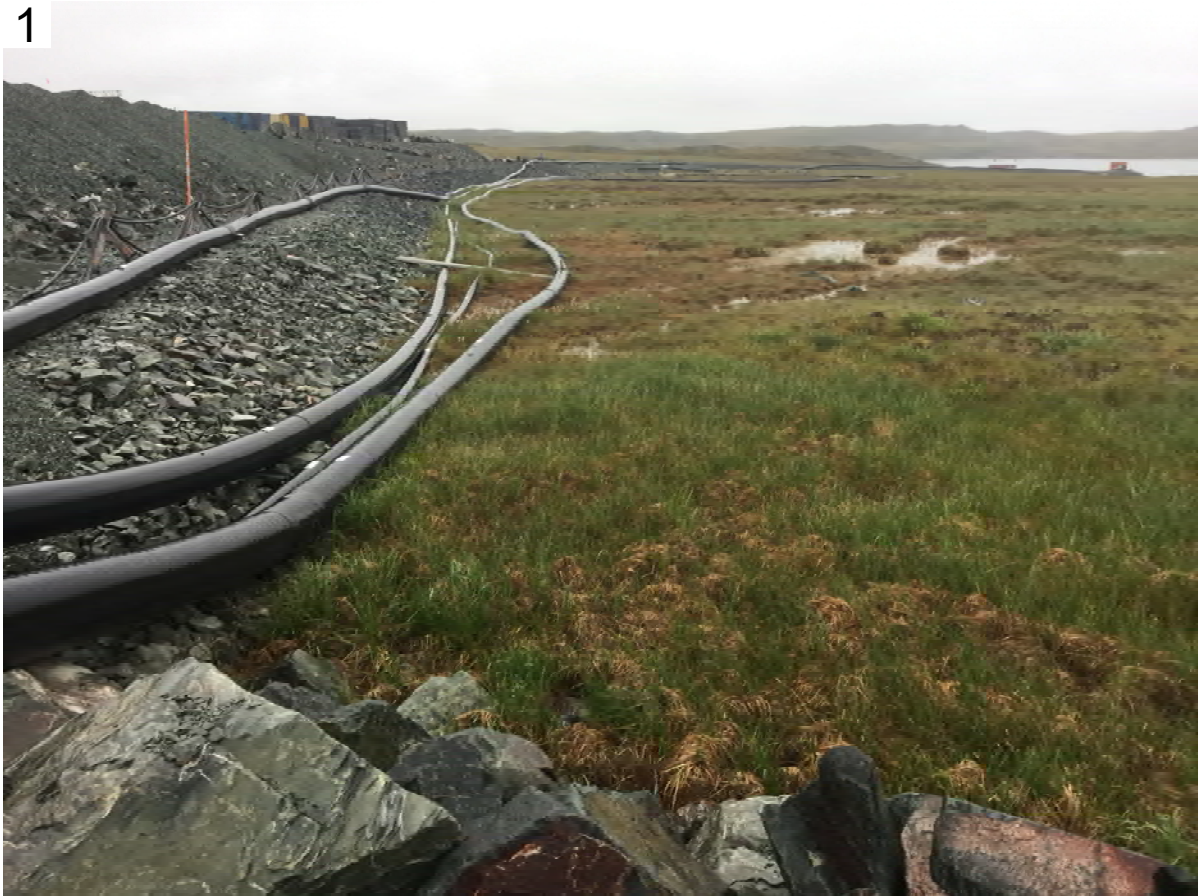
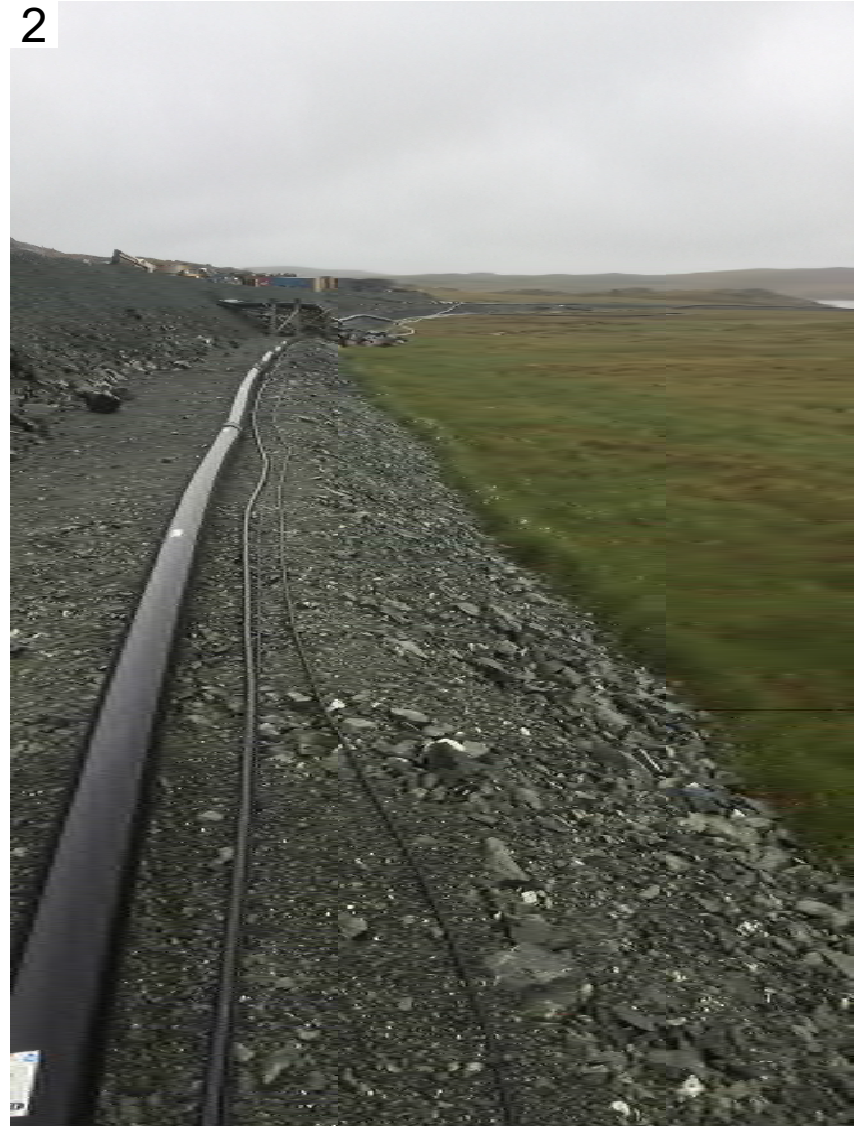
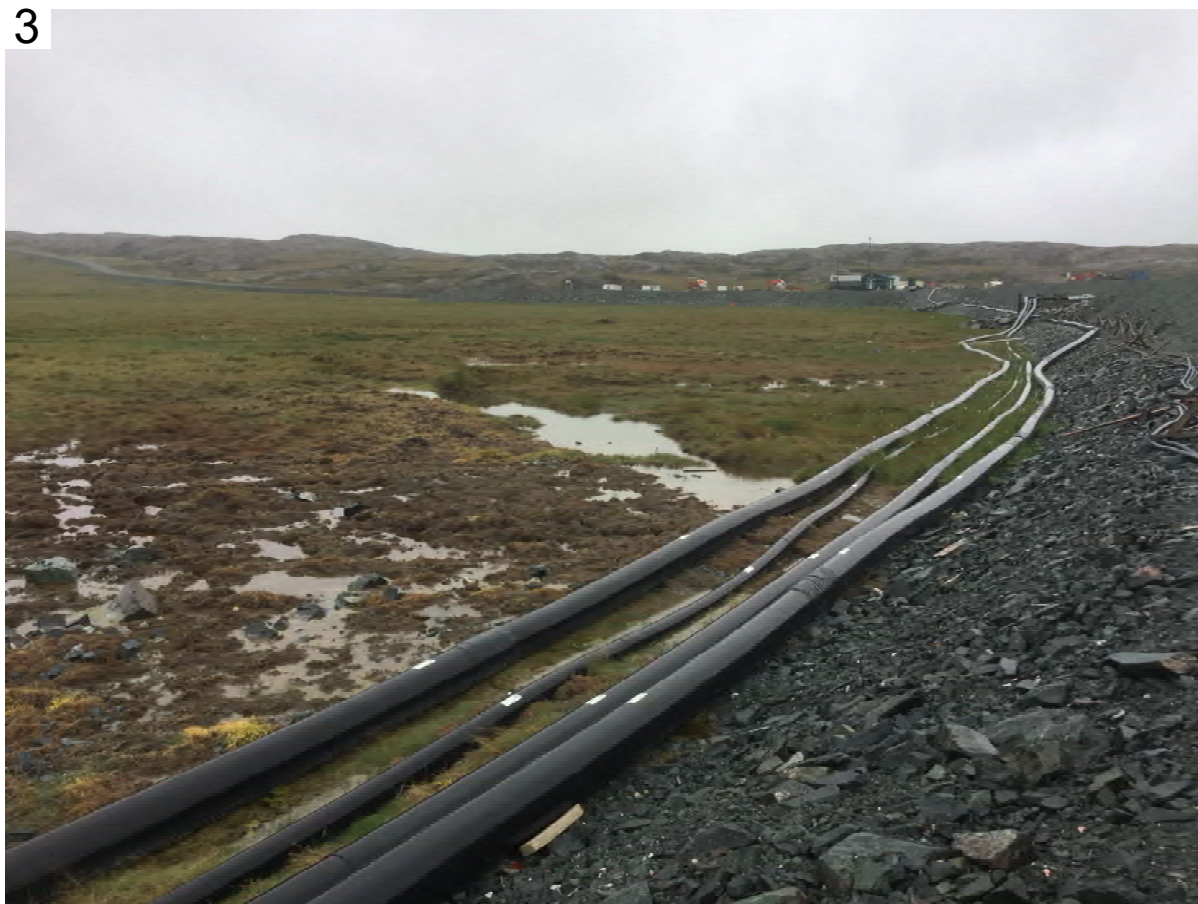
Photos:
 Photo 1: Photo of tundra degradation and pipeline on the tundra near the core laydown area
 Photo 2: Pipeline on pad near the helicopter pad
 Photo 3: Tundra degradation and pipeline on the tundra Looking back toward Photo 1

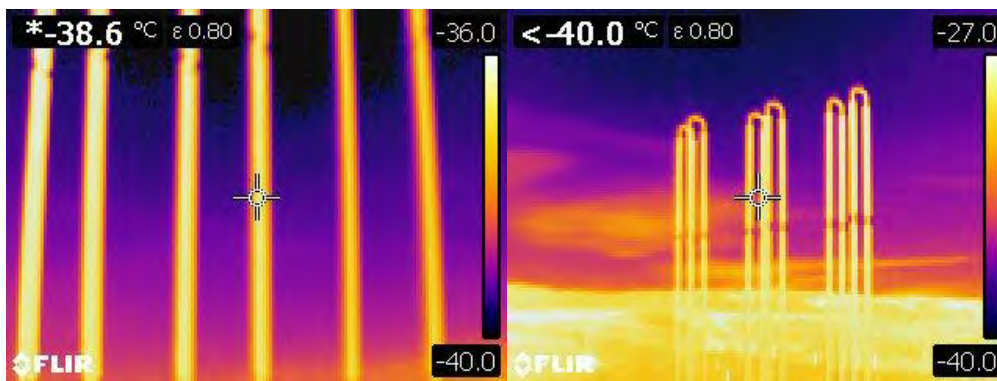
During the inspection, thermal imaging was used as an initial indicator to see if there were obvious signs of a non-functioning unit. Both the north and south banks were inspected and found to show consistent temperature gradients relative to ambient temperature.

North Bank

South Bank
