2019 Annual Geotechnical Inspection		
		North Dam Instrumentation and Thermosyphons		
Job No: 1CT022.038	Doris TIA	Date: March 2020	Approved: PL / JK	Photolog: 3
Filename: 2019NDGeotechInsp_Rev1_sw.pptx

## Appendix A – Arctic Foundations of Canada Inspection Report

## Doris North Dam – North Thermosyphon #2

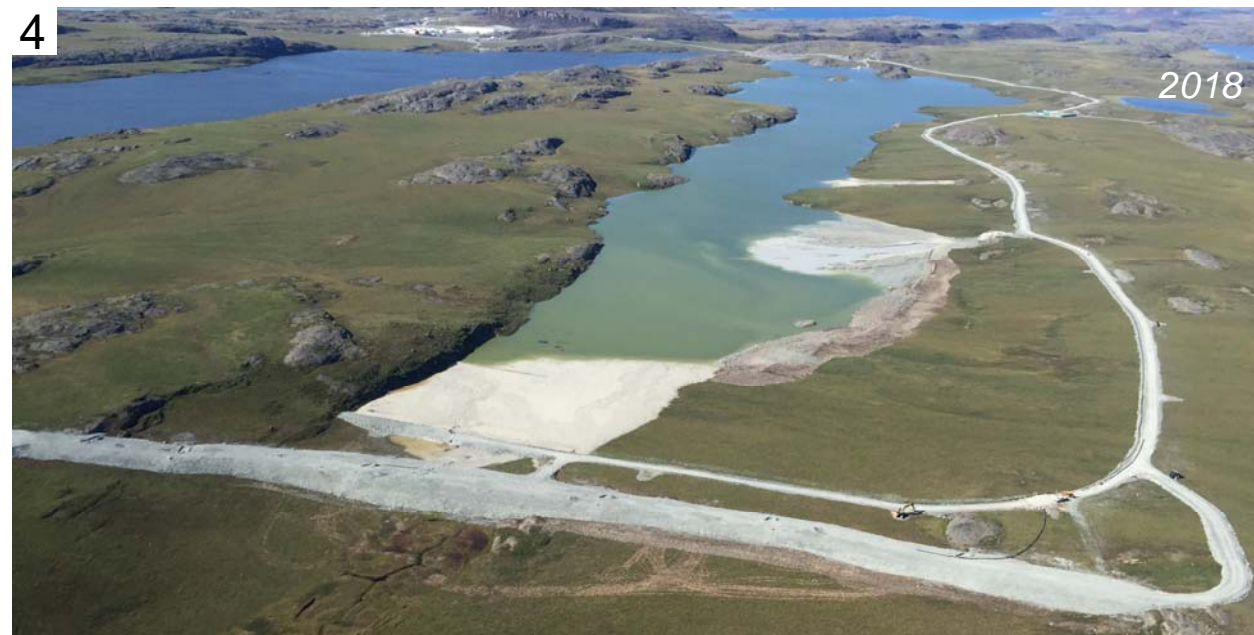
Photo 1a: Permafrost degradation near the reclaim pond access road (partially backfilled with tailings).

Location noted in past / earlier year inspections.

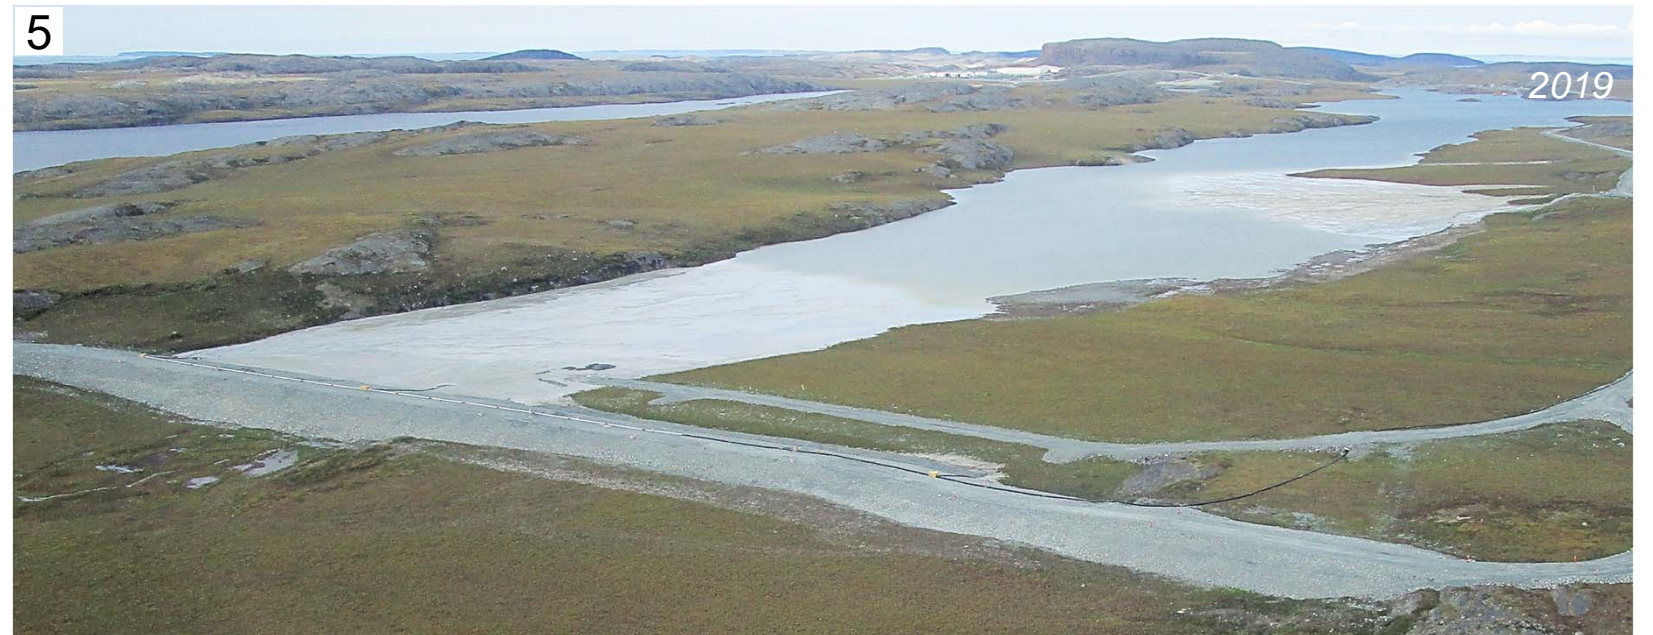
Photo 1b: Second view of the permafrost degradation near the reclaim pond access road

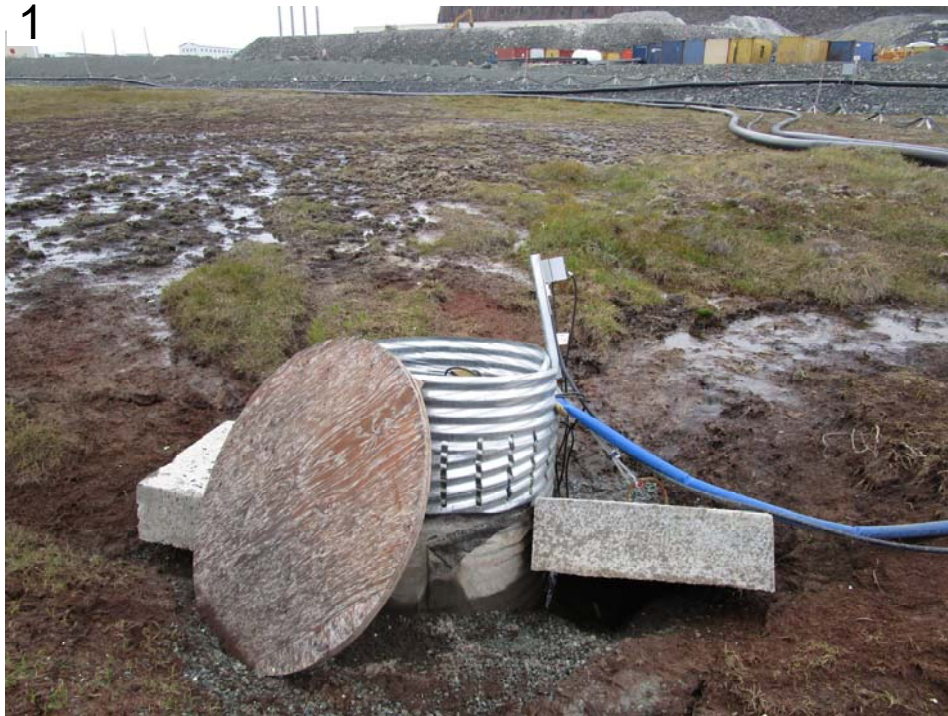
Photos:  
 Photo 1: Sump #3 area and associated tundra / permafrost degradation visible. Looking approx. west toward Doris Mill Area  
 Photo 2: A different view of the same sump, looking south, the deformation and sunken blocks due to permafrost degradation.  
 Photo 3: Reclaim pipelines leading toward the TIA from the Doris Creek Bridge, looking southeast  
 Photo 4 through 6: Sumps (#1 and 2) with pipelines showing pipelines directly on tundra. Near Doris Camp.

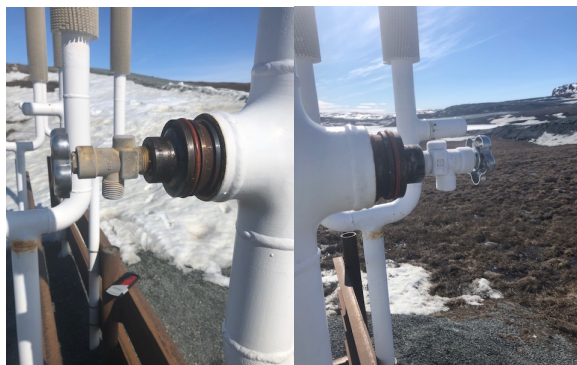
June 4-6 2019 One technician attended site to complete the discharge on North#2. Before the discharge, the protective valve cap, o ring and charge valve were in place, intact, and showed no signs of wear or damage. The unit was fully charged with refrigerant and showed no signs to indicate it should not be fully functional. The unit was discharged as planned and took many hours to completely depressurize.

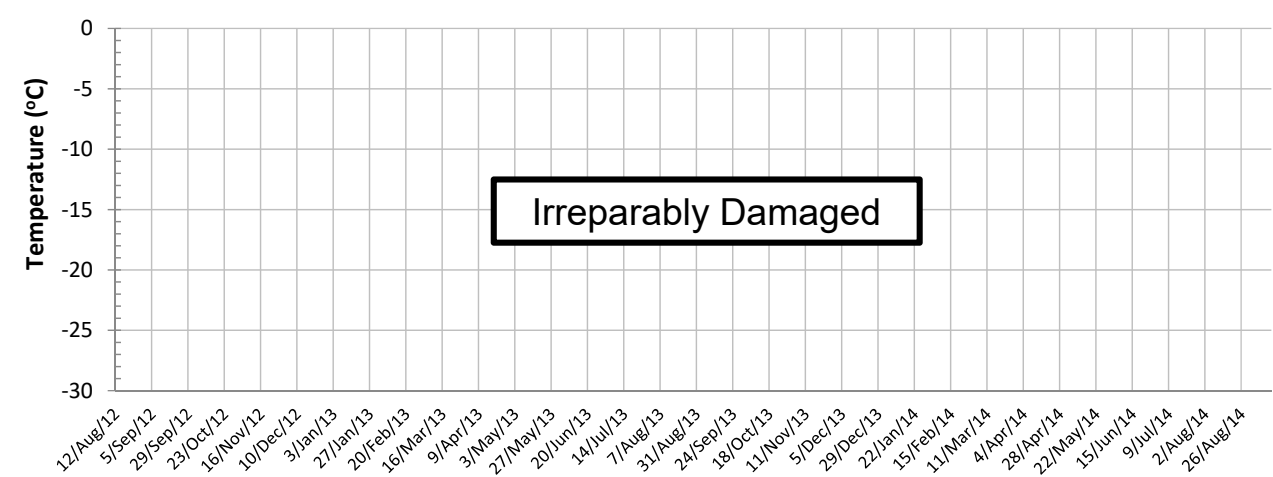
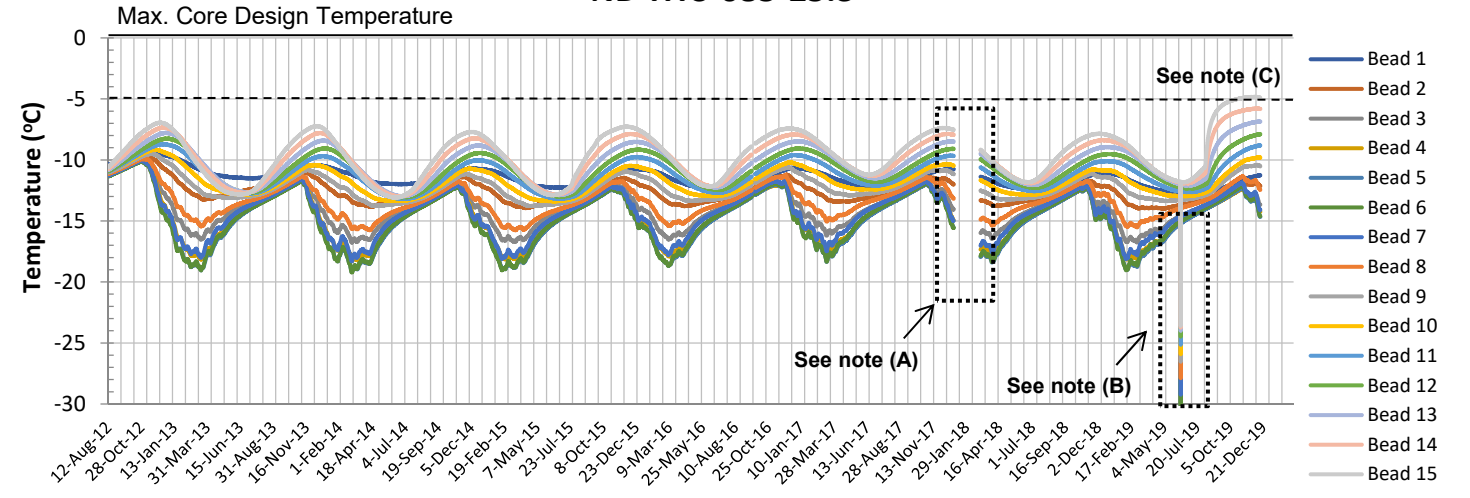
2019 AGI - North Dam		
<b>Station 0+85</b> <b>Horizontal Ground Temperature</b> <b>Cable Temperature Vs. Time</b>		
Date: Feb. 2020	Approved: AB	Figure: <b>B.7</b>

- Notes:**
- Bead numbers increase from downstream to upstream (horizontal) and top to bottom (vertical)
  - **(A)** Data logger was disconnected from January 1, 2018 to March 3, 2018 for recalibration
  - **(B)** A low temperature spike for all beads was observed for a single reading on June 12, 2019 and is attributed to an instrumentation error
  - **(C)** Temperature rise is expected to be a result of the rise in the reclaim pond water level.
