2019 AGI - South Dam		
		South Dam Station 3+65 Ground Temperature Cable Readings by Location		
Job No: 1CT022.038 Filename: AppB_1CT022.038_SD_GTC	Doris TIA	Date: Mar. 2020	Approved: PL	Figure: B.29

2019 AGI - South Dam		
		Station 3+65 Vertical Ground Temperature Cable Temperature Vs. Time		
Job No: 1CT022.038 Filename: AppB_1CT022.038_SD_GTC	DORIS TIA	Date: Mar. 2020	Approved: AB	Figure: B.30

2019 AGI - North Dam	
	Inclinometer 070-1A Velocity Time Series	
Job No: 1CT022.038 Filename: AppE_1CT022.038_Inclinometers.pptx	  DORIS TIA	Date: Feb. 2020 Approved: AB Figure: E.5

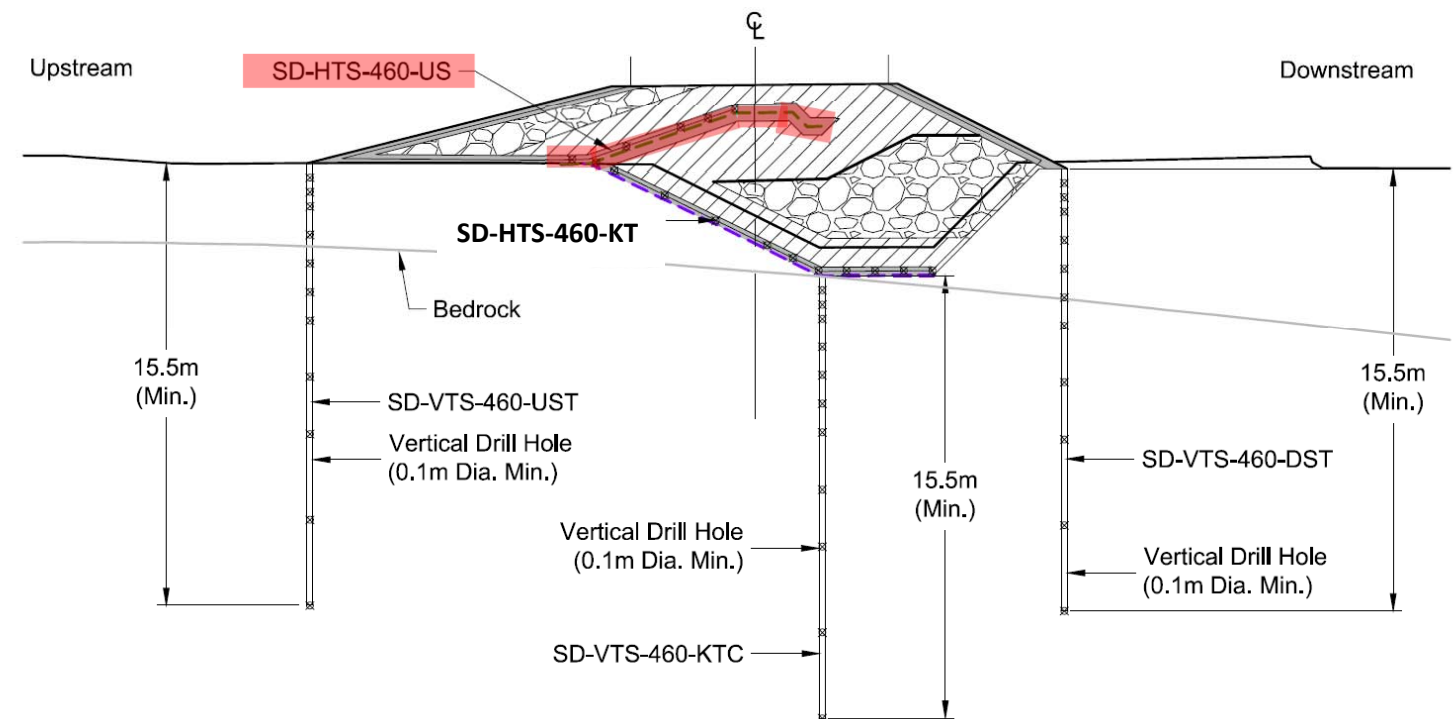
- Notes:
- Bead numbers increase from upstream to downstream (horizontal) and top to bottom (vertical)
 - SD-HTS-B1-KT is located along upstream crest of key trench (not shown in drawing)
 - (A) Measurements collected between April and August 2018 were taken during construction
 - (B) No measurements were collected between September 2018 to November 2018 as the GTC's were extended and repaired, and the data loggers were set up on site.
 - (C) From November 2018 onwards, data loggers were installed and placed on site, providing higher resolution and more frequent data transmissions

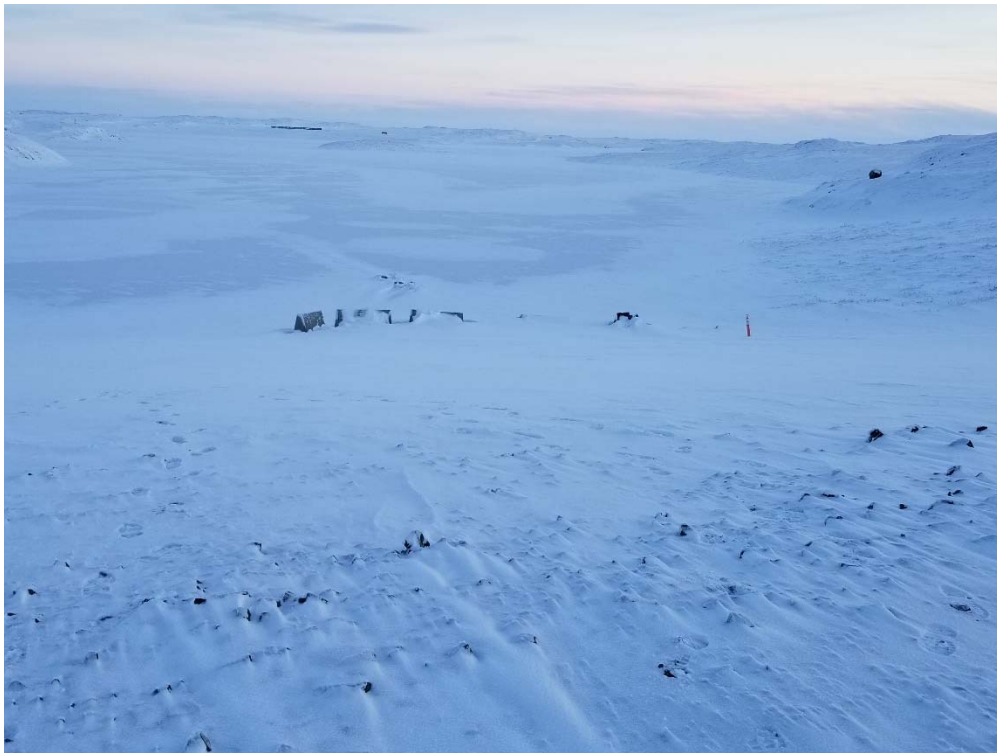
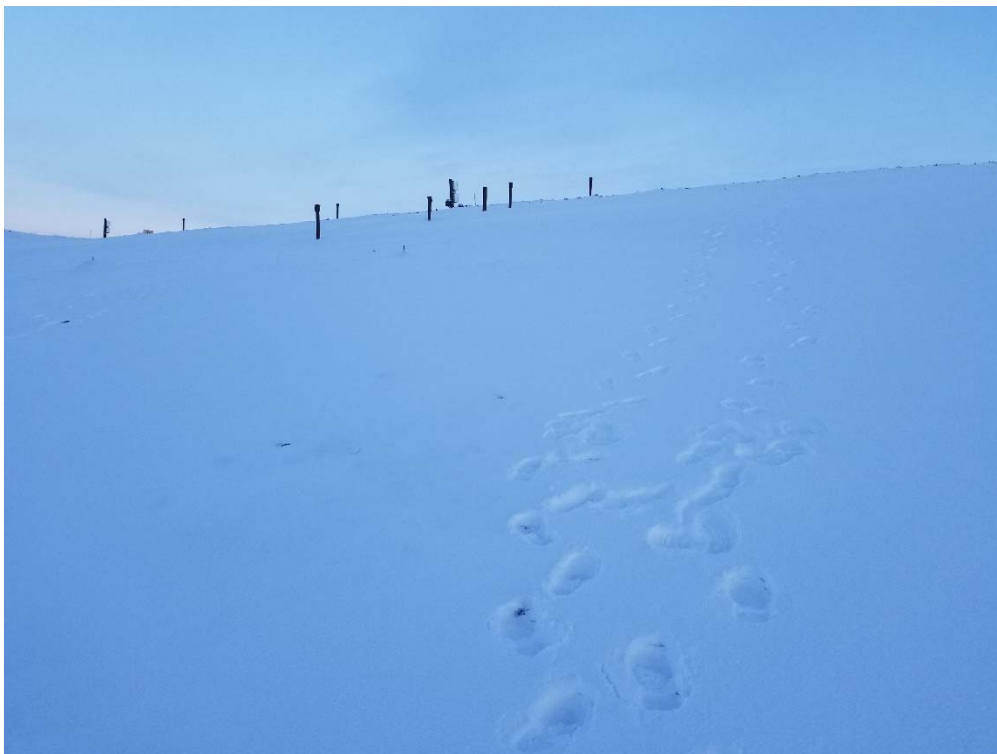
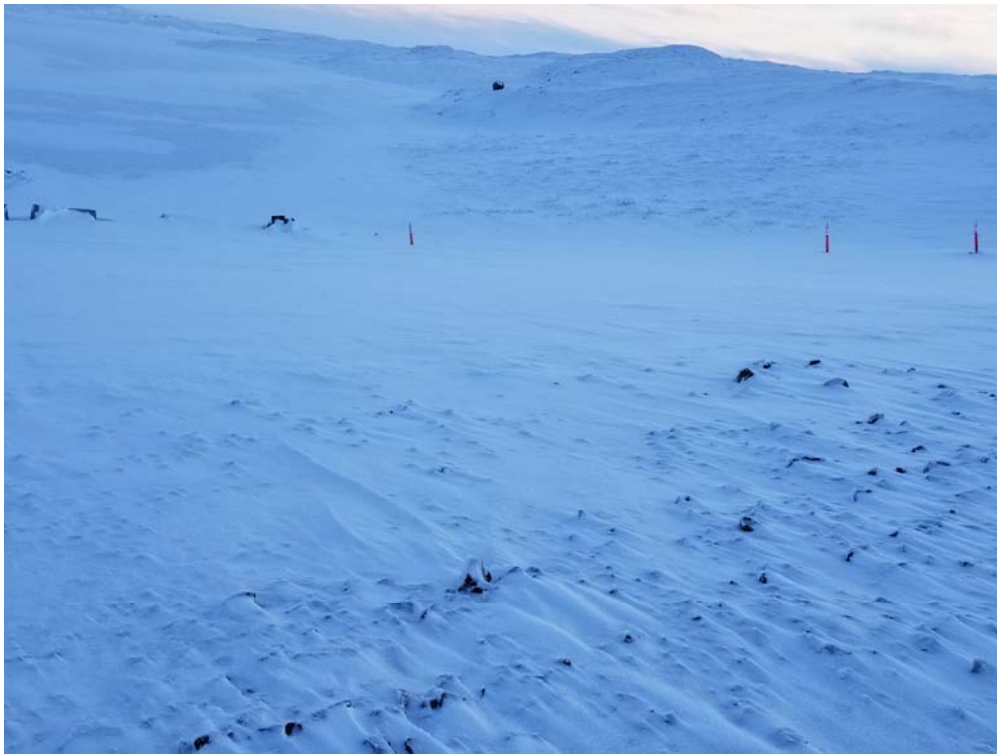
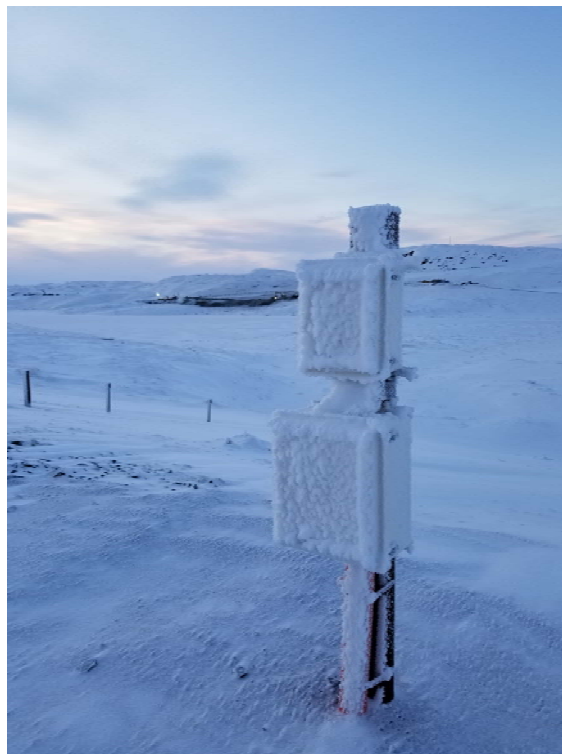
<p>If you answered yes to any of the questions above please provide details and photos. Observations can be sketched on the figure provided on the next page. If seepage has been noted please estimate the flow.</p> <p>All covered in frozen snow</p>
