North Dam Weekly Walkover Survey Report

Date:	April 14. 2019
Inspected By:	Mike Tarosa
Conditions:	(ie. snow on ground, clear) Snow

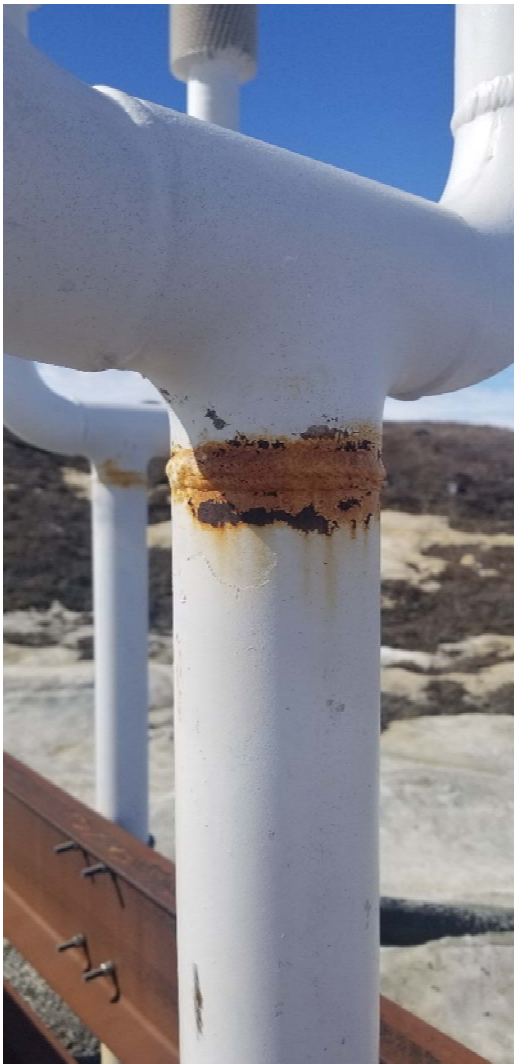
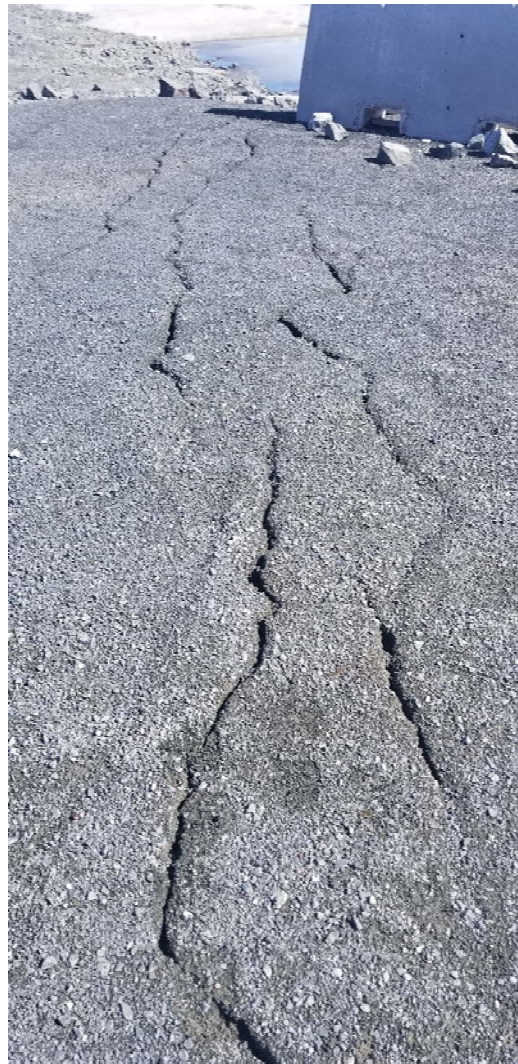
Upstream Side of Dam <i>Minor surface cracking</i>		
Any visible concerns? (cracks, depressions, erosion, etc.)	Yes	<input checked="" type="radio"/> No
Downstream Side of Dam		
Any visible concerns? (cracks, depressions, erosion, seepage, etc.) <i>Snow cover</i>	Yes	<input checked="" type="radio"/> No
Crest of Dam		
Any visible concerns? (cracks, depressions, erosion, etc.)	Yes	<input checked="" type="radio"/> No
Thermosyphons North Side <i>Minor rust</i>		
Any visible concerns? (cracks, punctures, peeling paint, birds nests, etc.)	Yes	<input checked="" type="radio"/> No
Thermosyphons South Side		
Any visible concerns? (cracks, punctures, peeling paint, birds nests, etc.)	Yes	<input checked="" type="radio"/> No
Instrumentation (on crest and downstream side)		
Any visible concerns? (bent, rusted, cracked, etc.)	Yes	<input checked="" type="radio"/> No
Thermistors and Dataloggers		
Any visible concerns? (frayed or cut cables, damaged boxes, etc.)	Yes	<input checked="" type="radio"/> No

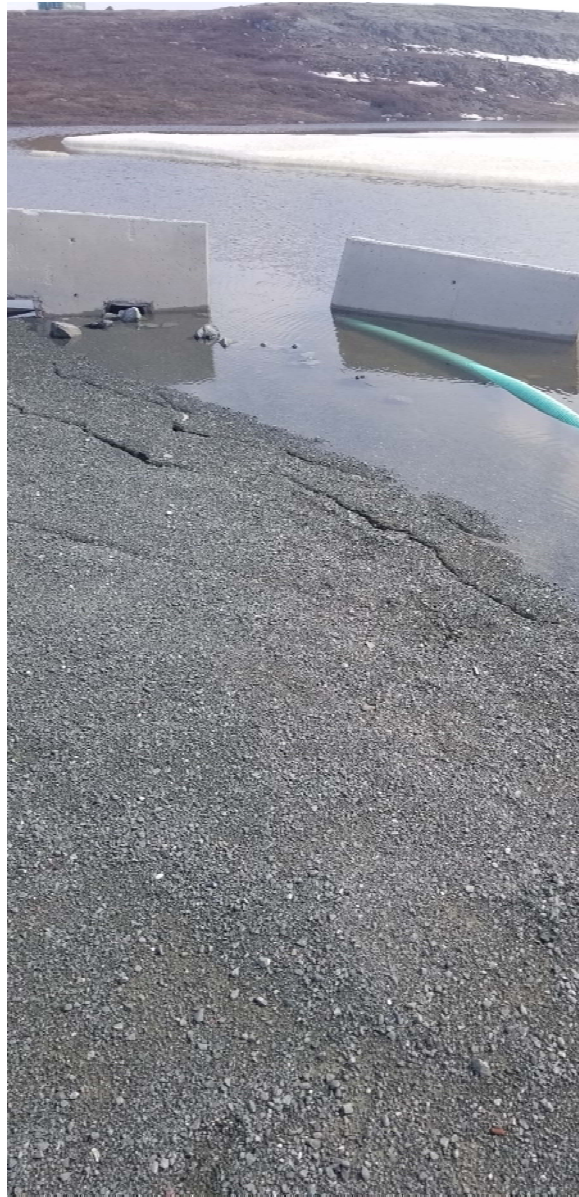
Upstream Side of Dam	<i>Surface cracks near discharge</i>	
Any visible concerns? (cracks, depressions, erosion, etc.)	Yes	<input checked="" type="radio"/> No
Downstream Side of Dam		
Any visible concerns? (cracks, depressions, erosion, seepage, etc.)	Yes	<input checked="" type="radio"/> No
Crest of Dam		
Any visible concerns? (cracks, depressions, erosion, etc.)	Yes	<input checked="" type="radio"/> No
Thermosyphons North Side		
Any visible concerns? (cracks, punctures, peeling paint, birds nests, etc.)	Yes	<input checked="" type="radio"/> No
Thermosyphons South Side		
Any visible concerns? (cracks, punctures, peeling paint, birds nests, etc.)	Yes	<input checked="" type="radio"/> No
Instrumentation (on crest and downstream side)		
Any visible concerns? (bent, rusted, cracked, etc.)	Yes	<input checked="" type="radio"/> No
Thermistors and Dataloggers		
Any visible concerns? (frayed or cut cables, damaged boxes, etc.)	Yes	<input checked="" type="radio"/> No

Up stream cracking.

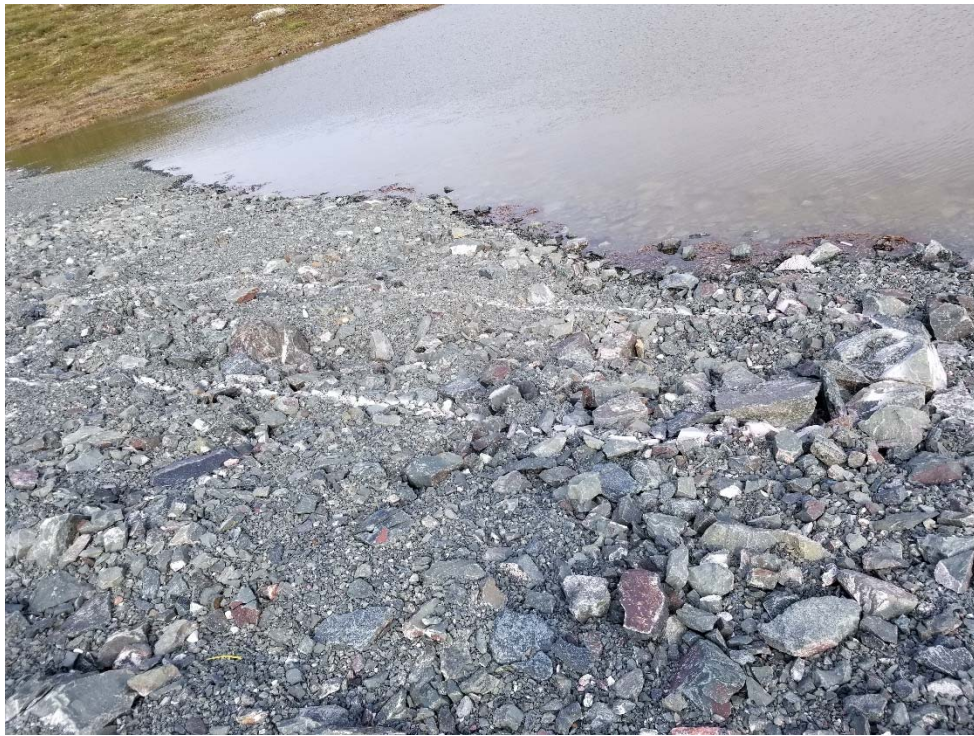
Yes	No
If you answered yes to any of the questions above please provide details and photos. Observations can be sketched on the figure provided on the next page. If seepage has been noted please estimate the flow.		
Minor depression on southern side near the water level

Minor depression near water contact on south side.
