Re: KIA Comments on 2019 Annual Geotechnical Inspection Report for the Tailings Impoundment Area Hope Bay Project, Nunavut

Reproduction of TMAC Responses to KIA-NIRB-37 through KIA NIRB-42 (TMAC, submitted September 4, 2020)

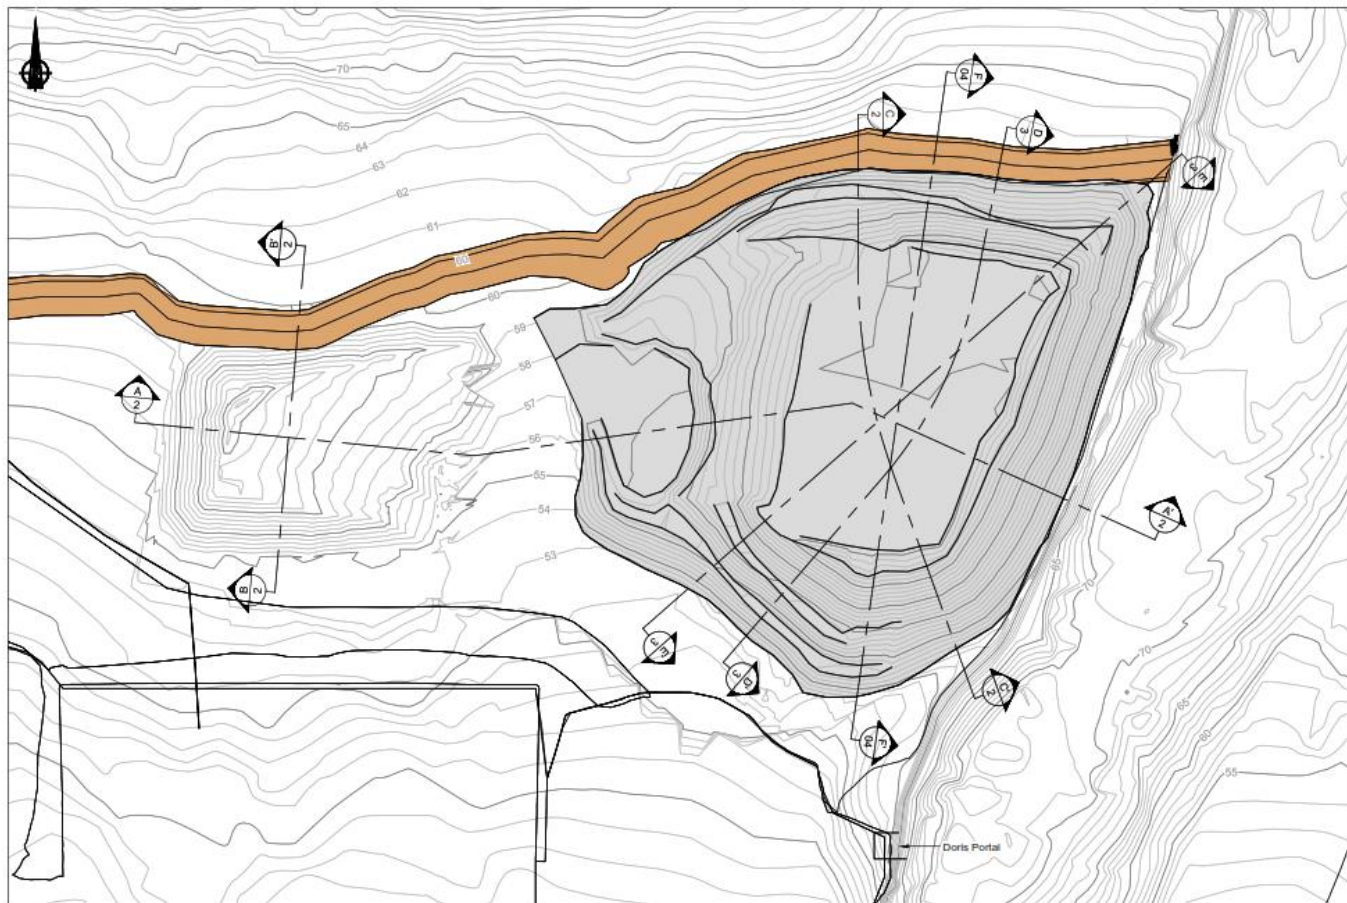
Figure 4: Pad-T As-Built Waste Rock Pile

Based on SRK's inspection of the waste rock pile on Pad T, the pile was noted to be both over-steepened and to exceed its maximum design height. TMAC's response was that the waste rock pile has been re-worked to reduce the height and slope angles and will continue to work with SRK to achieve the design parameters and safety factors. No details on the observed height or slope angles were provided.

The figures below provide the current (regraded) geometry of the waste rock pile (based on an August 2020 physical survey). As demonstrated in the figures, TMAC has conducted re-sloping of the waste rock pile since SRK's observations were noted in 2019. Checks completed have confirmed a Factor of Safety (FoS) above 1 and TMAC continues to work with SRK to ensure the long stability of the waste rock pile with a FoS in the 1.4+m range. It is noted, for a short term safety measure additional catch / safety berms have been placed around the area (upstream of the portal face) where risks from rolling rocks or shallow slope sloughing exist.

Provide the current (regraded) geometry of the waste rock pile and if not within the design criteria, an assessment of current safety factors and a plan to comply with the design criteria.
