# **2010 Annual Geotechnical Inspection, Doris North Project Hope Bay, Nunavut**

***Hope Bay Mining Ltd.***

*Project Reference Number  
SRK 1CH008.032*

*March 2011*

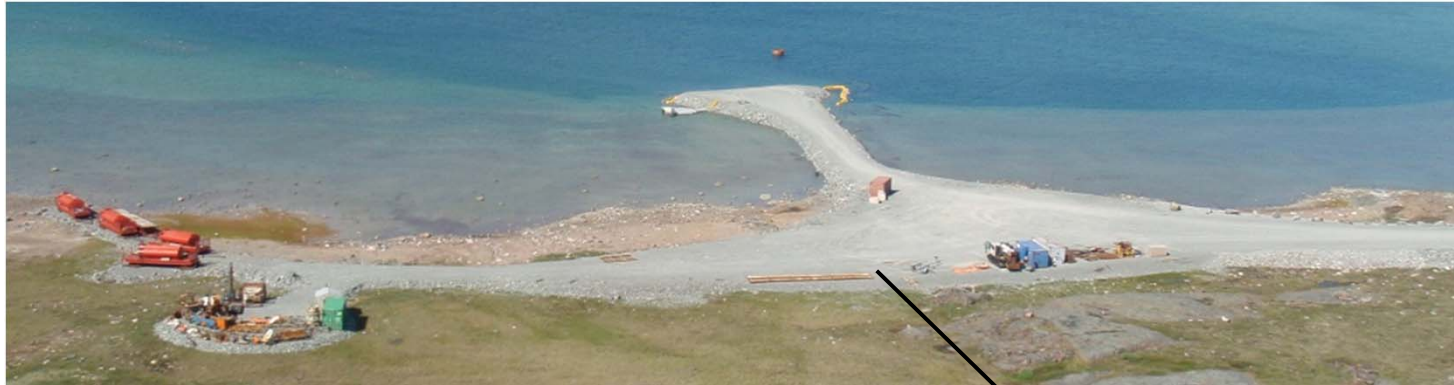
The 2010 geotechnical inspection of this structure revealed no cause for concern (Figure 6). There were no obvious signs of distress anywhere on the structure, and based on these observations, supported by verbal descriptions from site staff, settlement appears to have reached steady state. The SRK inspector has inspected the jetty annually since construction, and no visual differences could be observed since the 2009 inspection, other than the fact that the facility was raised and levelled. SRK imposed strict design and operational limitations on the use of the jetty due to the weak foundation conditions (SRK 2005a, 2009c, d), and based on observations, supported by staff interviews, HBML are following these recommendations carefully.

Eastern face of jetty looking south.

1. An annual survey of the jetty should be carried out at the same time the bathymetric survey around the jetty is carried out. This would allow for actual measurement of ongoing settlement. Should the proposed modifications to the jetty go ahead, the commencement of the annual survey could be deferred until 2012.
2. Operational staff responsible for the operation and maintenance of the jetty should be reminded annually of the operational limitations of the jetty imposed by its design. Excessive loading may result in catastrophic failure. Should the proposed jetty modifications be carried out, these limitations would no longer apply.
3. Continue monitoring the jetty thermistors in accordance with the protocols stipulated in Section 3.2.

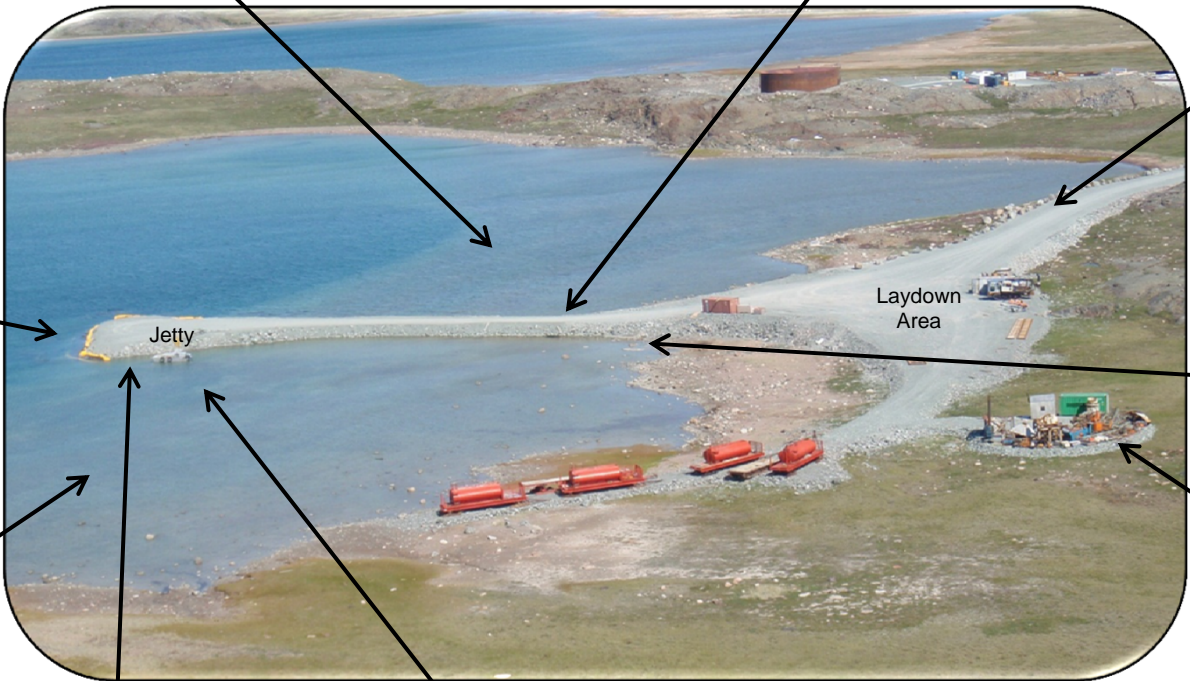
Western face of jetty at connection point to shoreline, looking north.

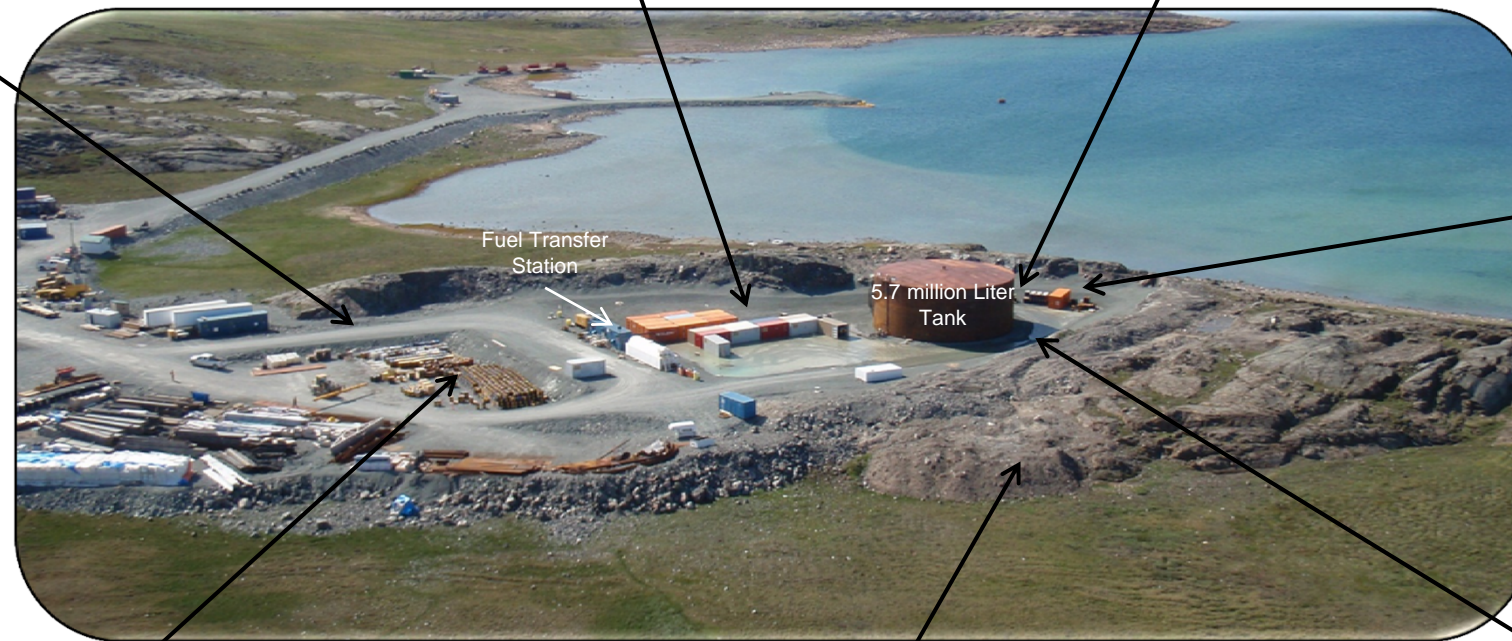
During the geotechnical inspection it was noted that significant quantities of jet fuel in drums were stored within the secondary containment facility, both on pallets and in sea cans. It should be confirmed that the presence of this fuel does not compromise the design capacity of the secondary containment facility.

Jet fuel storage on crest of containment berm below highwall.

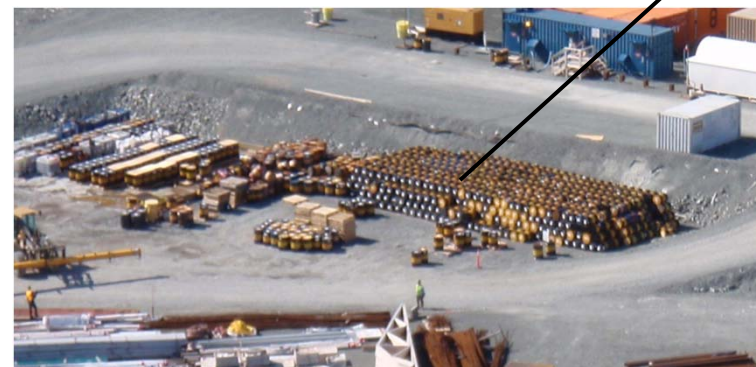
At the time of the inspection it was noted that there were at least two separate areas, at opposite ends of the facility, where water was ponding within the secondary containment facility. Since these are the obvious low spots, consideration should be given to installing sumps which would allow for pumping out any standing water. Whilst the presence of this water should not impact the integrity of the facility, it is good practice to ensure that it is well drained at all times. Ponded water was also observed in the area reserved for storage of the jet fuel and hydraulic oil, immediately adjacent the fuel transfer pad but outside of the secondary containment area. Since this area does not have a liner, and is founded on ice rich overburden, ponding should be avoided. A sump should be installed, or alternatively the area should be re-graded to allow free-draining off the pad.

Ponded area with no sump.

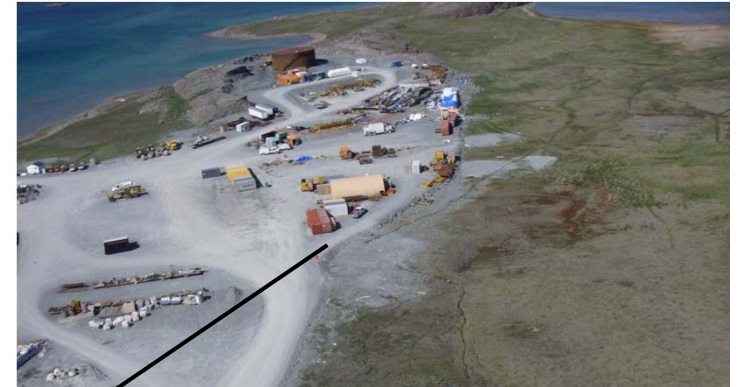
Northwest view across laydown area. Grey colour of tundra is where rock was removed. All drainage flows unhindered.

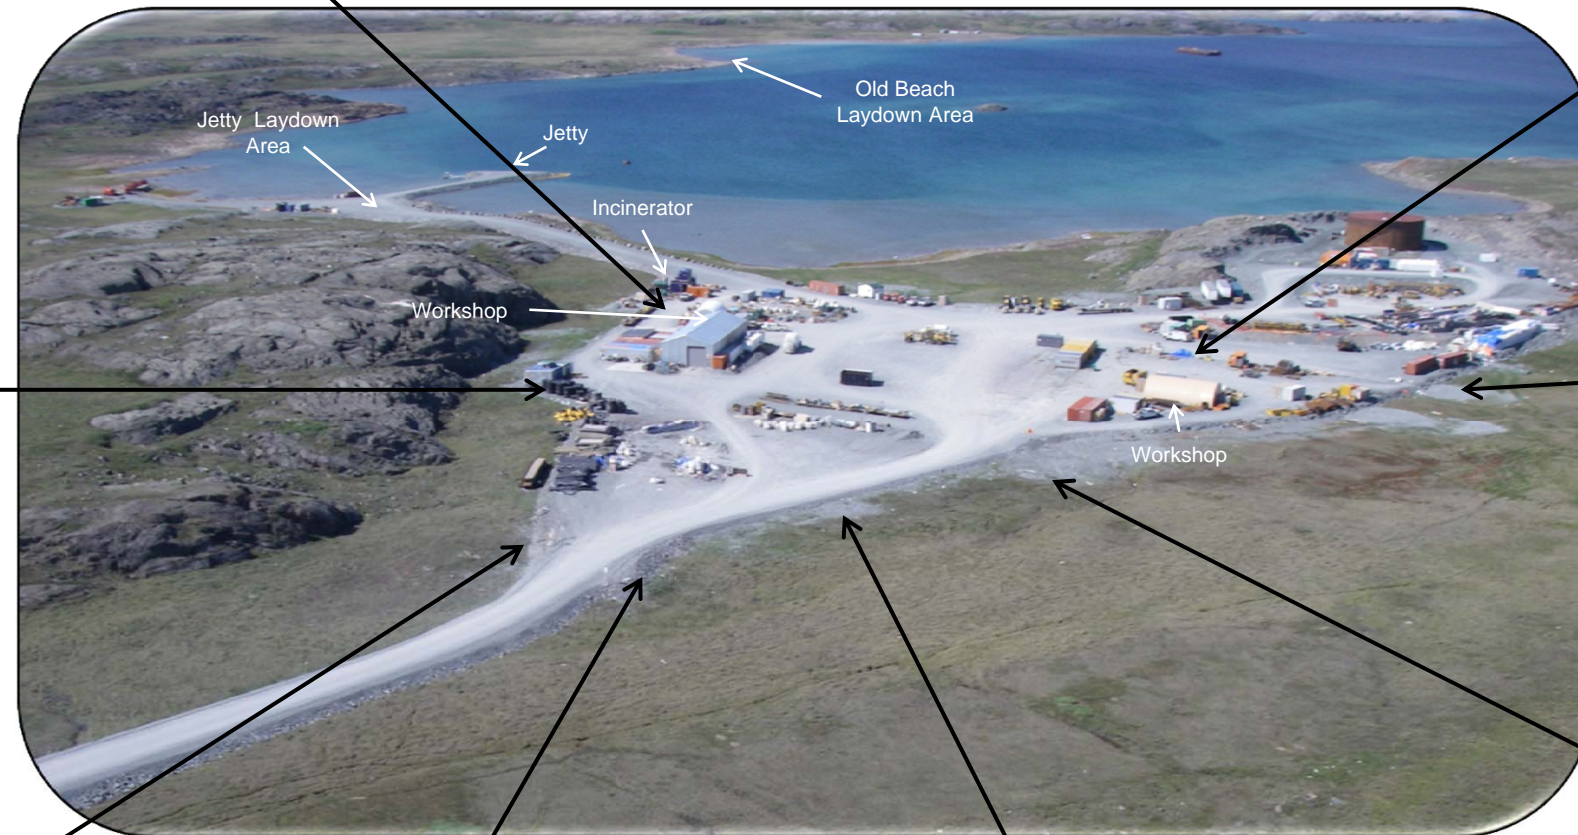
Light grey area in foreground is where stockpile crushed rock was stored. It has been removed without damaging tundra and drainage flows unimpeded.

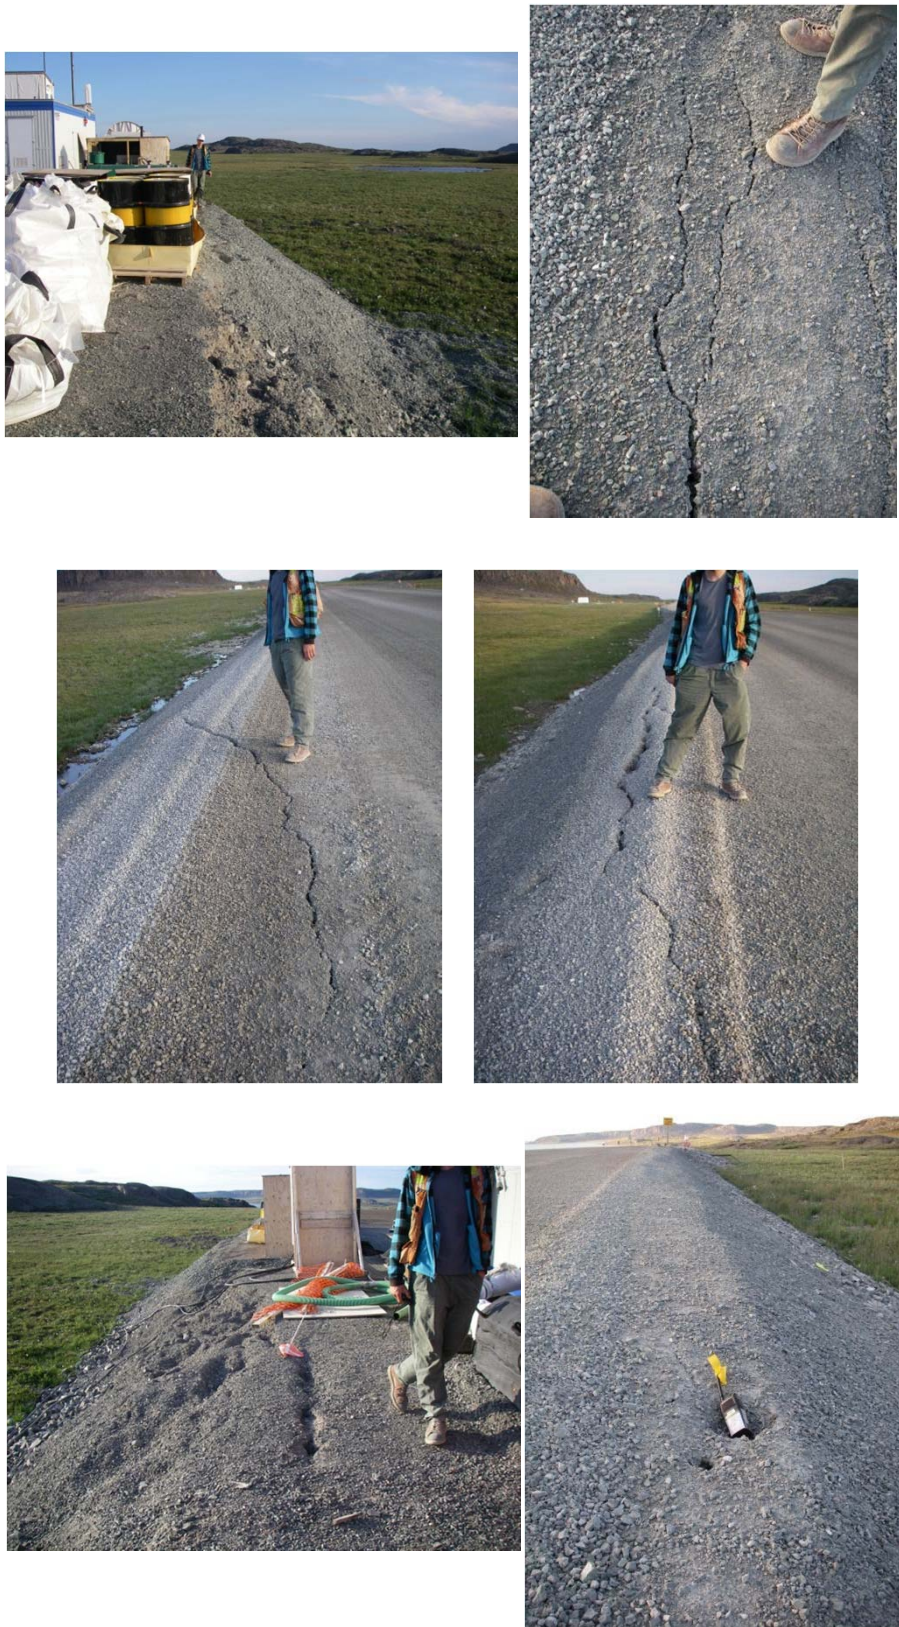
Examples of Tension Cracks

The airstrip required a significant amount of maintenance during since its completion in 2008, which according to the staff was mostly as a result of frequent construction traffic passing over the runway. Some of the maintenance can also be ascribed to ongoing settlement. The settlement is to be expected, since the airstrip was not completely constructed to design grade during the winter, and as such, there was not complete frost in the foundation which would result in consolidation settlement of the active layer. There were tension cracks along the edge of the runway present at the time of the inspection, which supports the observation that minor settlement is occurring; however, the manifestation of these cracks are also partially as a result of the over-steepened shoulders.

1. Relocate the fuel storage areas to at least 3 m from the edge of the shoulder.
2. Conduct daily inspections of the airstrip shoulder to monitor the tension cracks.
3. Areas where temporary roads were removed leaving behind a veneer of gravel should be monitored for signs of thermal erosion.
4. Maintain the practice of inspecting the runway during freshet and after significant and prolonged rainfall events for ponding water and pumping it out.

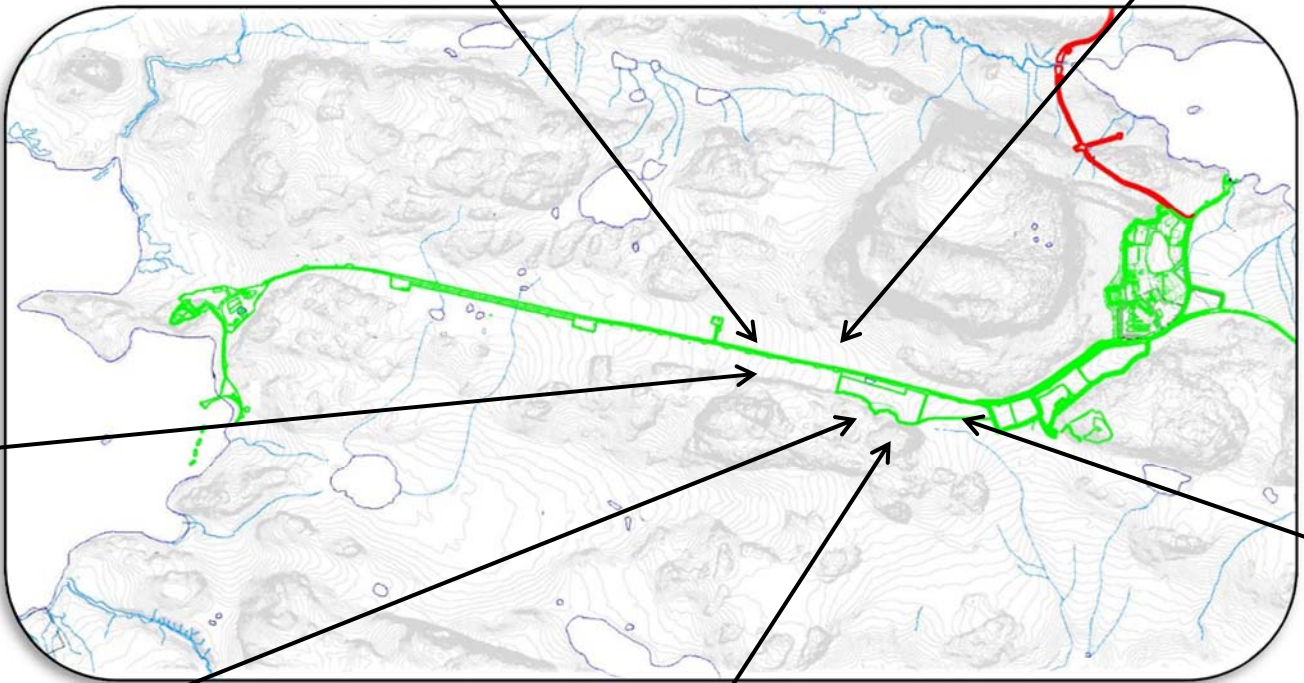
Oblique view looking south across road laydown area. Note rock pulled back of tundra adjacent to turnout.

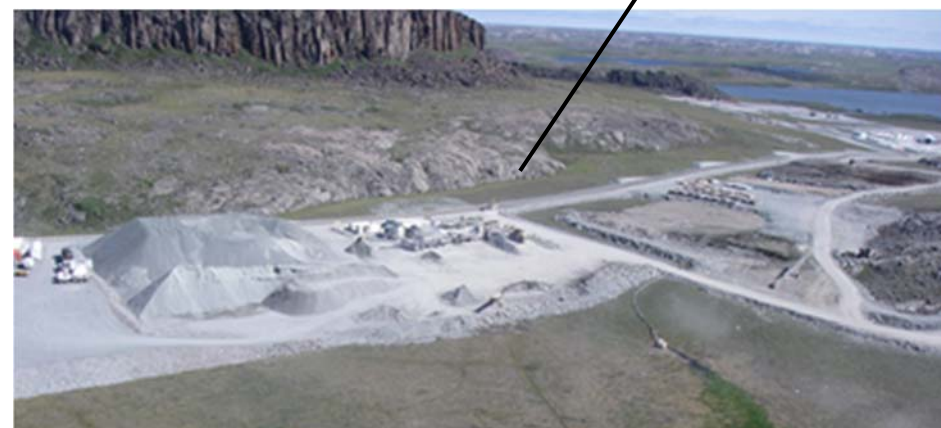
The grey water (sewage treatment effluent) pipeline is discharged directly onto the tundra immediately south of the crusher pad (Figure 11). Visual inspection confirmed that there was significant ponding of water; and tundra vegetation dieback has started with associated erosion damage. This practice should not continue for an indefinite time and an alternate strategy should be implemented.

Looking north across the crusher pad with the STP discharge area in the foreground.
