# **2011 Annual Geotechnical Inspection Doris North Project, Hope Bay, Nunavut**

**Hope Bay Mining Ltd.**

SRK Consulting (Canada) Inc  
1CH008.046  
March 2012

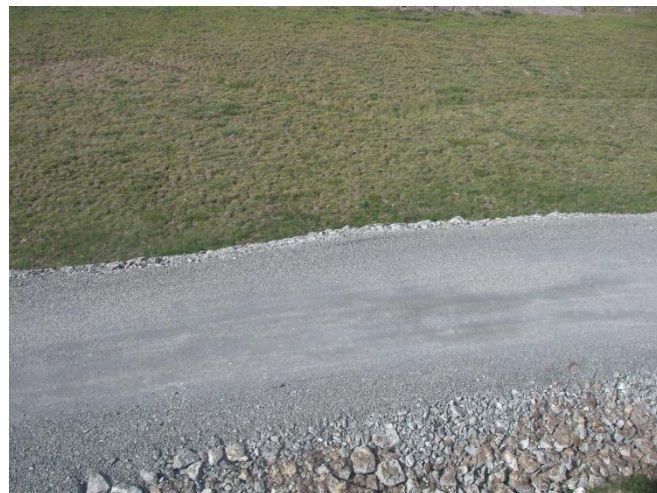
End of the constructed portion of the Doris-Windy Road. Photo looking northeast. The road was continued later in 2011

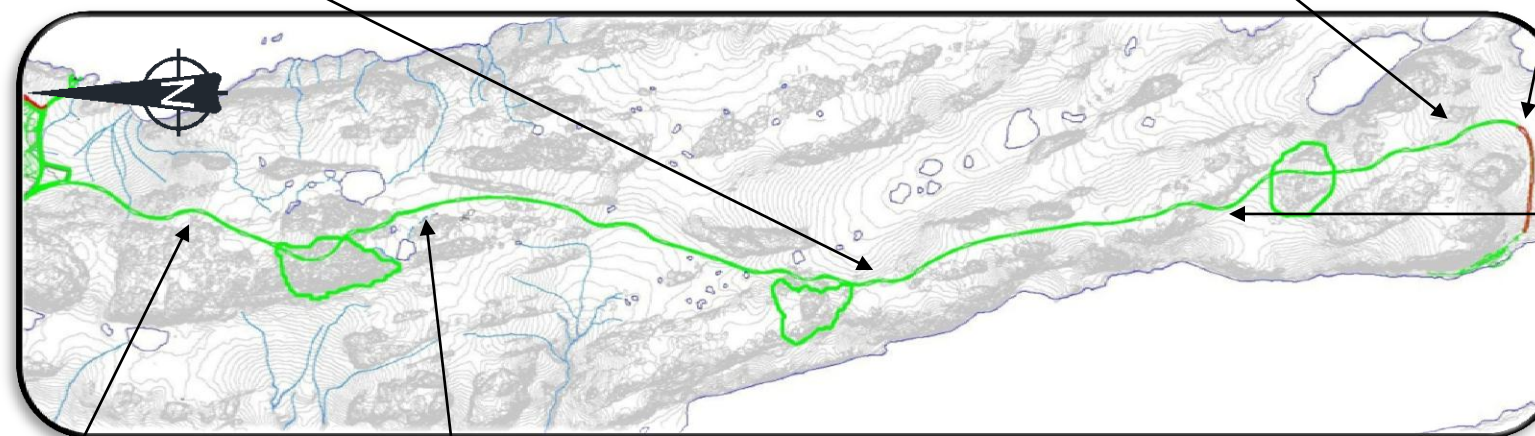
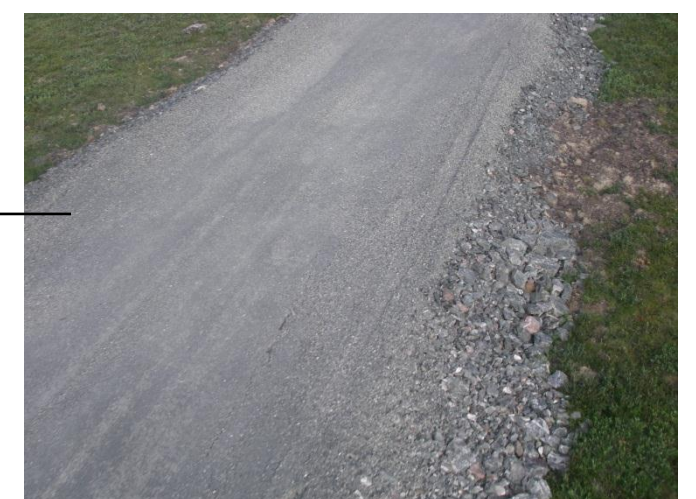
Tension cracks on side of Doris-Windy All Weather Road

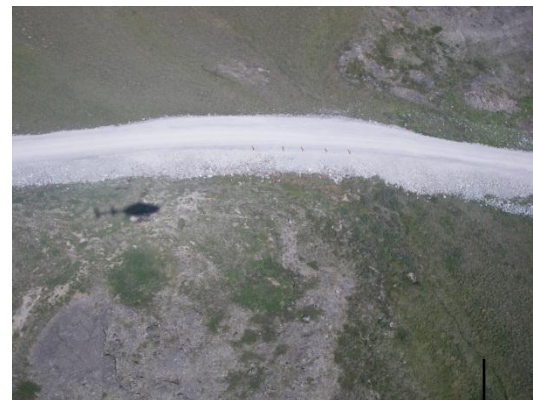
Secondary road, photo looking southwest
