2012 Annual Geotechnical Inspection Doris North Project Hope Bay, Nunavut

SRK Consulting (Canada) Inc.
1CH008.066
March 2013

Site operations were conducted under a Type "A" Nunavut Water Board (NWB) Licence 2AM-DOH0713 (the Licence), dated September 19, 2007, which entitles HBML (the Licensee) to use water and dispose of waste associated with their operations. HBML contracted SRK Consulting (Canada) Inc. to conduct the annual geotechnical site inspection of the Doris North Project in accordance with stipulated Licence conditions. This annual investigation was carried out from September 7 to 10, 2012.

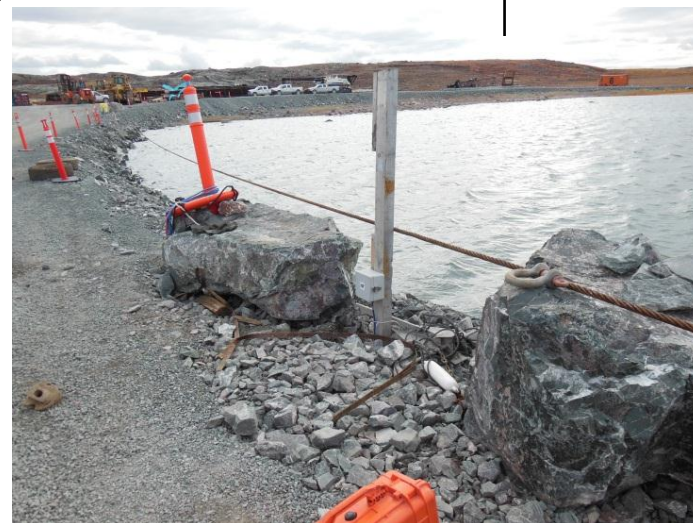
Toe of Jetty. Exposed geotextile placed on marine sediments

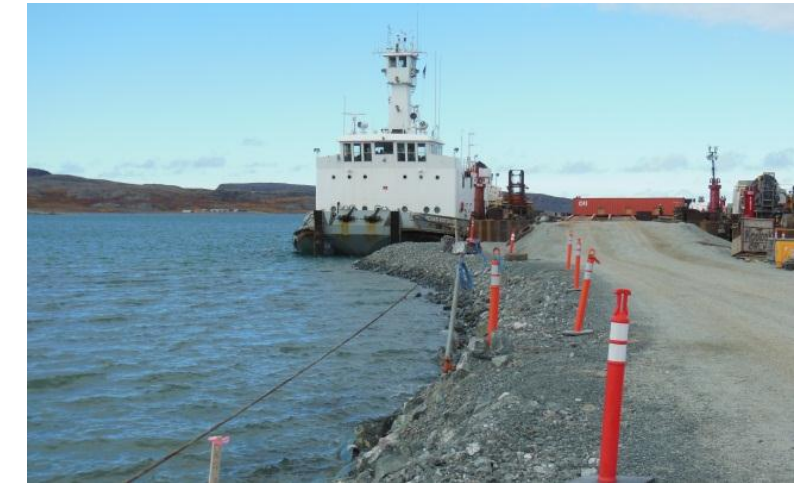
Western Jetty Shoreline showing ground temperature cable SRK-JT1-09

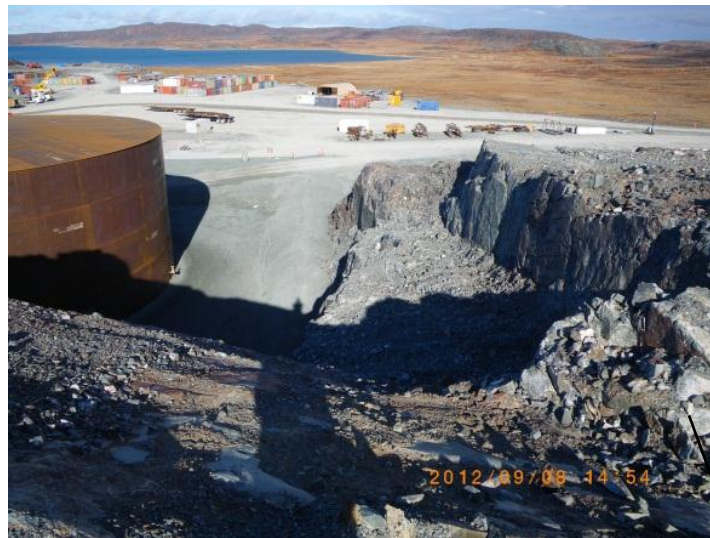
Condition of the South Highwall

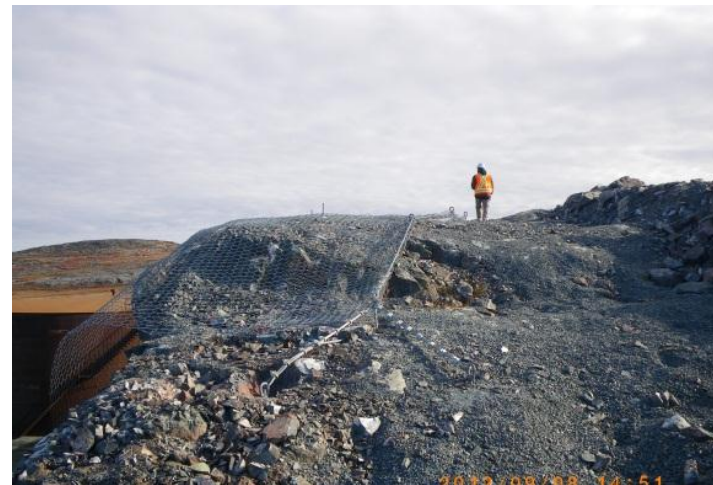
High wall reinforcement along the top of the west high wall

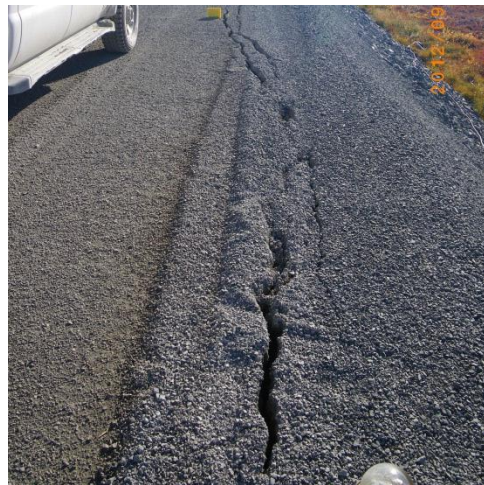
Tension cracks along west side of run-way

1. Monitor areas where rock was relocated from the tundra for signs of thermal erosion.
2. Maintain practice of inspecting the runway toe line during freshet and after significant or prolonged rainfall events. Pump ponded water to prevent onset of thermal erosion.
3. Conduct daily inspections of the airstrip shoulder (if in use) to monitor the tension cracks.

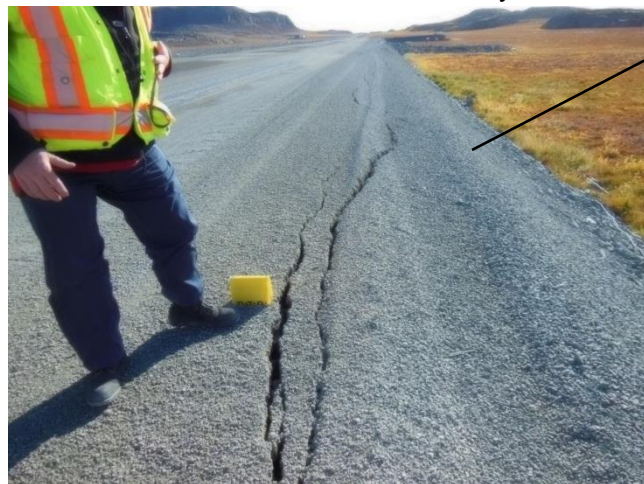
Tension cracks along west side of run-way

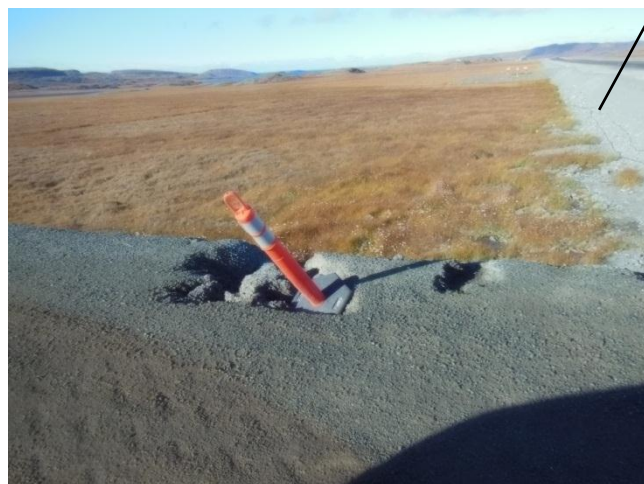
Sinkholes and erosion gully on the south edge of the South Apron

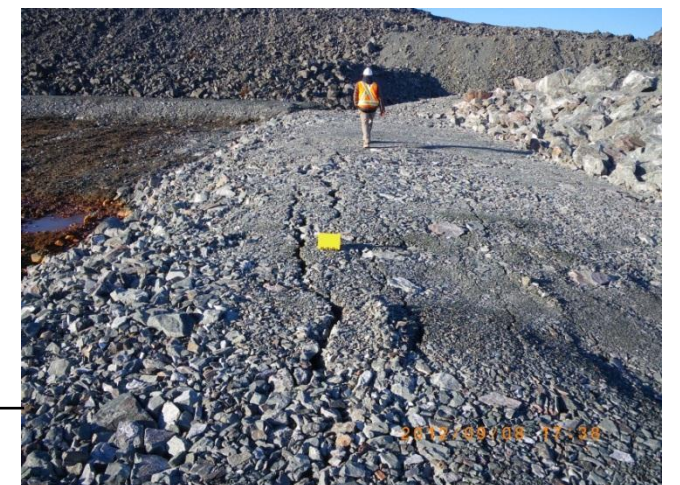
Tension cracks on the interior bench of the Pollution Control Pond

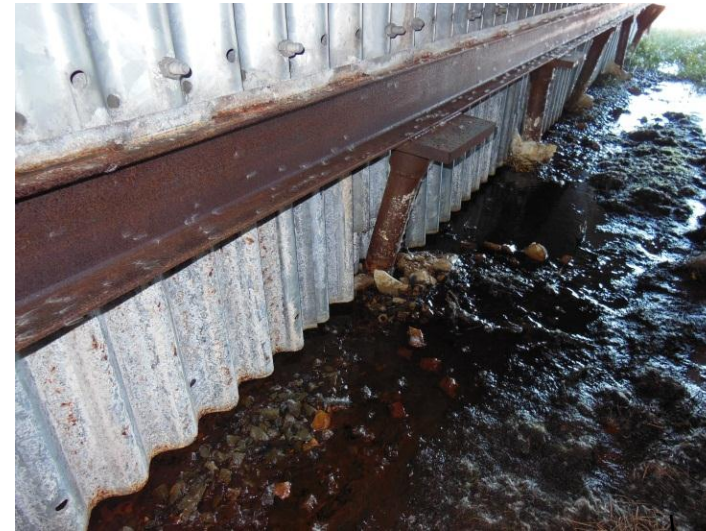
Condition of the battered and straight piles along the north side of Arched Culvert #1

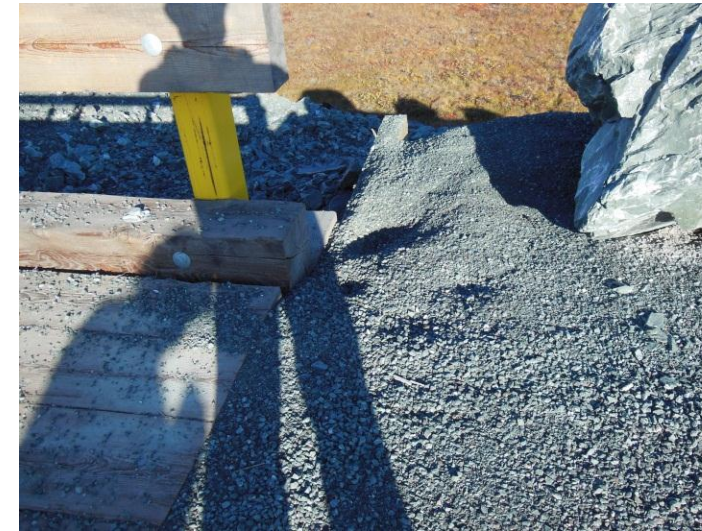
Small sinkholes were observed where the abutment joined the bridges for Stream Crossings #2 and #3

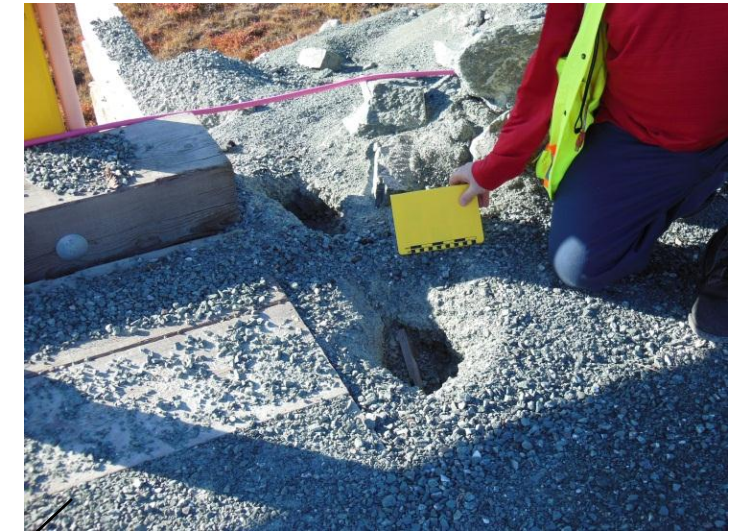
Sink holes were observed where the abutment joins the bridges for Stream Crossing #4

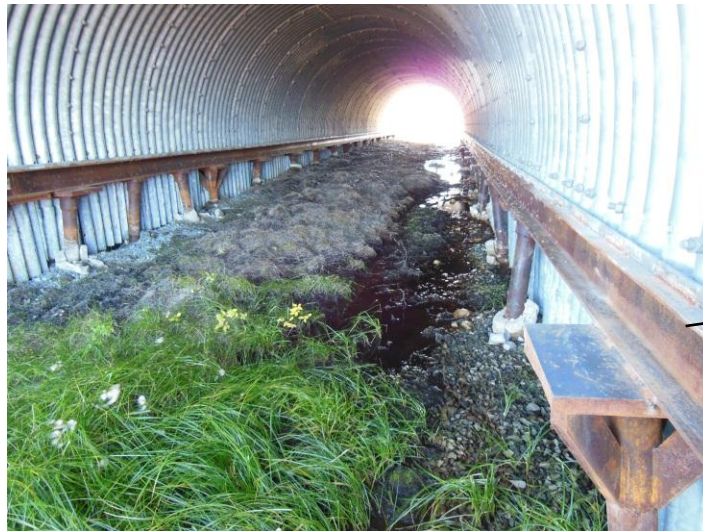
Water running against the north piles around Culvert #1

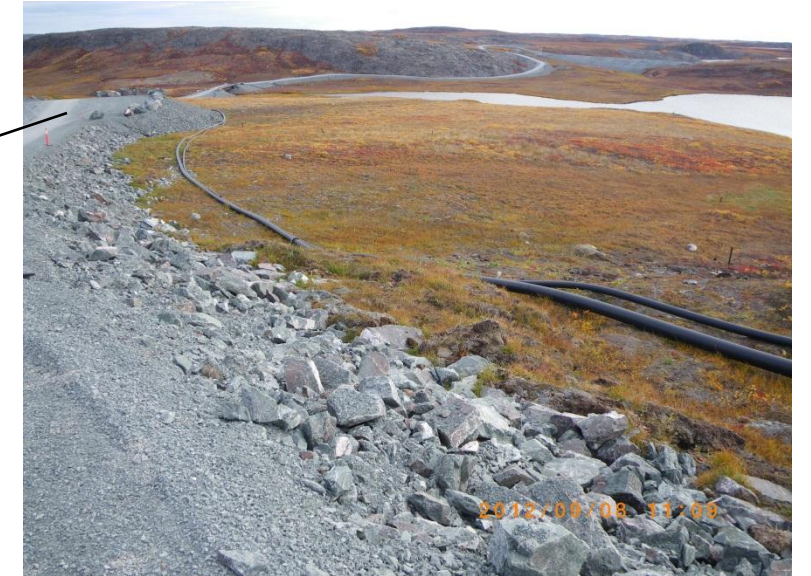
A surficial slope failure occurred in August 2010 during construction of the Secondary Road at approximately chainage 0+550 (Figure 17). At the time construction in this area was stopped and a temporary bypass was constructed. The ground was allowed to freeze during the subsequent winter season and road construction commenced completing this section of road in April 2011. SRK recommended that a buttress be constructed at the same time to ensure that the failure would not get remobilized. This buttress was not constructed; however, no further movement in the road shoulder was observed during the 2012 inspection.

Secondary Road slope failure

1. Inspect road toe lines during freshet and immediately following significant or prolonged rainfall events. Pump out ponded water to prevent onset of thermal erosion.
2. Monitor areas where rock was relocated from the tundra for signs of thermal erosion.
3. The buttress recommended for the Secondary Road should be constructed, and until such time as the buttress is constructed a visual monitoring system should be put in place and warning signs posted along the section in question.

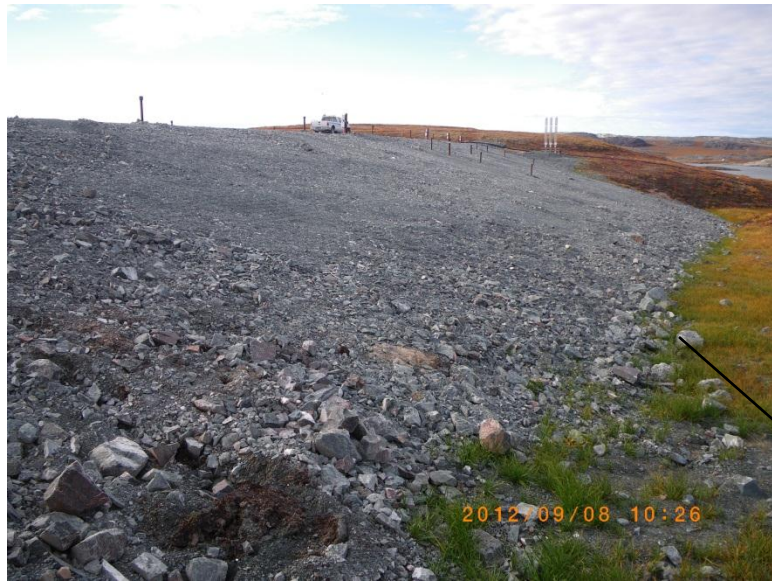
A sinkhole in the upstream face of the North Dam
