Re: 2AM-DOH1323 – 2013 Annual Geotechnical Inspection Report

Please find enclosed with this letter TMAC Resources Inc.'s ("TMAC") 2013 Annual Geotechnical Inspection Reports for water licence 2AM-DOH1323.

Table A: Summary of the Inspection Items and Associated Inspection Recommendations

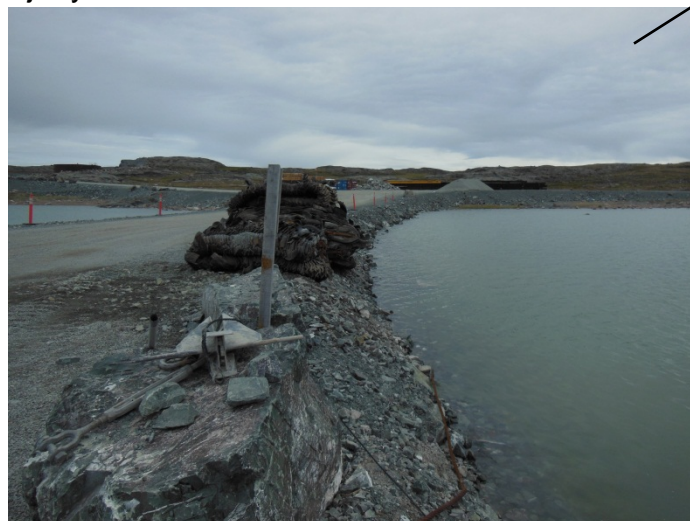
Two thermistors were installed through the jetty into submarine permafrost in 2009 (SRK 2009b). One of the thermistor strings was damaged and had to be replaced in 2012 but was damaged again in 2013. Data from these strings supports an observation that the submarine permafrost has similar trends to onshore conditions.

Condition of thermistor cable SRK-JT1-09 – looking south

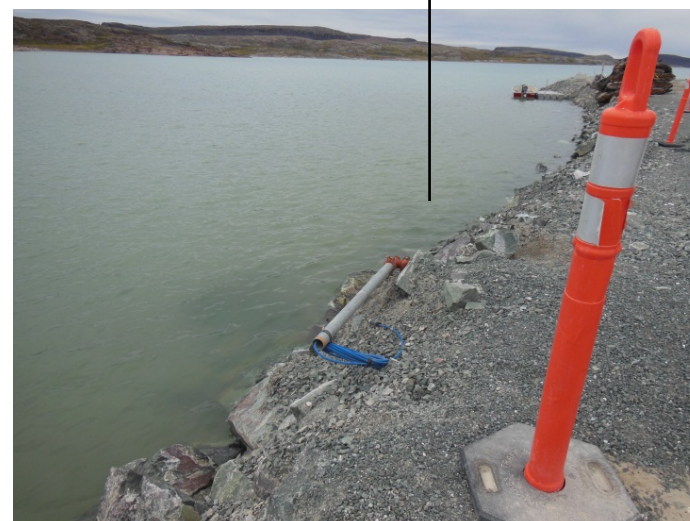
Condition of thermistor cable SRK-JT2-12 – looking north

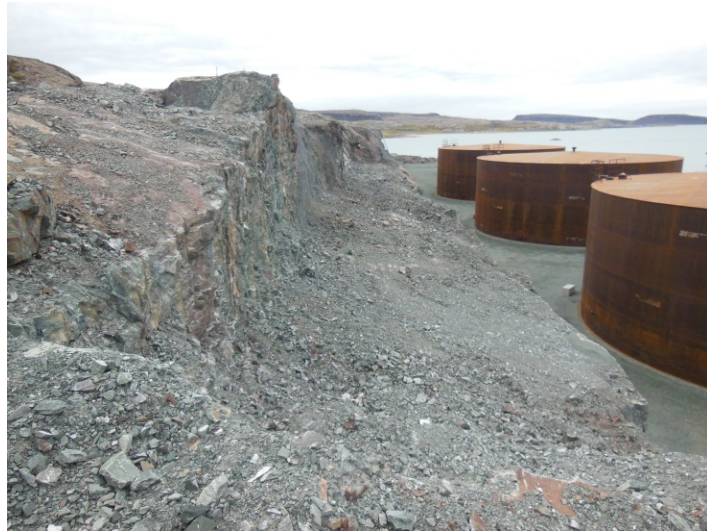
Condition of the west high wall

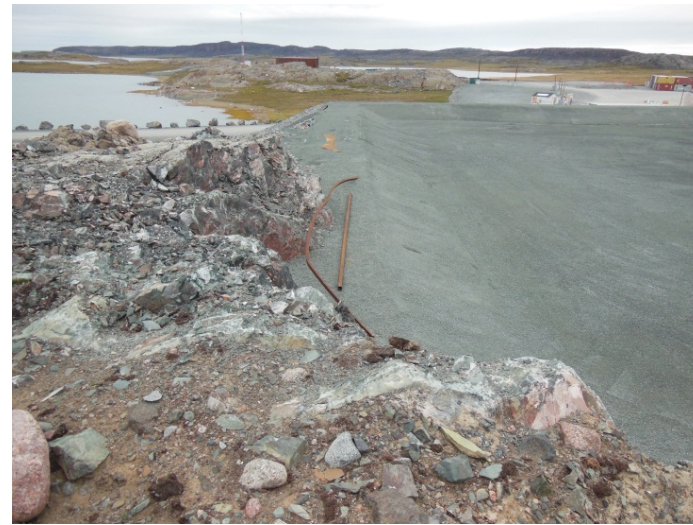
Condition of the berm at the north end of the 20 ML fuel tank farm – looking east from the high wall

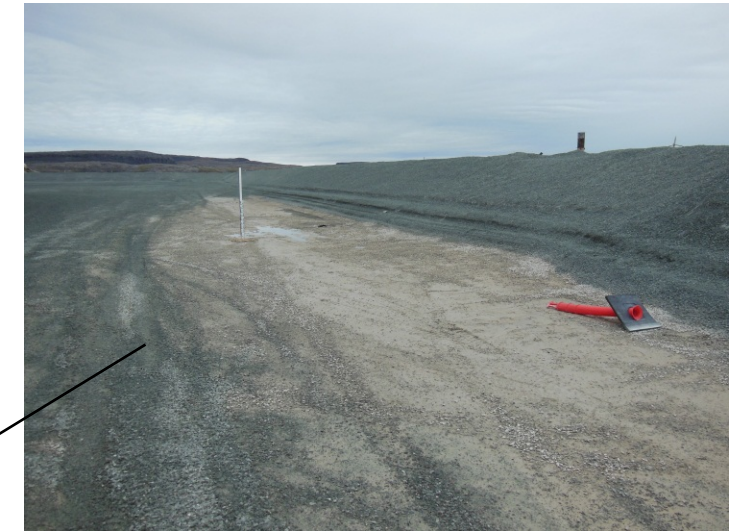
Interior berm along the east side of the 20 ML Tank Farm. Evidence of wheeled traffic along the toe of the berm and high water levels – looking north from Tank #2

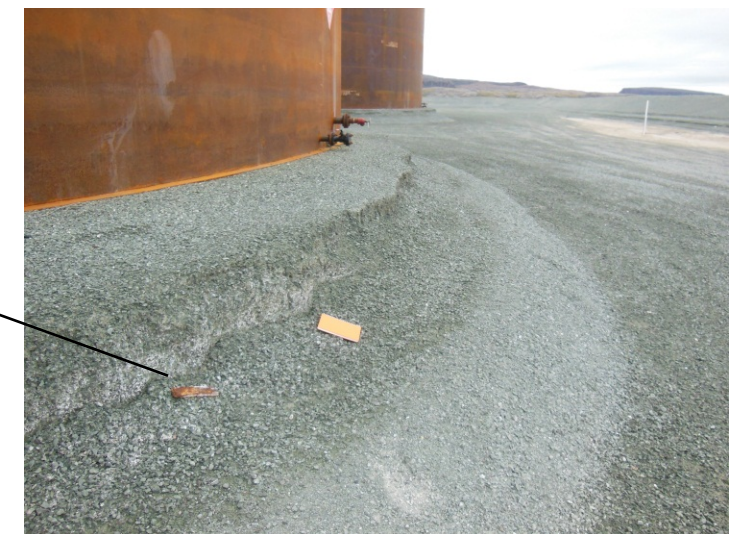
Condition of the Tank #2 pedestal

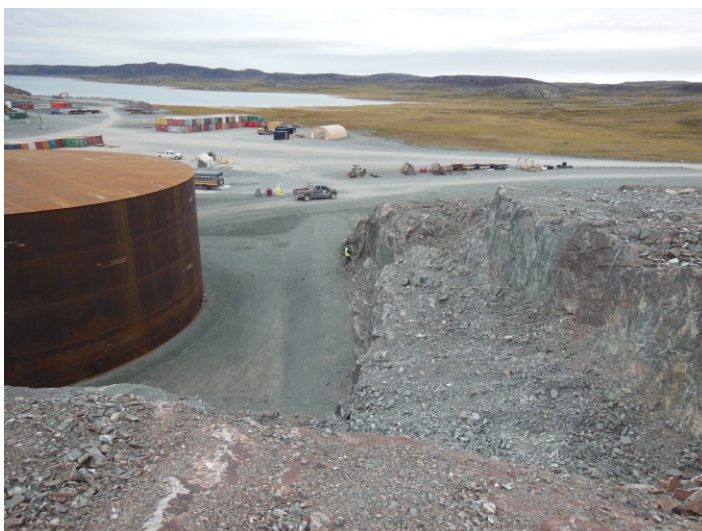
Condition of the south high wall

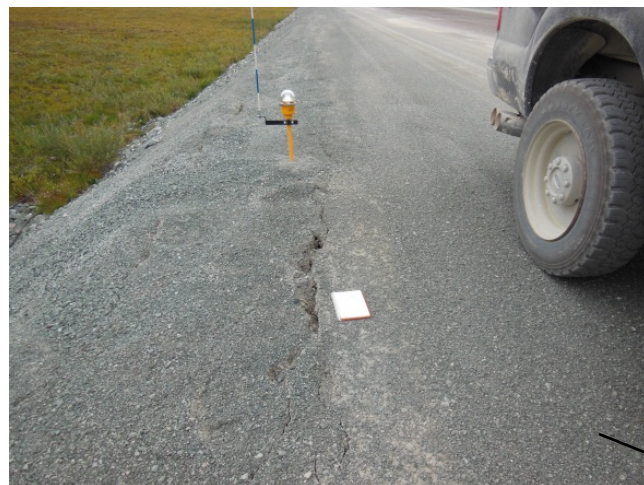
Tension cracks along west side of run-way

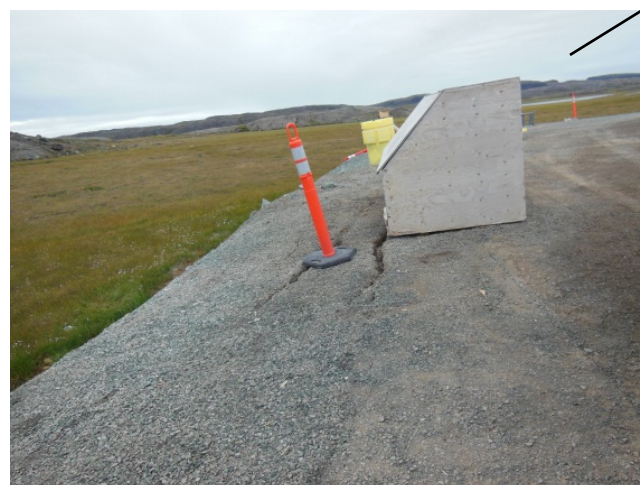
Tension cracks along the south end of the south apron

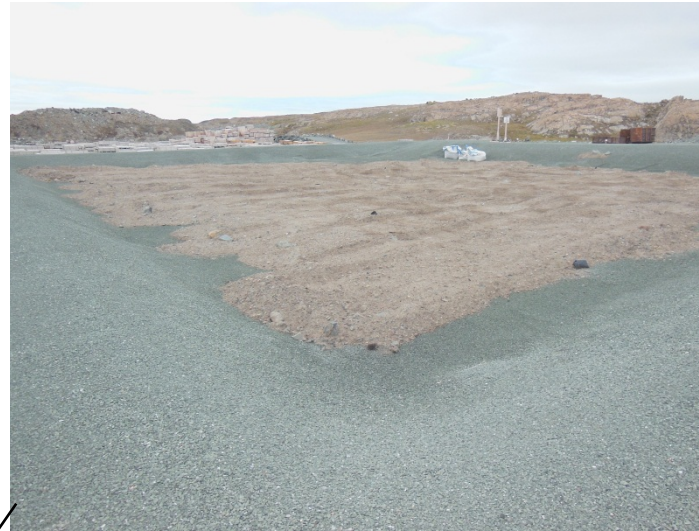
Condition of the Soil Pond

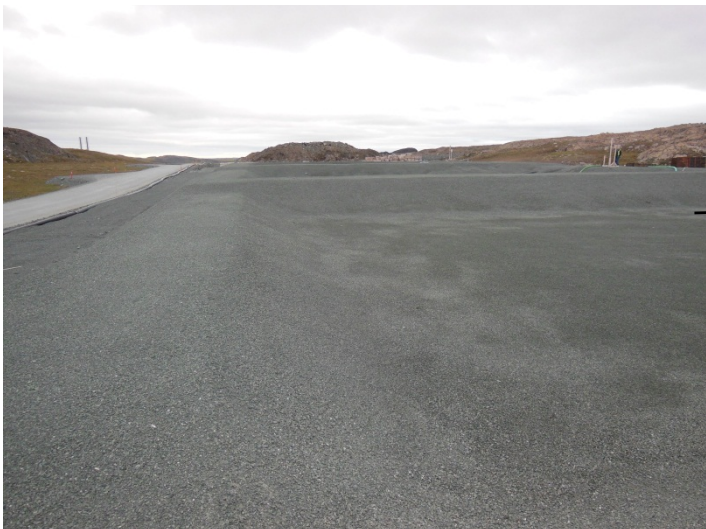
The condition of the eastern berm of the Water Pond – looking south

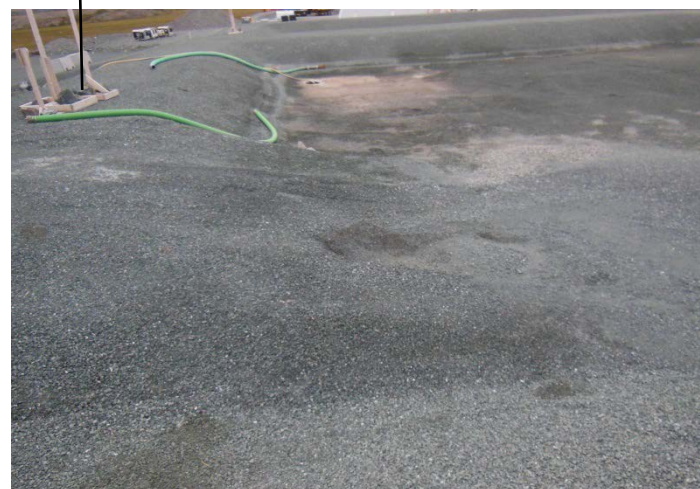
Large depression in the access ramp and condition of the sump in the Snow Pond – looking north

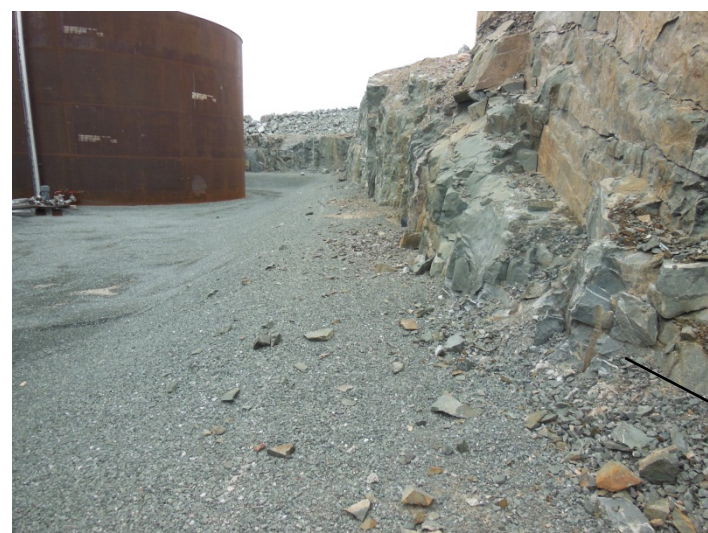
Condition of the 7.5 ML Doris North Camp Tank Farm north high wall – looking west

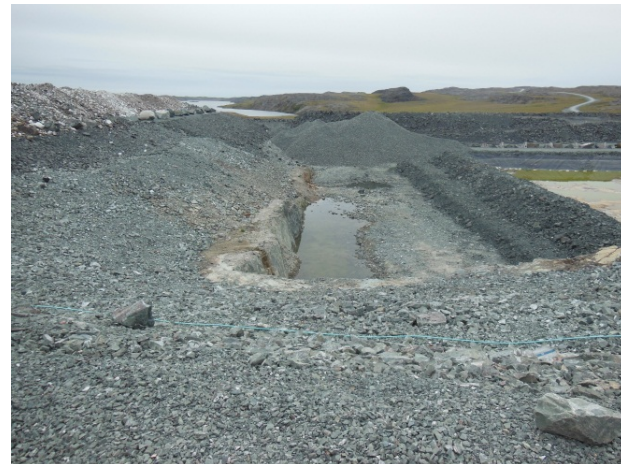
The condition of the east high wall of Pad D. There is water ponding against the high wall.

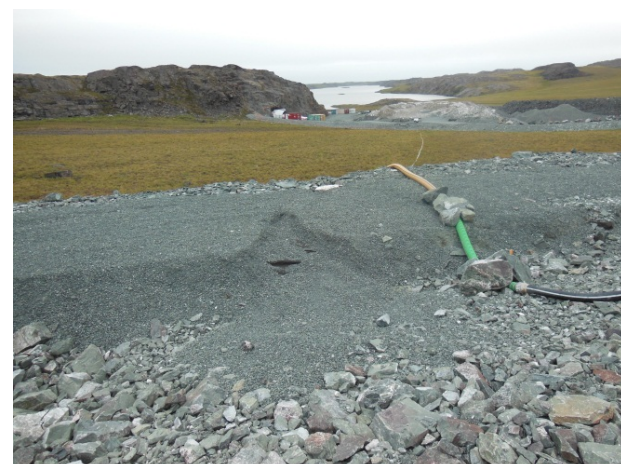
Exposed liner along the crest of the Doris North Diversion Berm

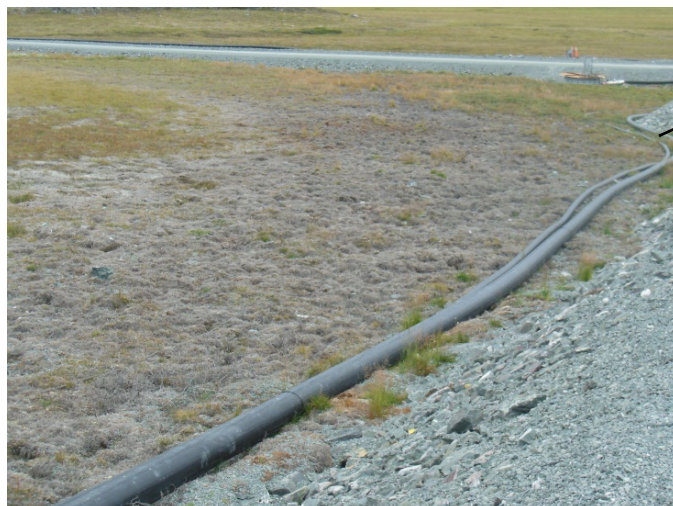
Salt burn along the east side of the Secondary Road with Sump #2 in the background

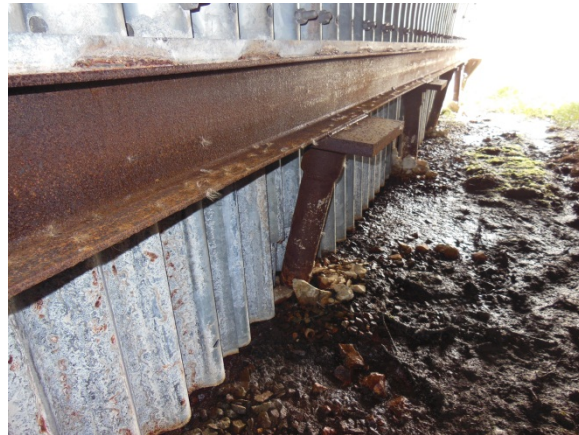
Condition of the battered and straight piles along the north and south sides of Arched Culvert #1

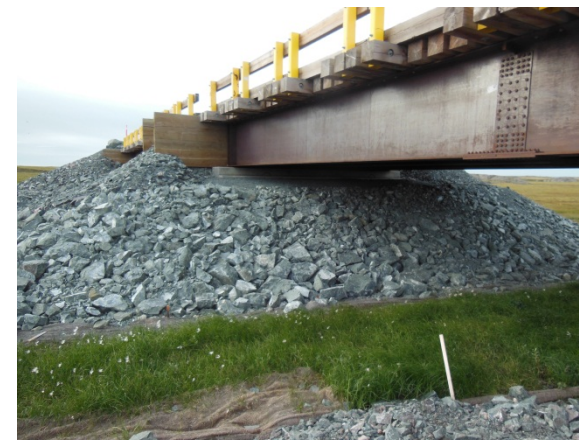
The condition of the north abutment of the bridge over Stream Crossing #2

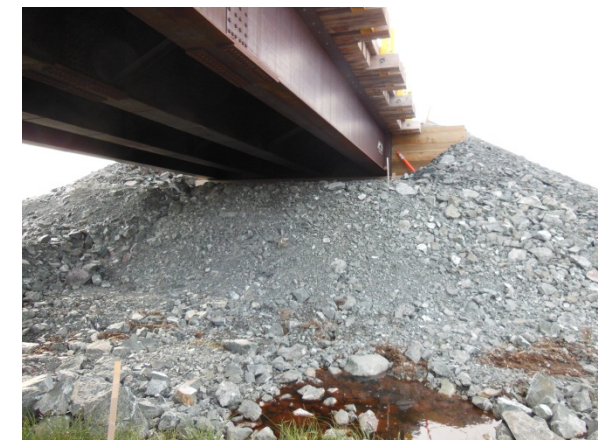
Ponded water against the south abutment of the bridge over Stream Crossing #3

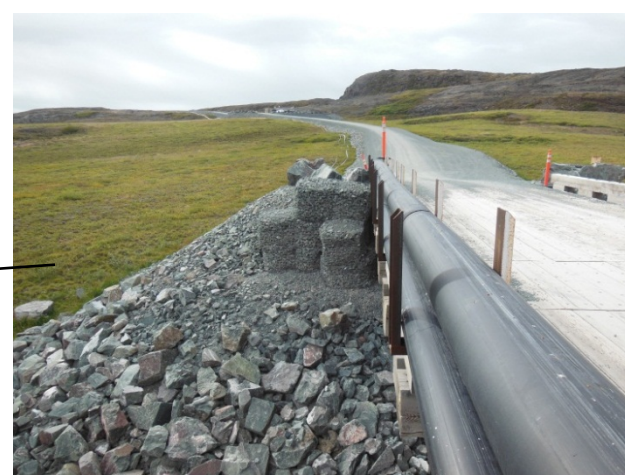
The condition of the rock gabions on the southwest side of the Doris Creek Bridge west abutment

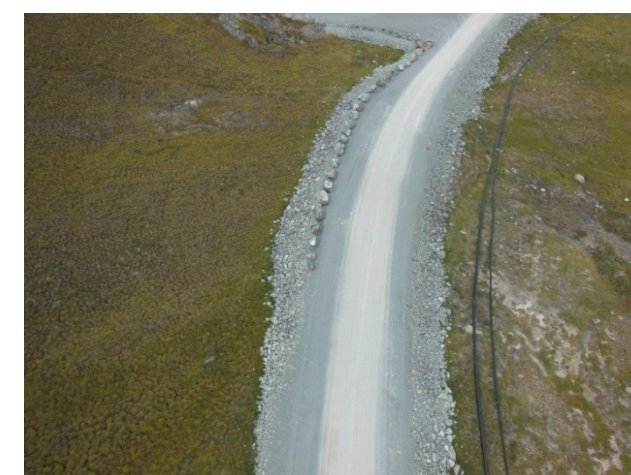
Aerial view of the Secondary Road slope failure

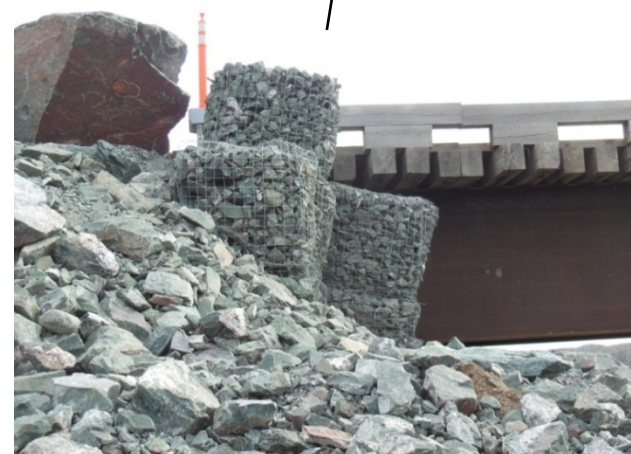
The condition of the rock gabions on the northeast side of the Doris Creek Bridge east abutment

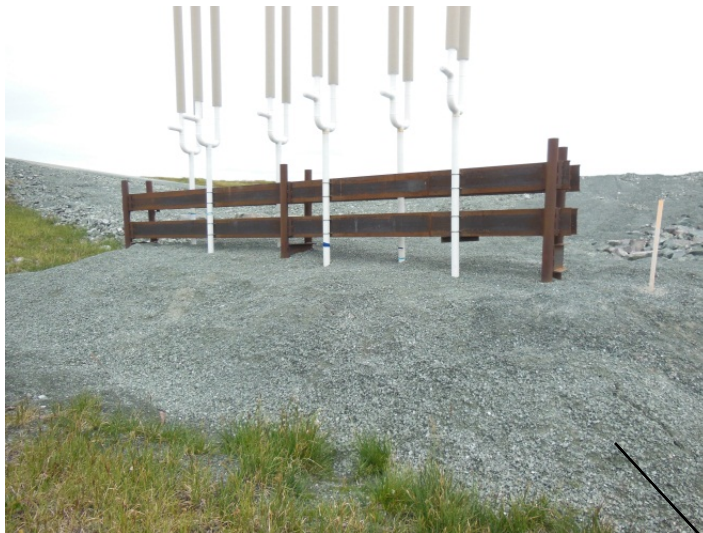
Condition of north radiator foundation. The surface contact thermistor bead appears to be exposed.

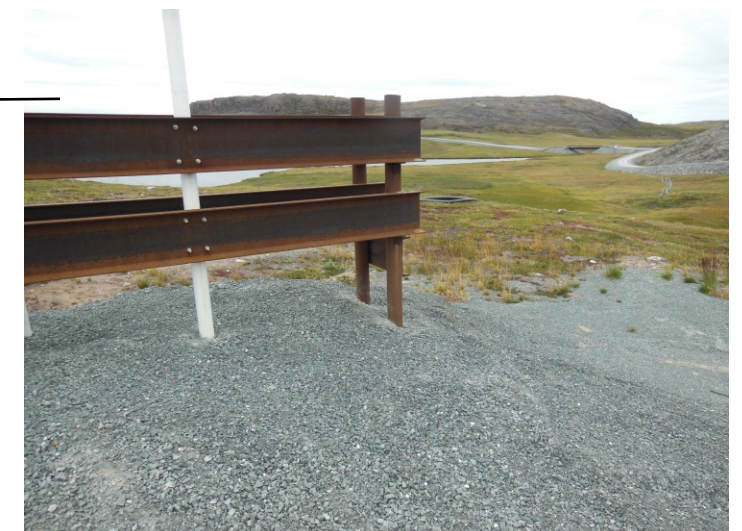
Condition of south radiator foundation – looking northwest with Doris Creek Bridge in the background

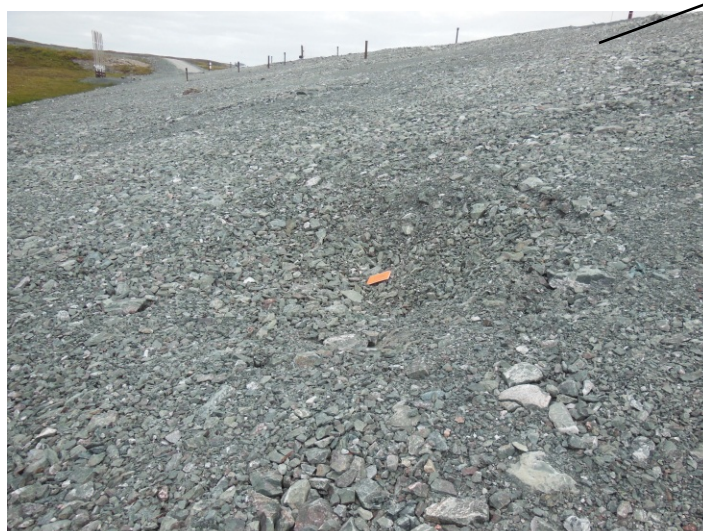
Sink holes in the downstream face of the North Dam
