## Memo

Subject: Doris North Project: 2014 Annual Roberts Bay Jetty Inspection

2014 Annual Geotechnical Inspection

2014 As-Built Survey for the Roberts Bay Jetty

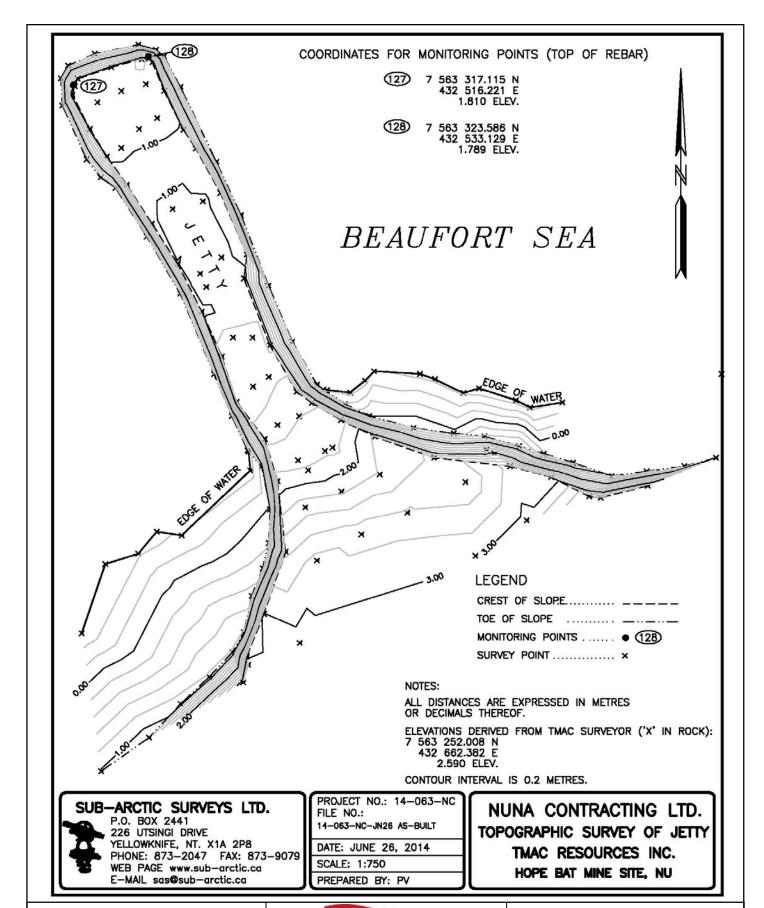
Figure: 1

In 2013, the jetty was damaged due to a severe storm at the beginning of August. Large waves washed the rock fill at the end of the jetty out into Roberts Bay. PND Engineers Canada Inc. supervised the jetty reconstruction and became the Engineers-of-Record for the jetty. As part of the reconstruction activities two survey monitoring points were installed at the end of the jetty (PND 2013). These two survey monitoring points are shown on drawing JT-1 (Attachment 2). An updated as-built survey of the jetty was completed on June 26, 2014 (Attachment 3). The two survey monitoring points have settled 0.52 m since their installation on September 9, 2013.
