## Appendix A: Ground Temperature Cable Data

| | | 2014 Geotechnical Inspection | | |
| Job No: 1CT022.001 | HOPE BAY MINING LTD. | Date: Oct. 2014 | Approved: MMM | Figure: <b>A.1</b> |

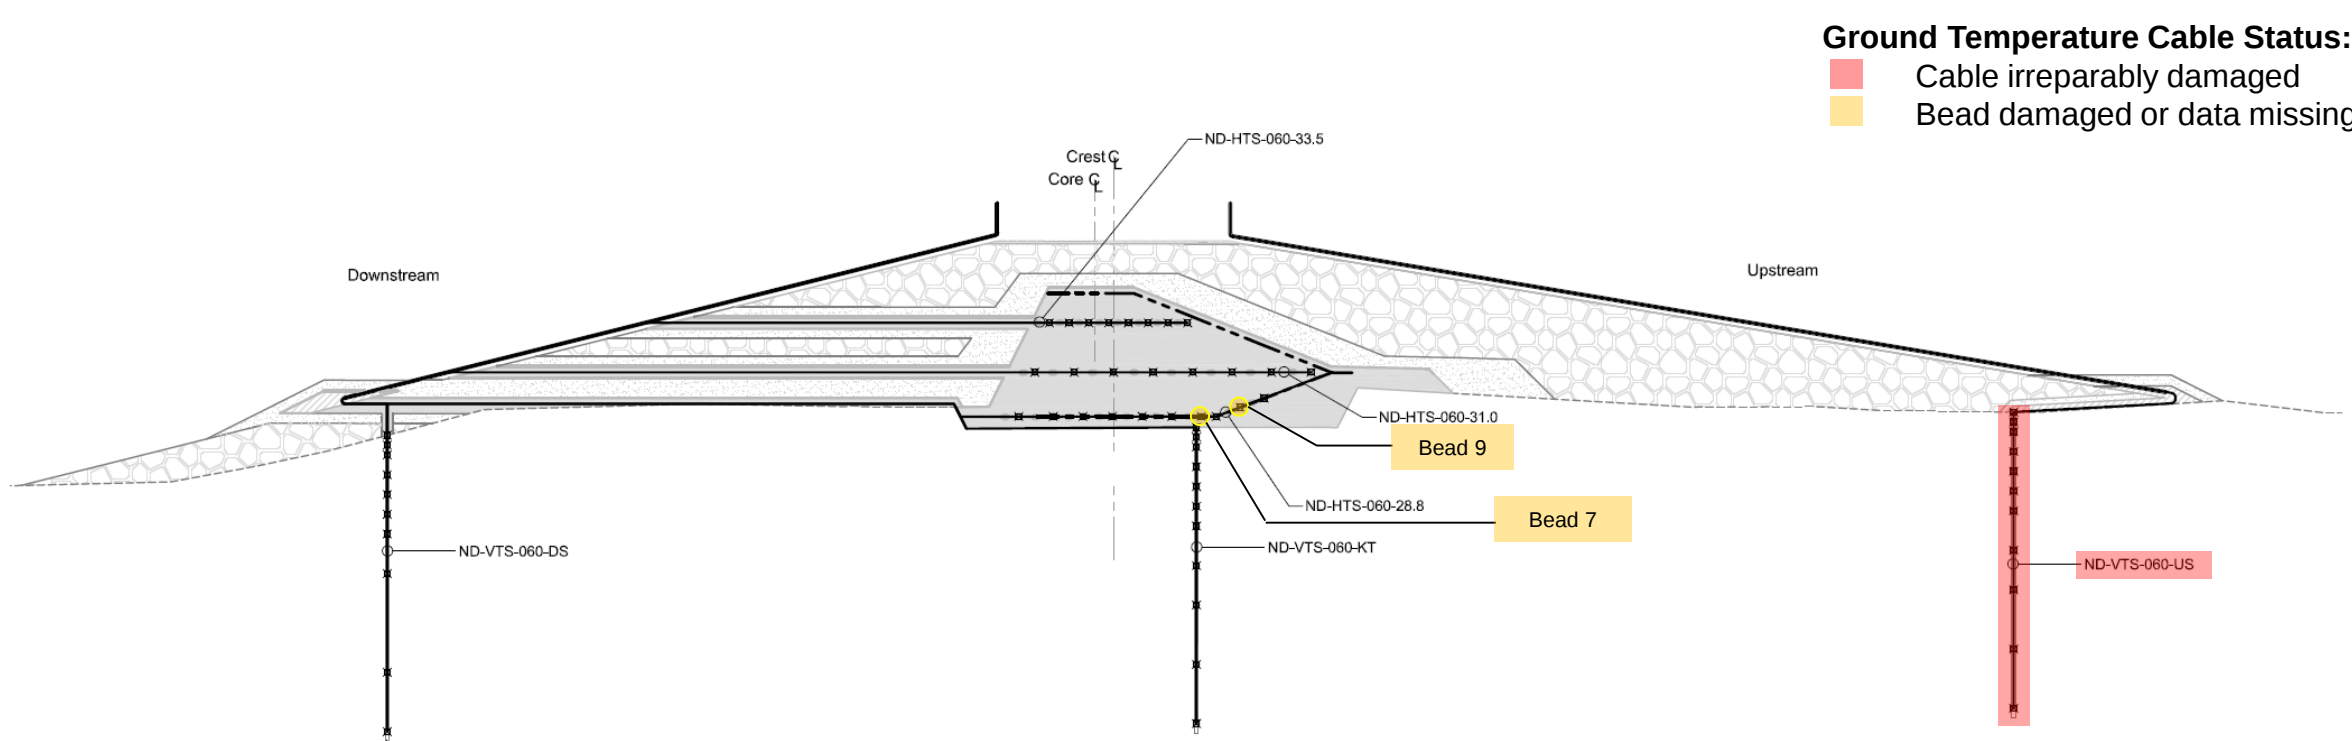
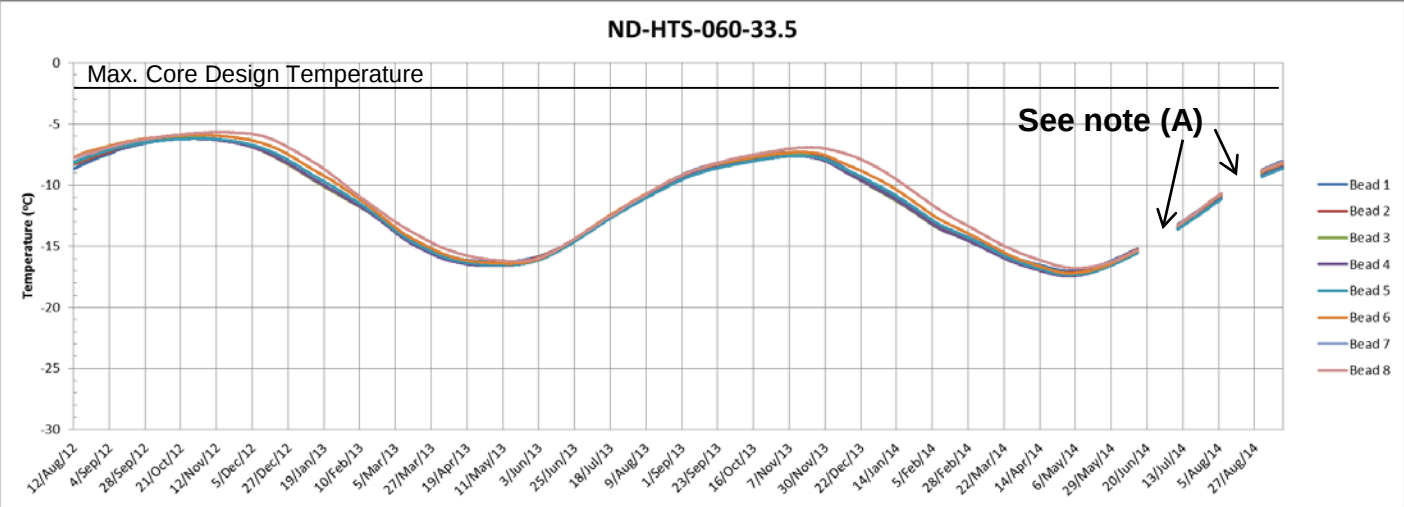
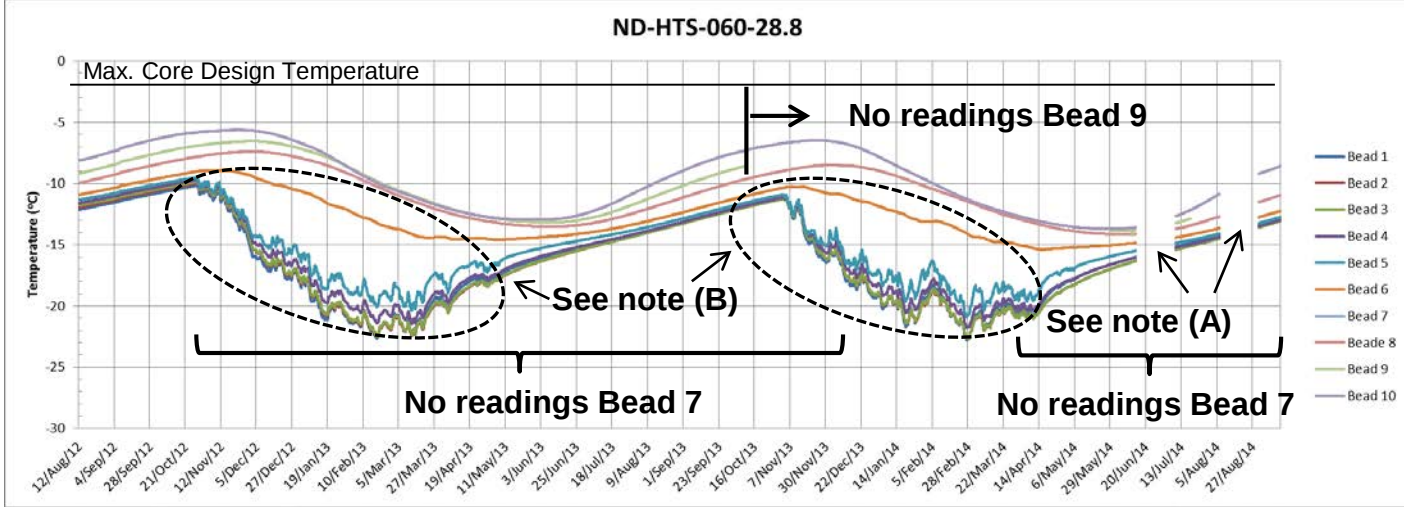
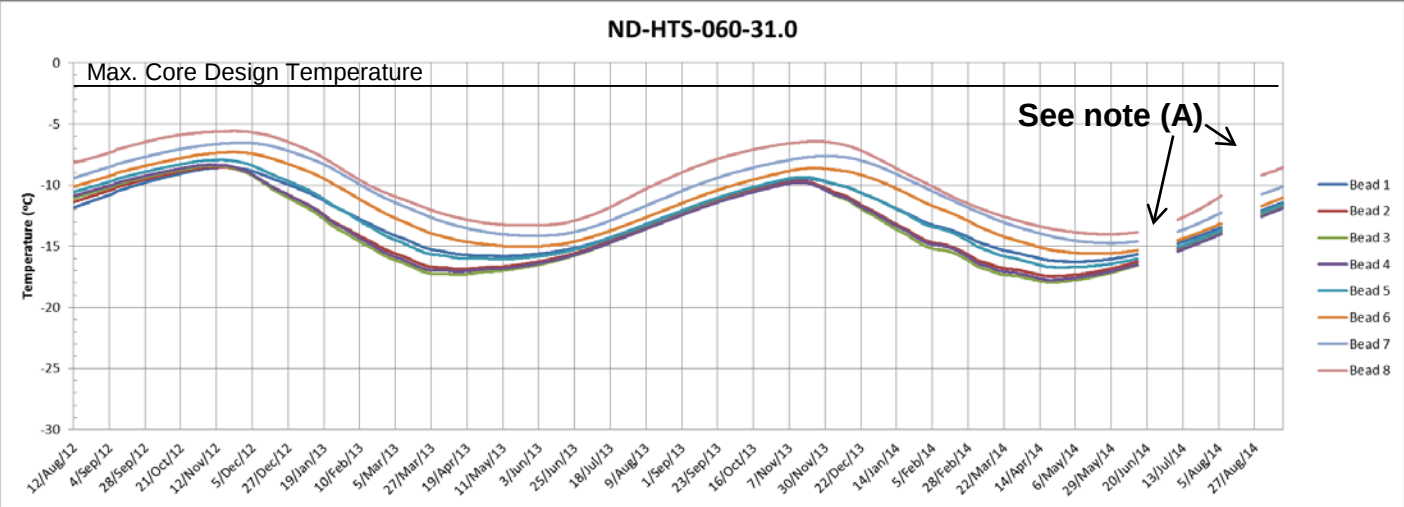
- Bead numbers increase from downstream to upstream (horizontal) and top to bottom (vertical)
- (A) Card download error: data needs to be extracted from datalogger.
- (B) Variation in Ground Temperature Cable readings during winter months due to close proximity of Ground Temperature Cable beads to thermosyphon pipes.

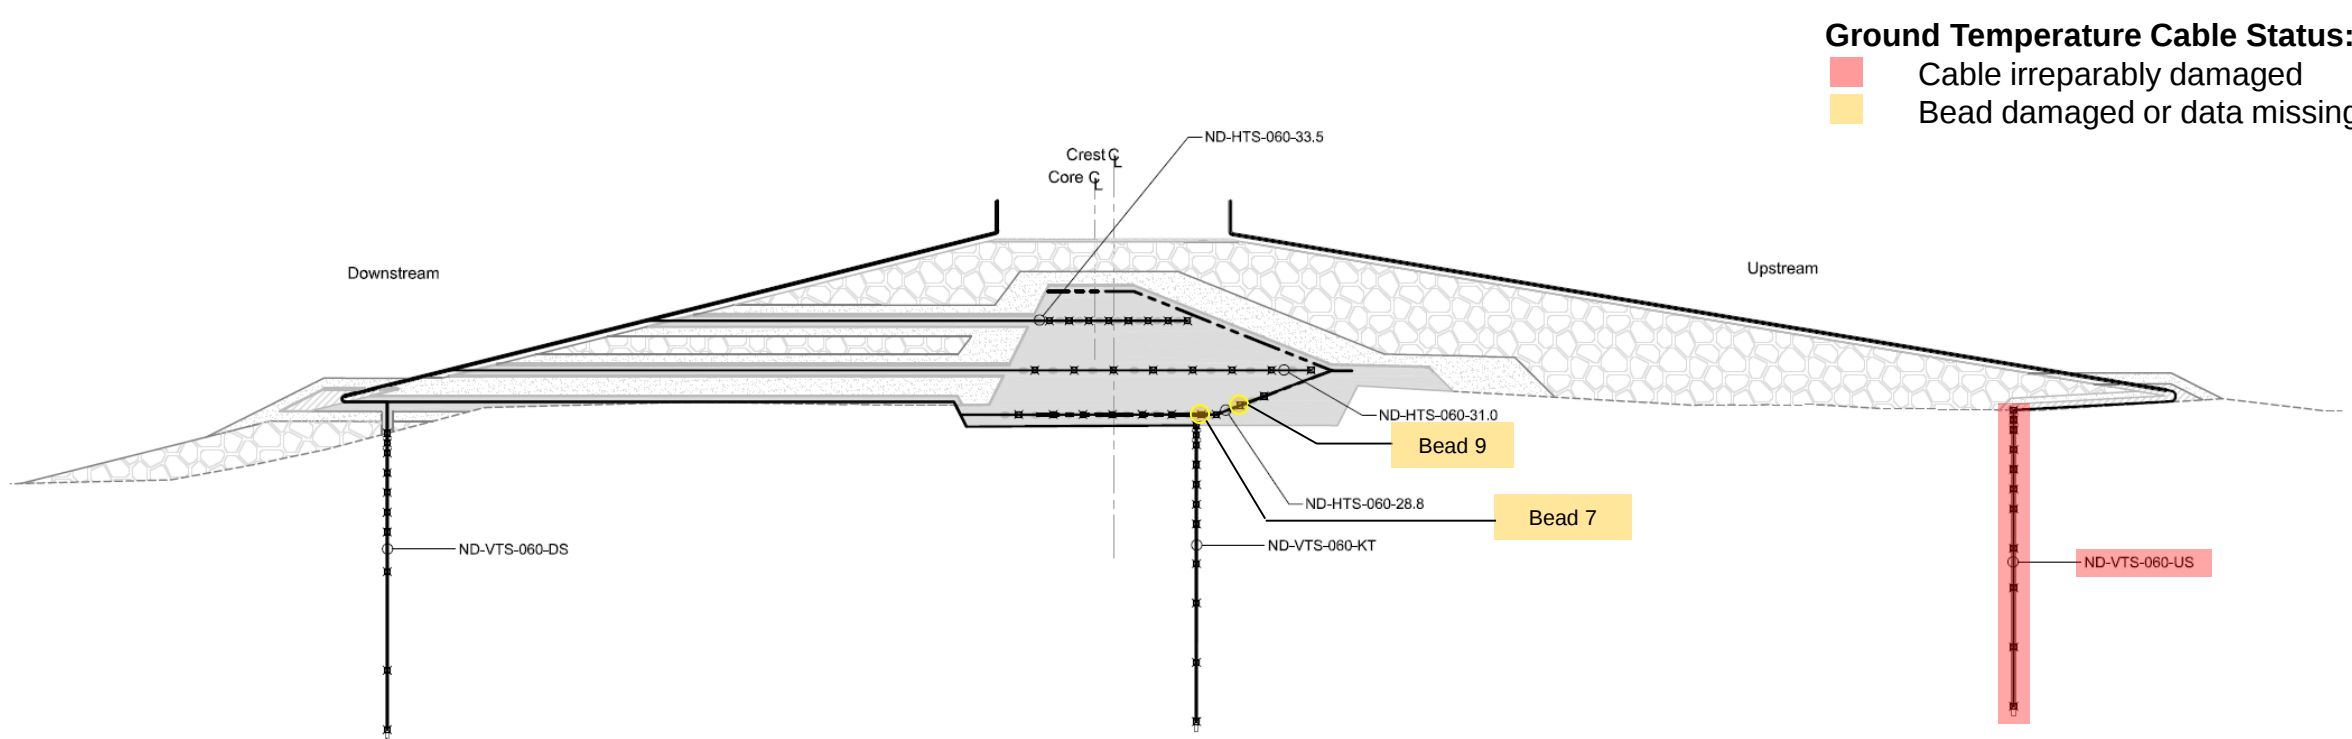
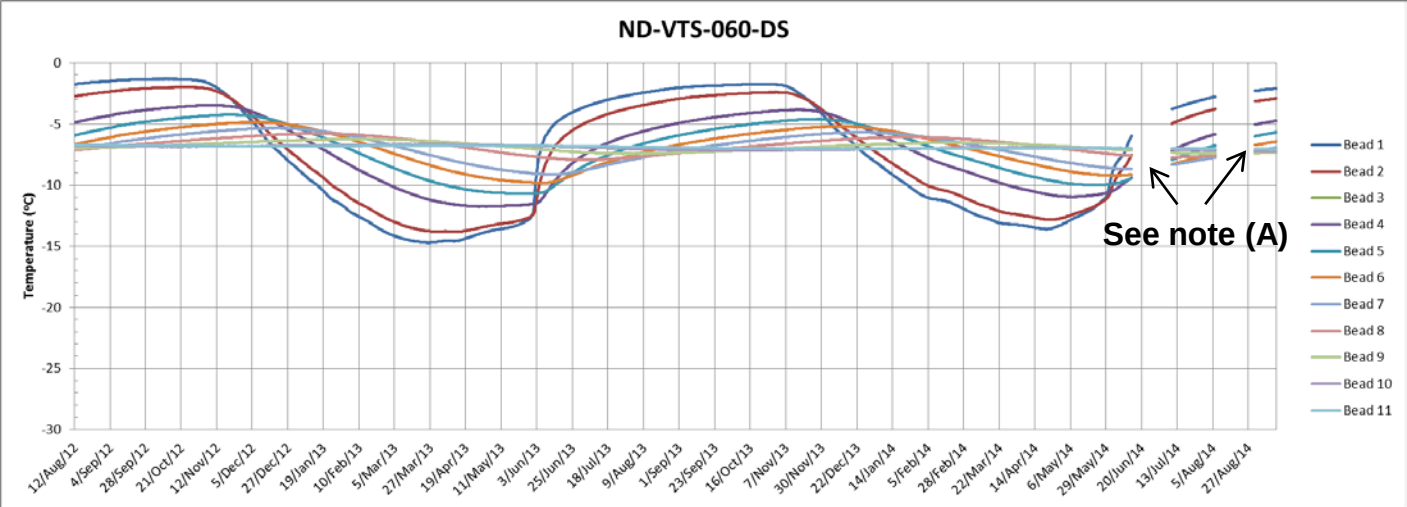
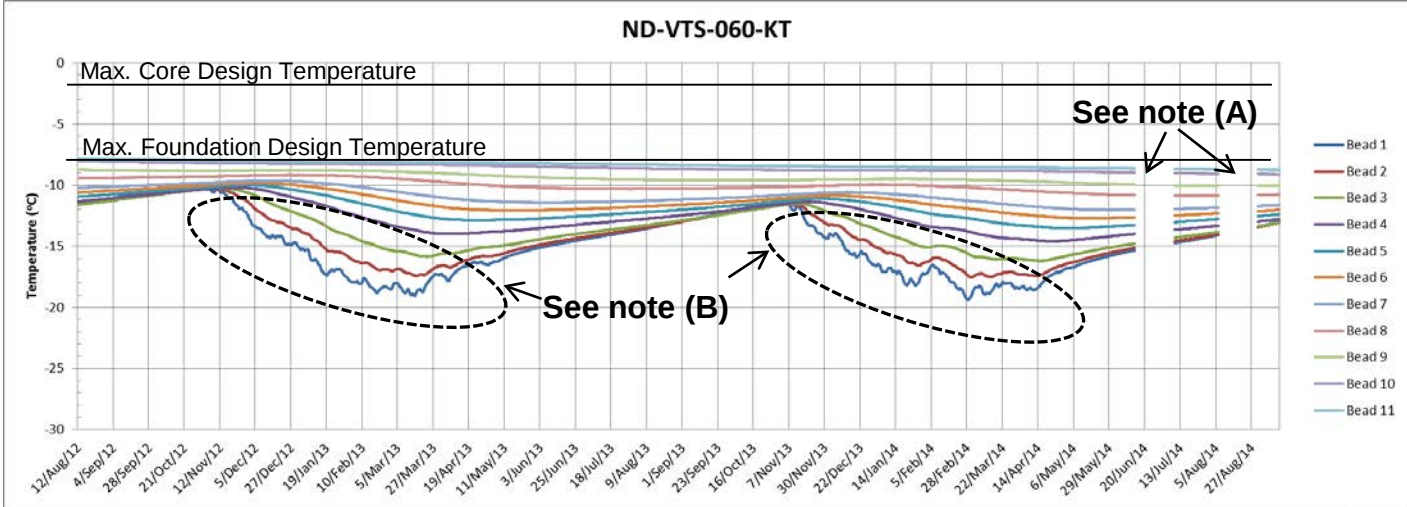
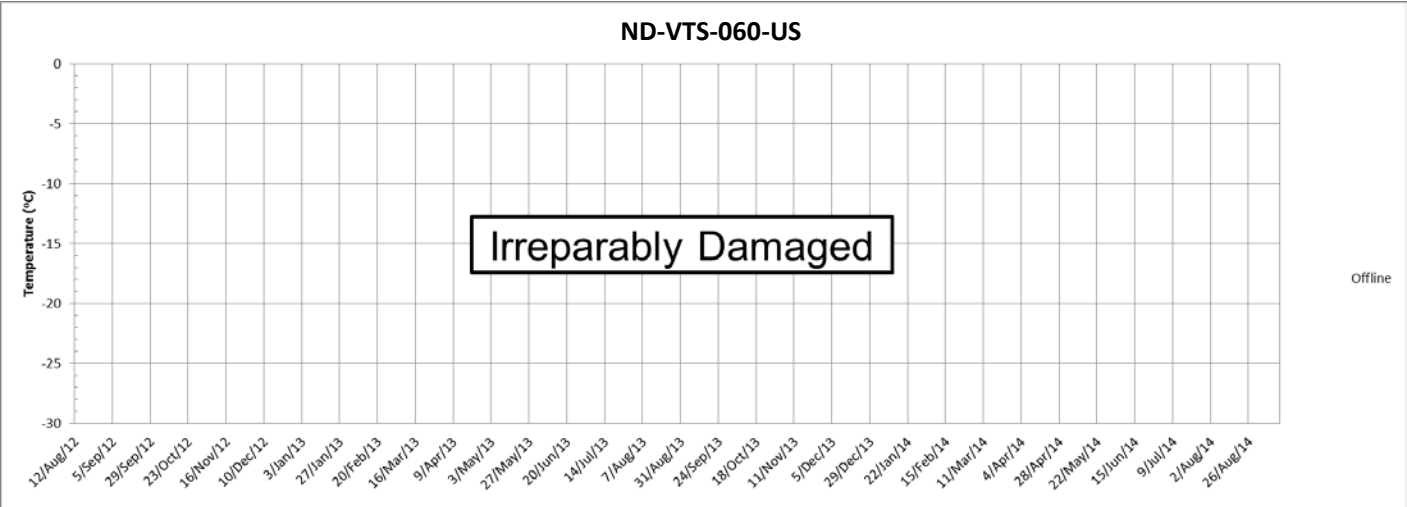
- Notes:**
- Bead numbers increase from downstream to upstream (horizontal) and top to bottom (vertical)
  - (A) Card download error: data needs to be extracted from datalogger.
  - (B) Variation in Ground Temperature Cable readings during winter months due to close proximity of Ground Temperature Cable beads to thermosyphon pipes.

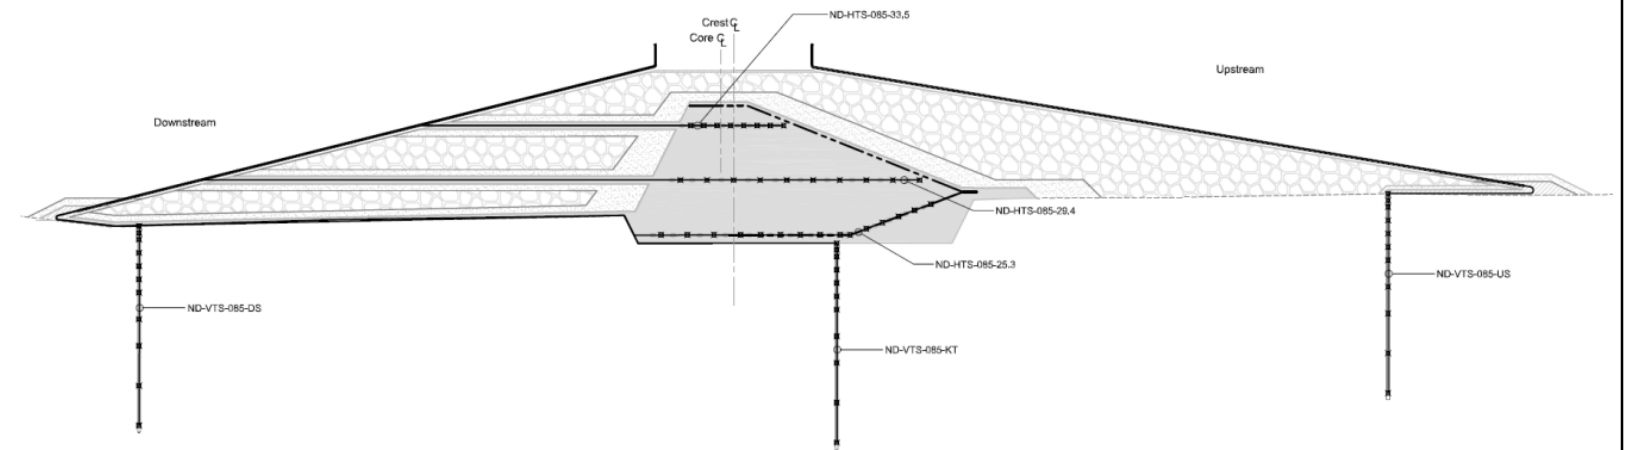
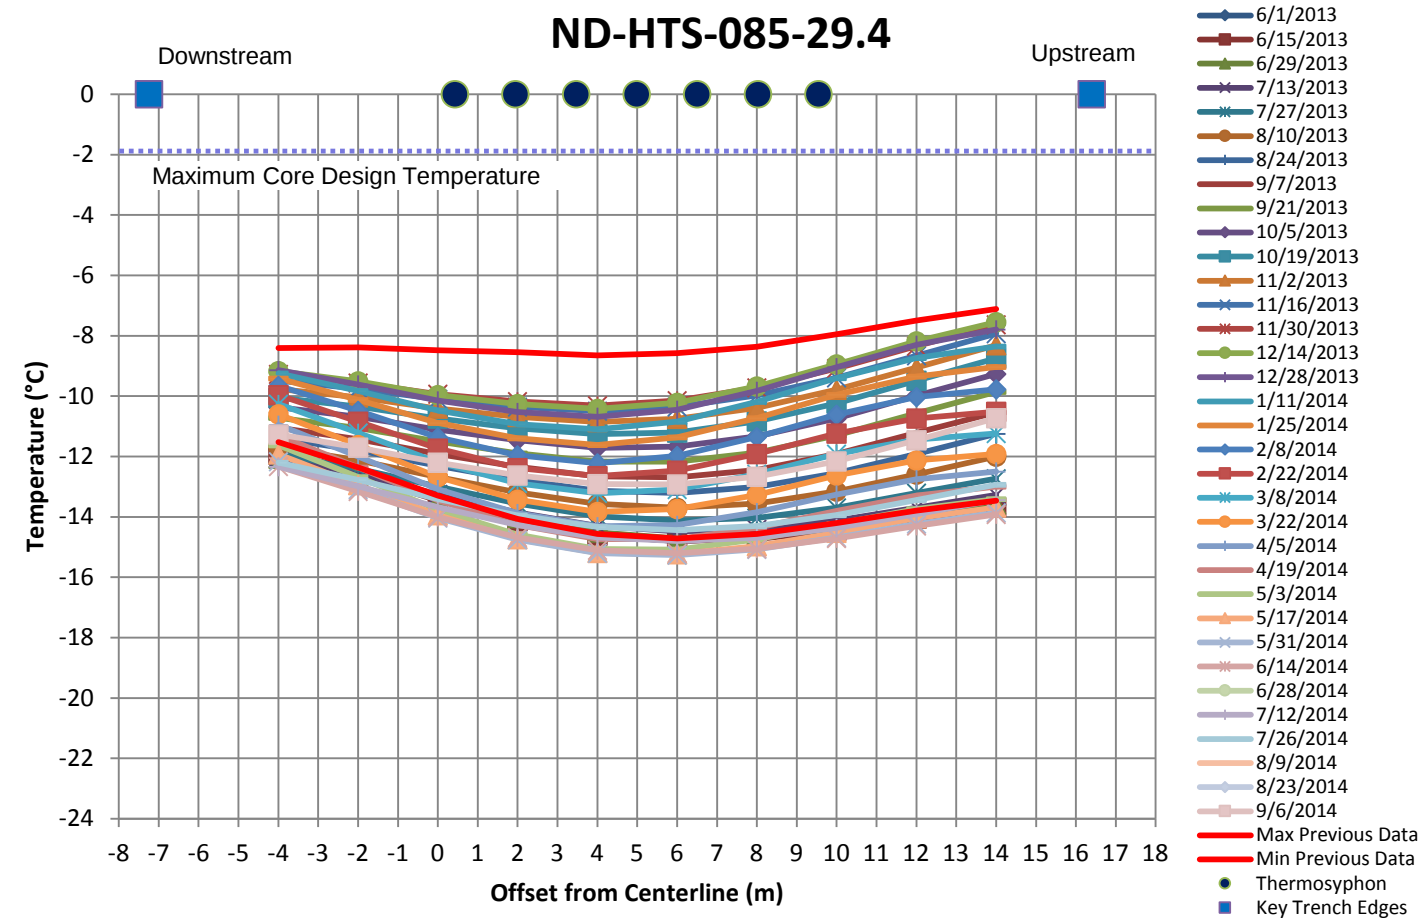
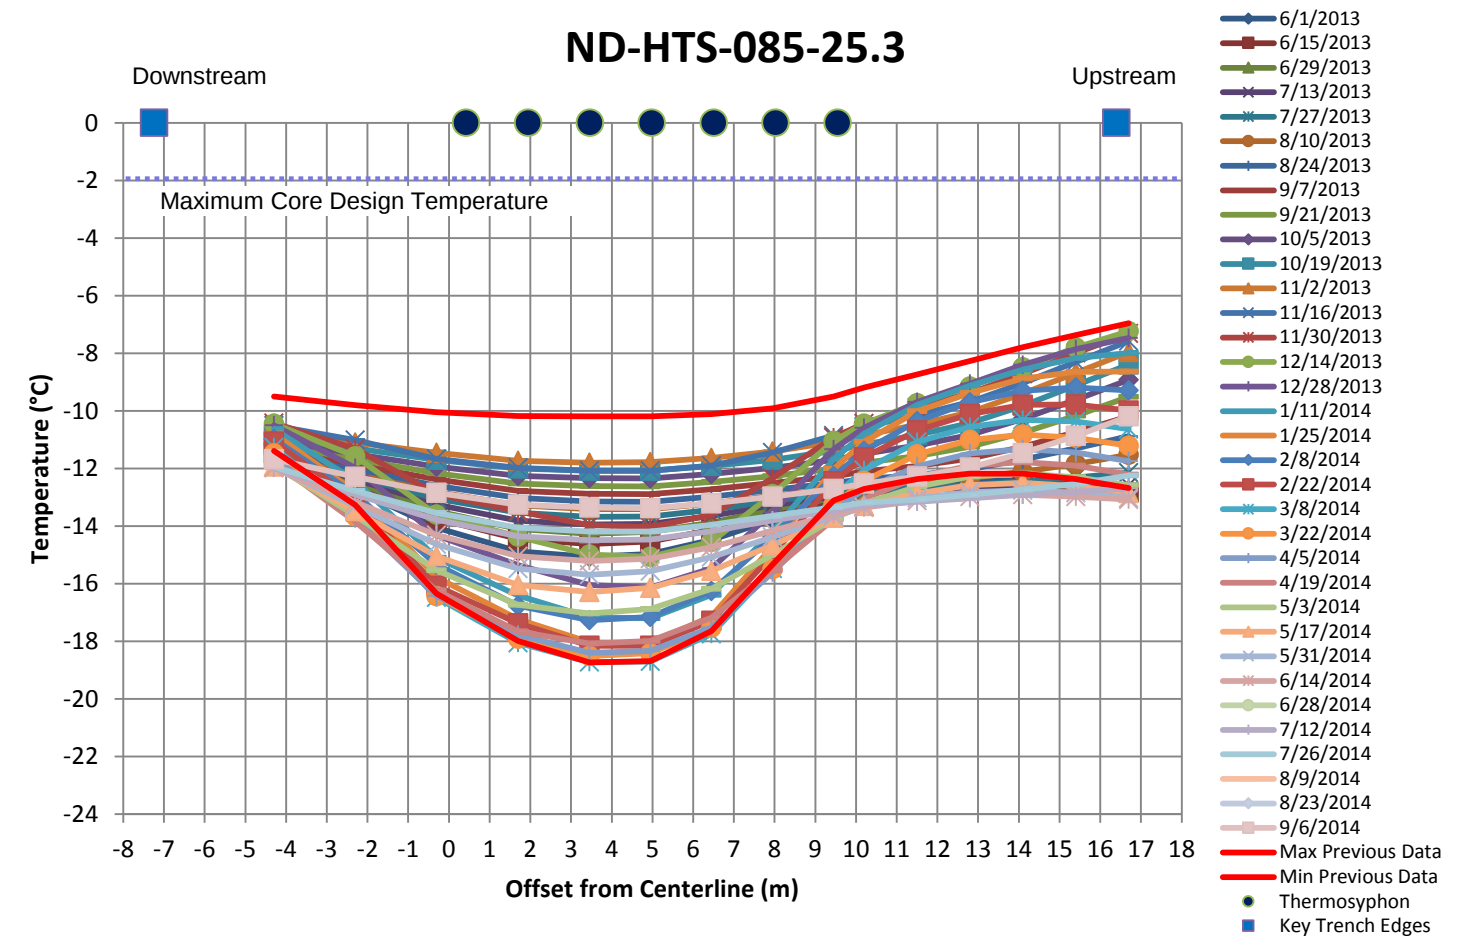
Date: Oct. 2014    Approved: MMM    Figure: **A.8**

- ND-HTS-085-33.5 was irreparably damaged during construction
- Previous Data was recorded between August 2012 and May 2013

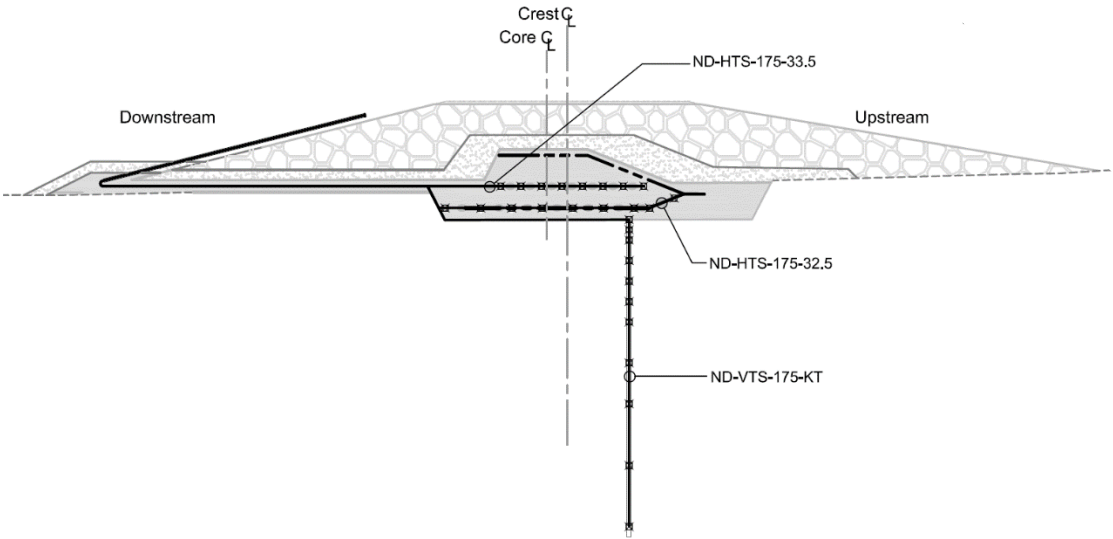
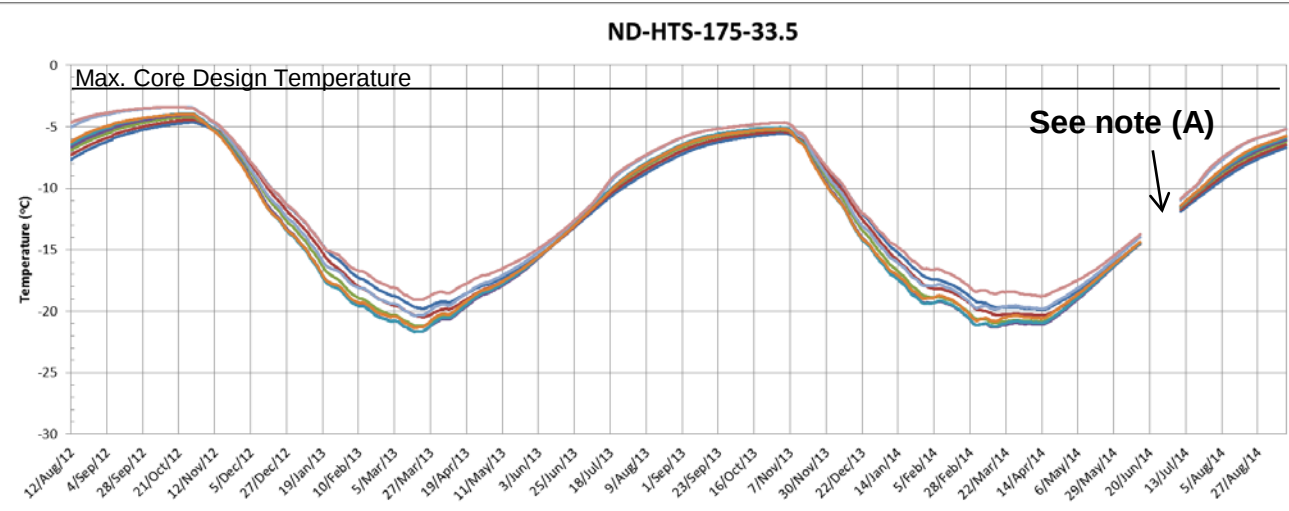
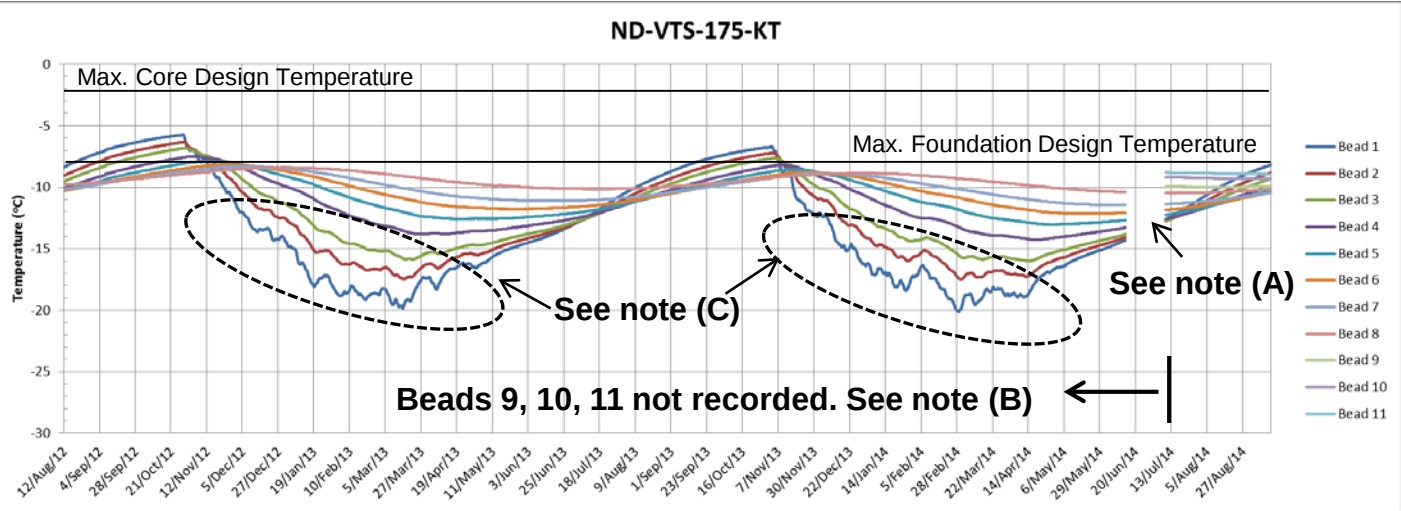
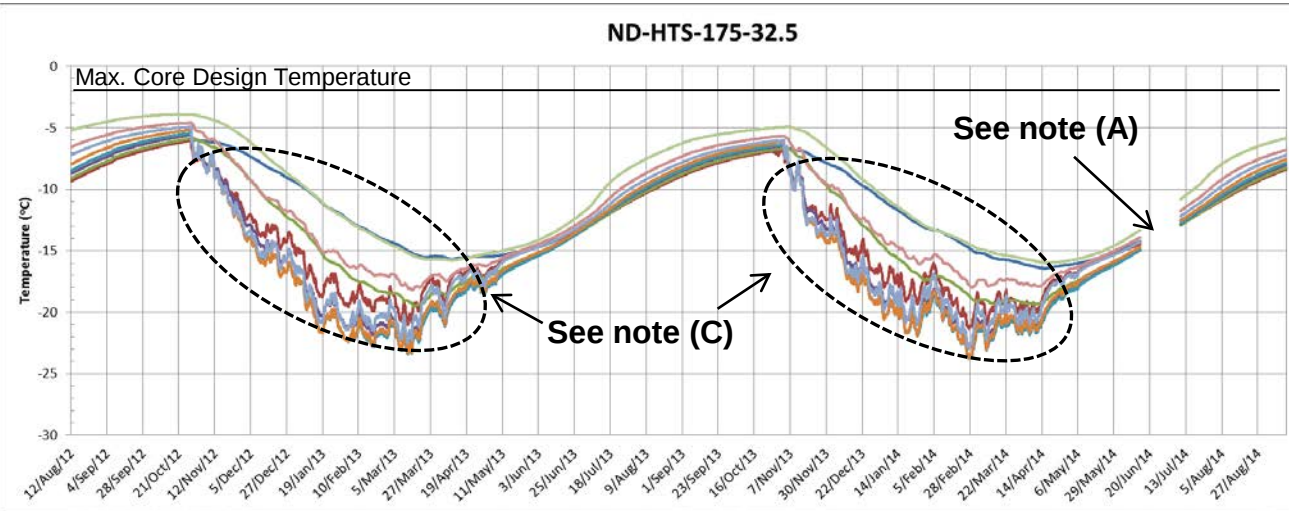
| Job No: 1CT022.001 | HOPE BAY MINING LTD. | Date: Oct. 2014 | Approved: MMM | Figure: <b>A.16</b> |

- Notes:**
- Bead numbers increase from downstream to upstream (horizontal) and top to bottom (vertical)
  - **(A)** Card download error: data needs to be extracted from datalogger.
  - **(B)** Incorrectly connected to datalogger as ND-HTS-175-33.5; therefore, no readings for beads 9, 10 and 11.
  - **(C)** Variation in Ground Temperature Cable readings during winter months due to close proximity of Ground Temperature Cable beads to thermosyphon pipes.
