2014 Geotechnical Inspection		
		Quarry #2 and Landfarm		
Job No: 1CT022.001 Filename: 2014GeotechInsp_rev00.pptx	HOPE BAY MINING LTD.	Date: Oct 2014	Approved: LW	Figure: 13

2014 Geotechnical Inspection

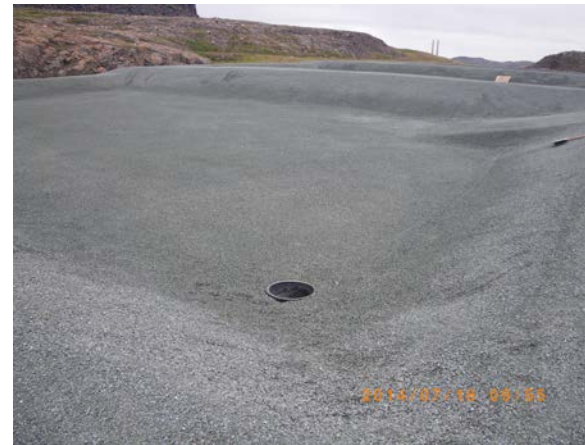
Condition of the Landfarm's Water Containment Pond

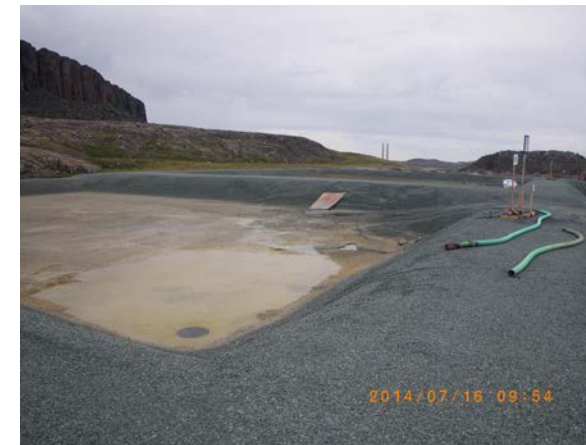
Condition of the Landfarm's Snow Containment Pond

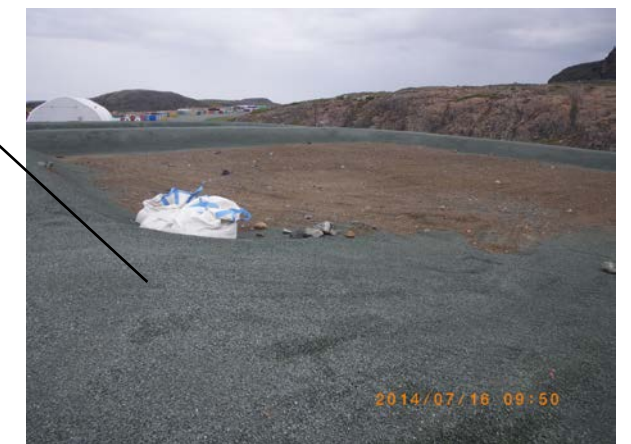
Condition of the Landfarm's Soil Containment Pond

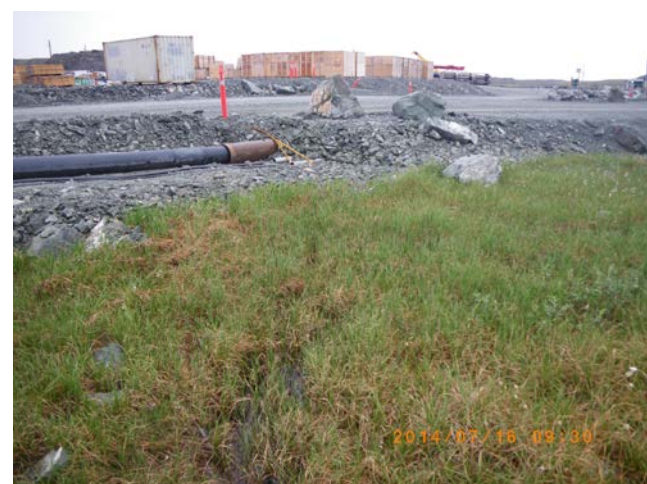
The junction of the Primary, Doris-Windy, and Float Plane Dock Access Roads – the rock fill is 0.5 m thick with surface water into the junction of the roads

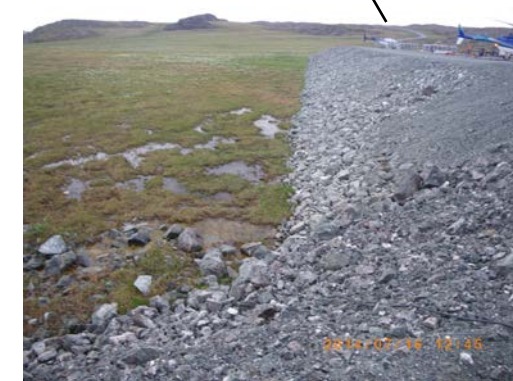
Seepage coming from along the eastern edge of the Helipad – looking south

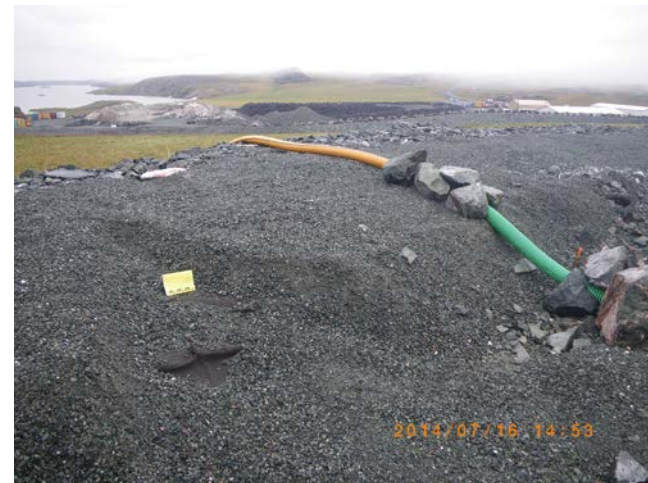
Exposed geotextile along the North Diversion Berm

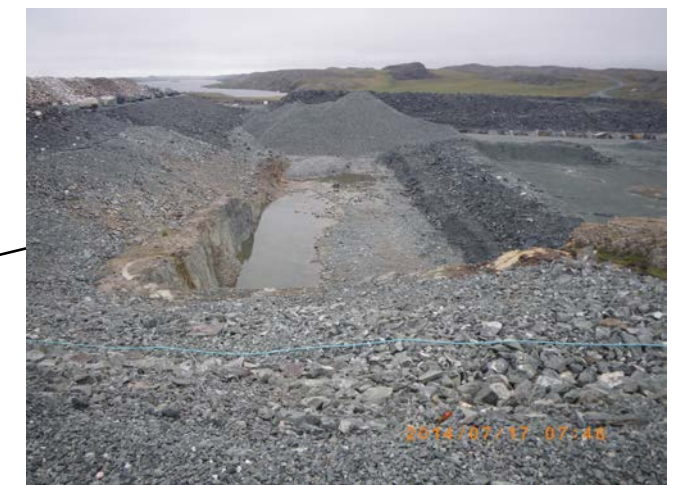
Water ponding by the highwall near northeast corner of Pad D

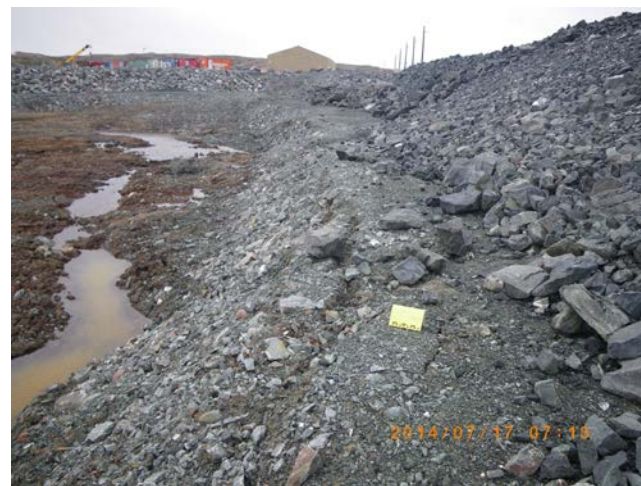
Seepage from the toe of the Waste Rock Pile and from the toe of Pad I. Tension cracks have developed along the crest of Pad I Pad I– looking west

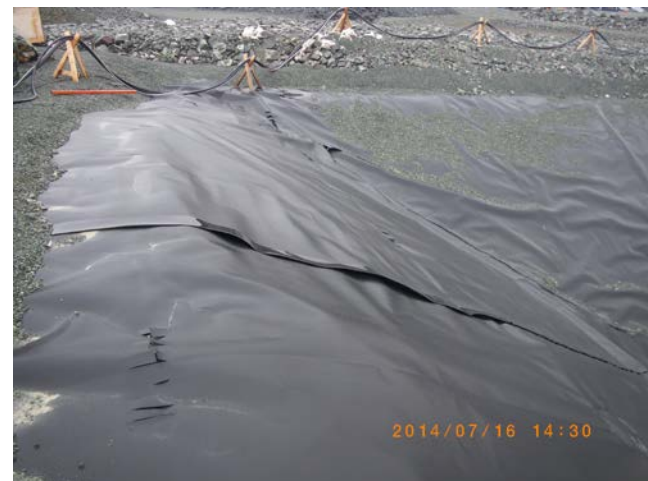
Cuts in HDPE liner along the crest of the Sediment Control Pond at Pad E/P

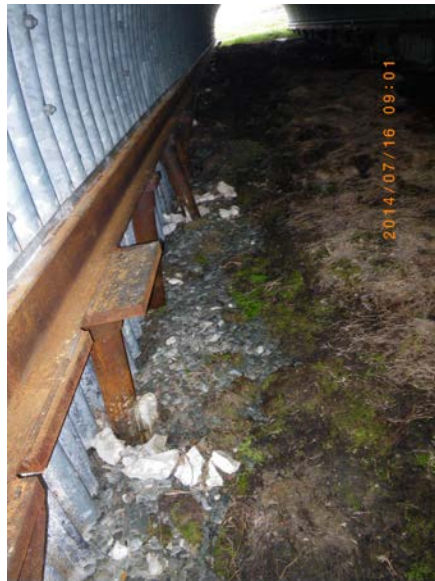
Condition of the battered and straight piles along the north and south sides of Arched Culvert #1

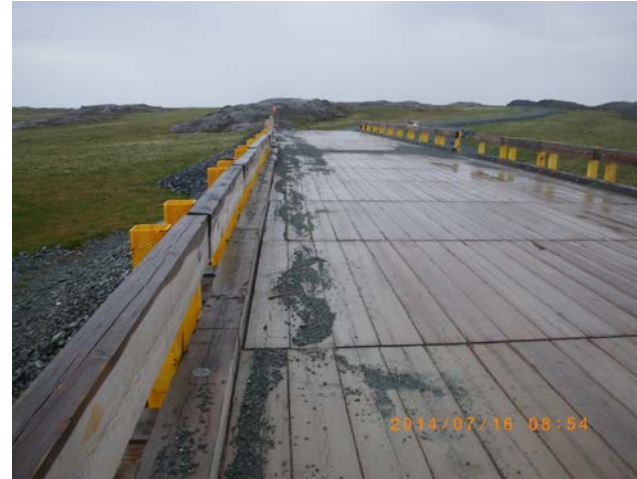
The bridge over Stream Crossing #3 appears to have been shifted as indicated by the decking – looking north from the south end of the bridge

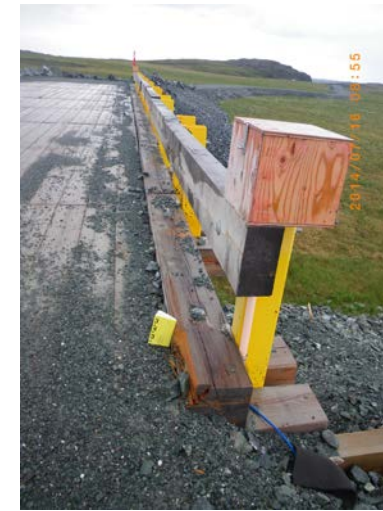
The wooden timber, along the west side, at the north end of the bridge over Stream Crossing #3 has been damaged

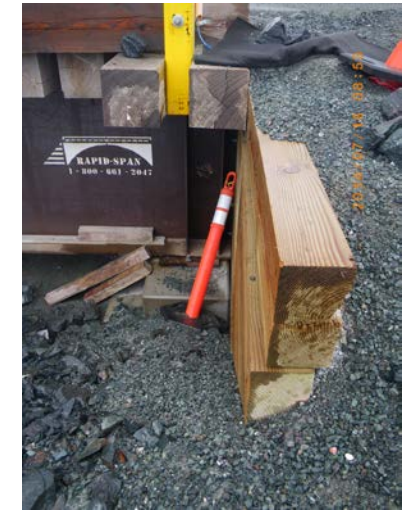
The timber retaining wall at the south abutment of the Bridge over Stream Crossing #3 has also been shifted

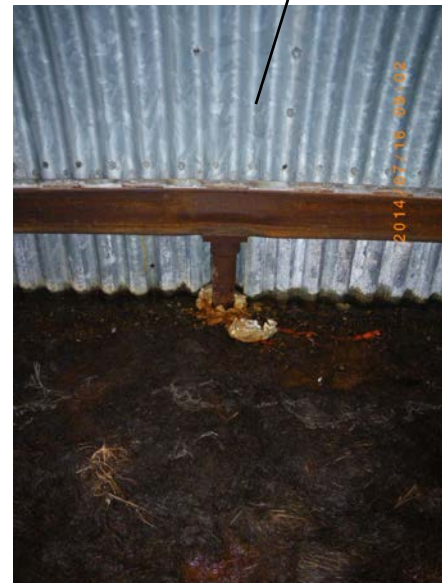
The condition of the I-beam along the south side remains unchanged

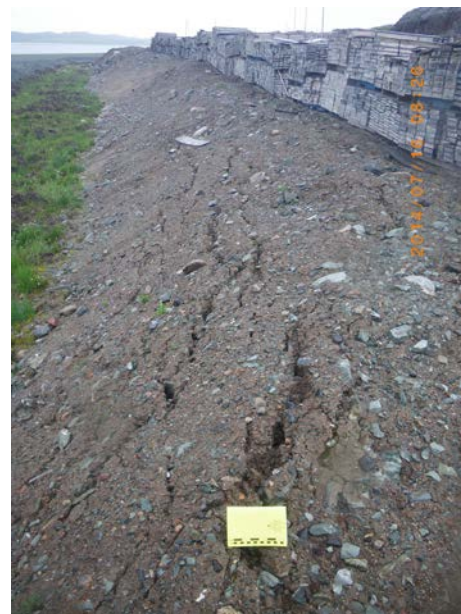
Tension cracks on west side of the Quarry D Overburden Stockpile

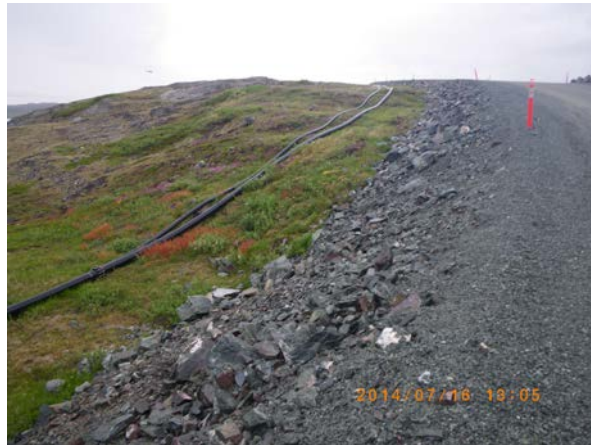
The 2010 surficial slope failure – looking southwest from the Primary Vent Raise

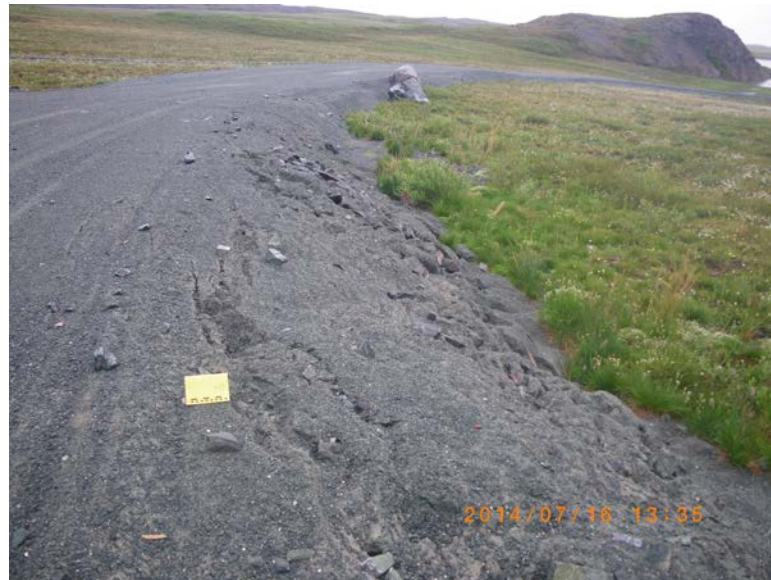
Tension cracks on the south side of the Tail Lake Access Road near the Frozen Core Plant Pad - looking east

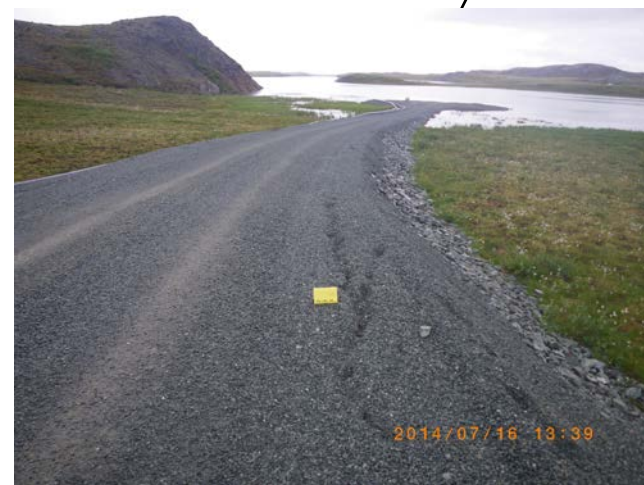
Tension cracks on the south side of the Tail Lake Access Road near the Frozen Core Plant Pad
