HOPE BAY MINING LTD.

2014 Geotechnical Inspection

2014 Geotechnical Inspection	
	HOPE BAY MINING LTD.		Jetty and Shoreline Laydown Area	
Job No: 1CT022.001 Filename: 2014GeotechInsp_rev00.pptx	Date: Oct 2014	Approved: LW	Figure: 6

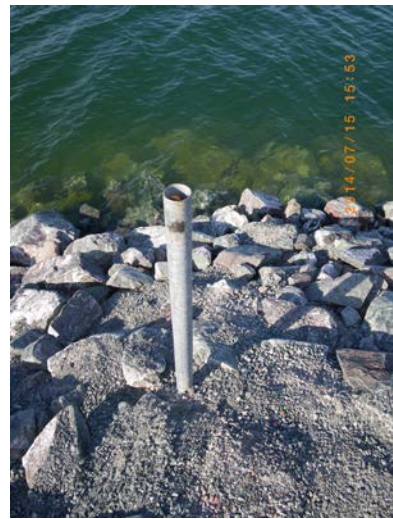
Survey monument 1500 on east end of jetty

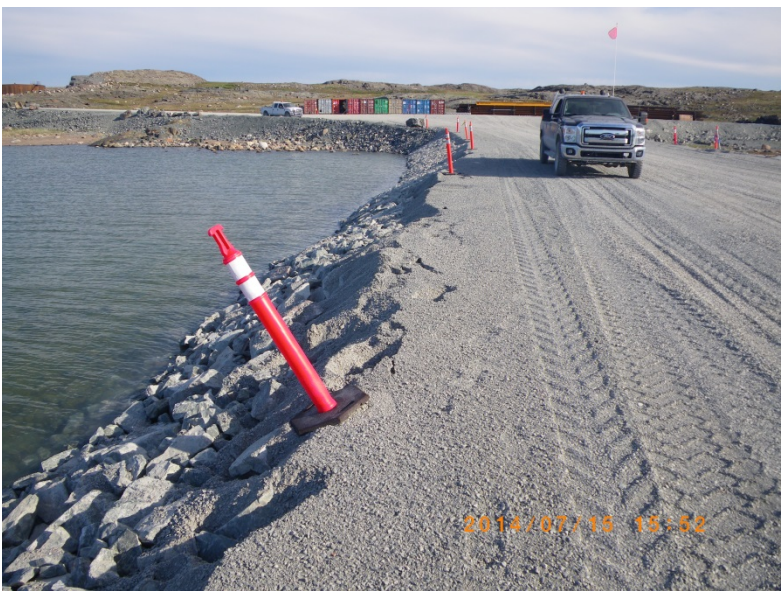
East side of Jetty - looking south

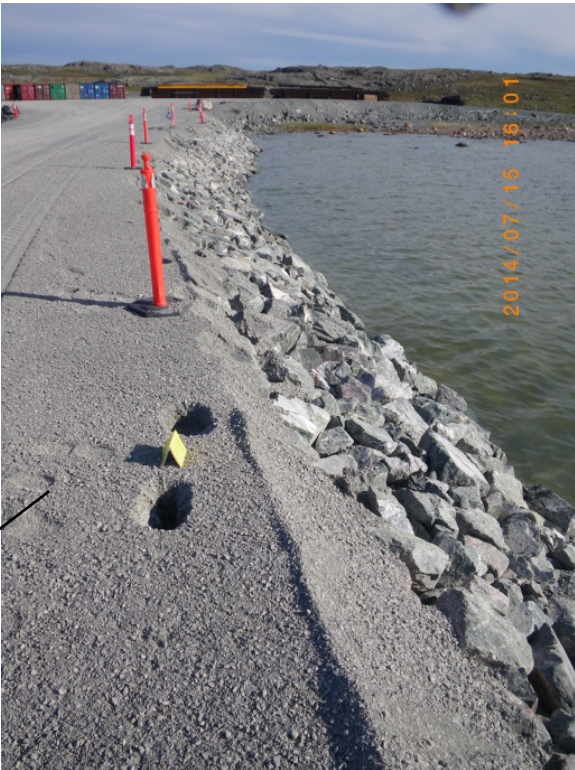
Settlement/Pothole along west edge of Jetty – looking south

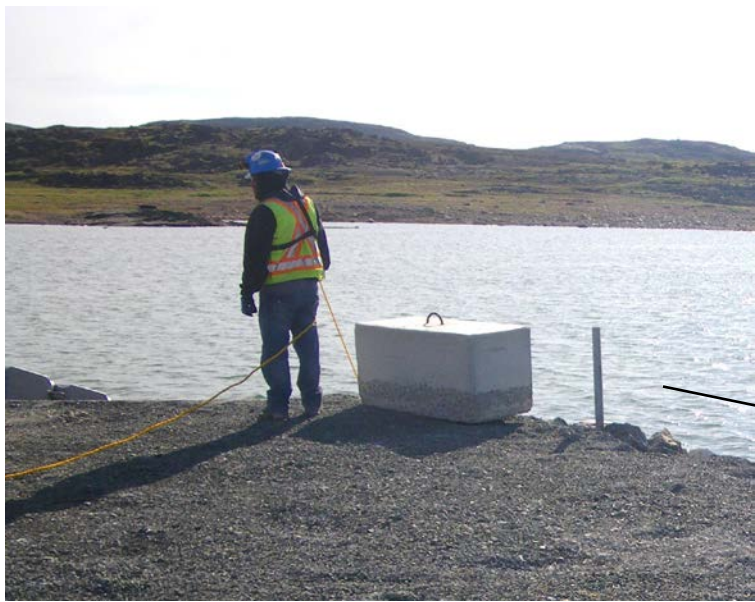
Survey monument 1501 on west end of the jetty

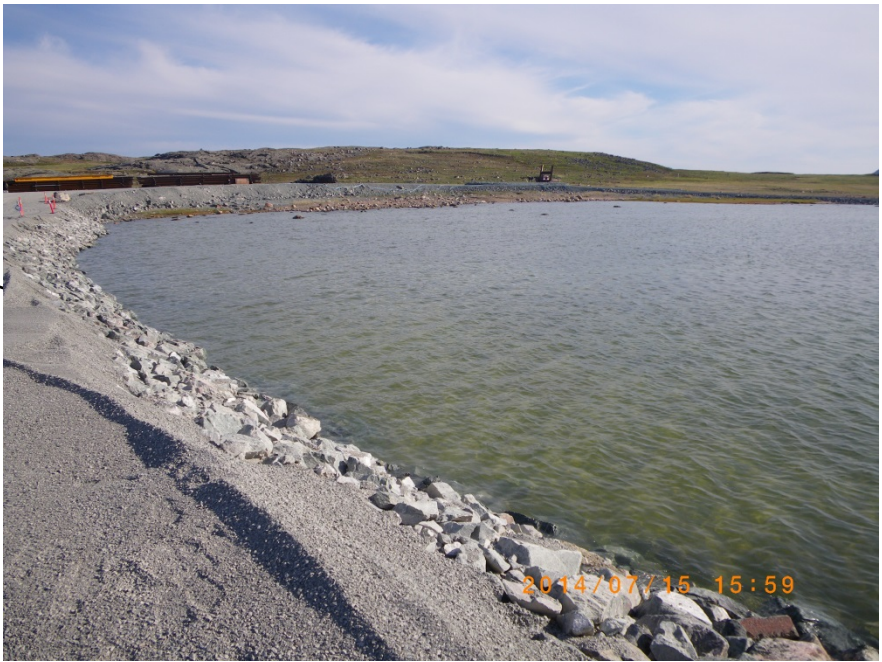
Western shoreline - looking southwest

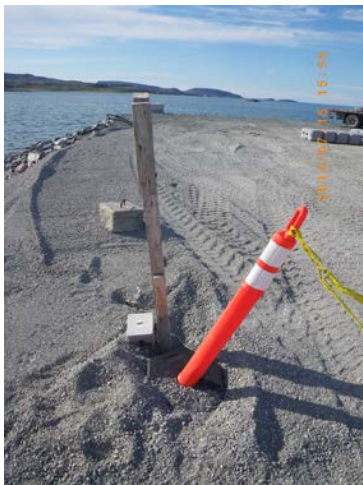
Condition of thermistor cable SRK-JT1-09 – looking north

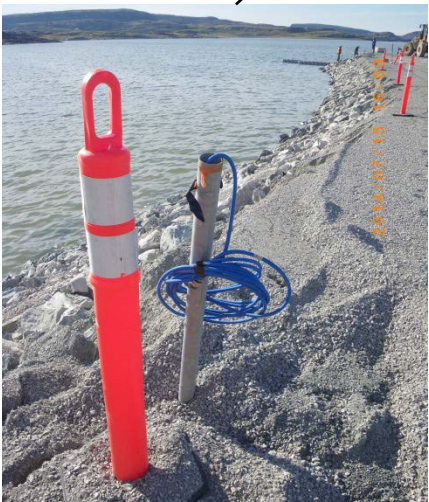
West side of jetty looking north, thermistor string SRK-JT-12 in foreground

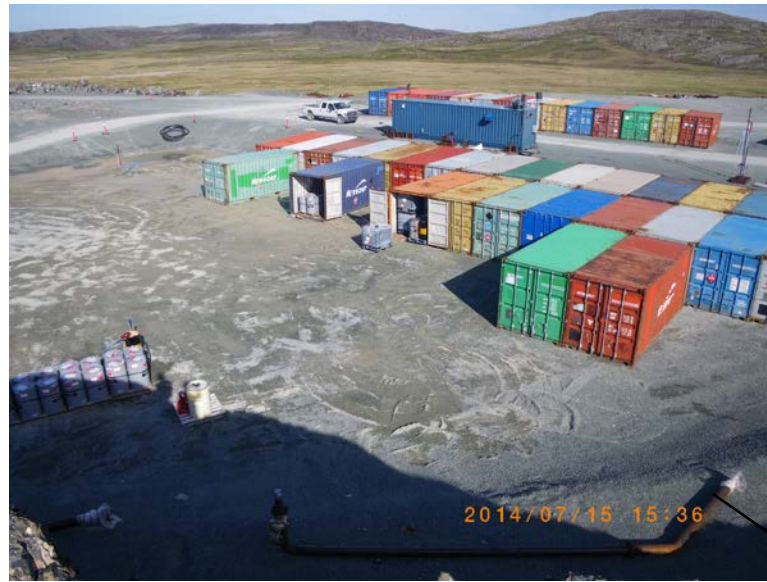
Laydown area within Quarry #1 Tank Farm – looking southeast

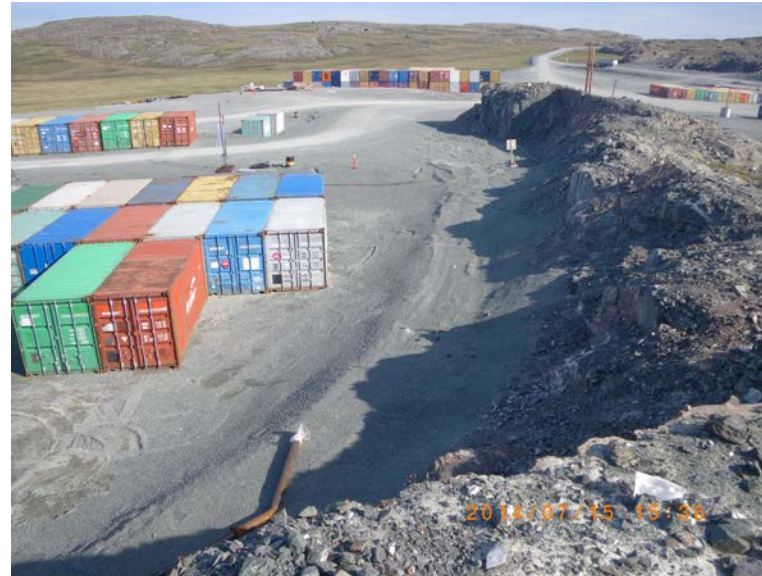
East end of Quarry #1 laydown – looking southeast

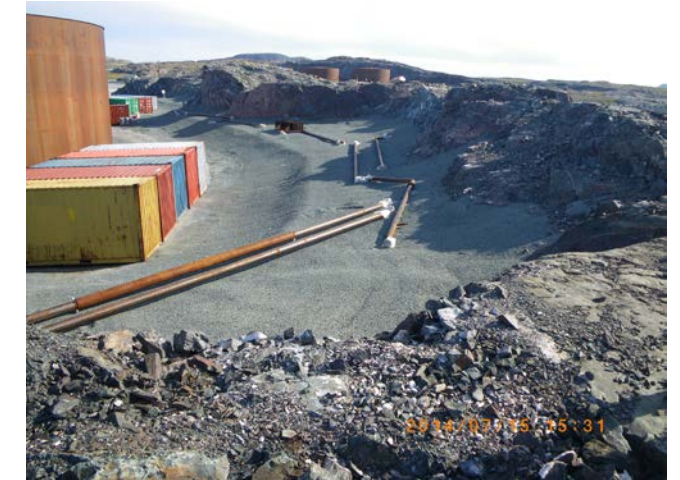
West high wall of the Quarry #1 Tank Farm with the fuel transfer pipes disconnected – looking west

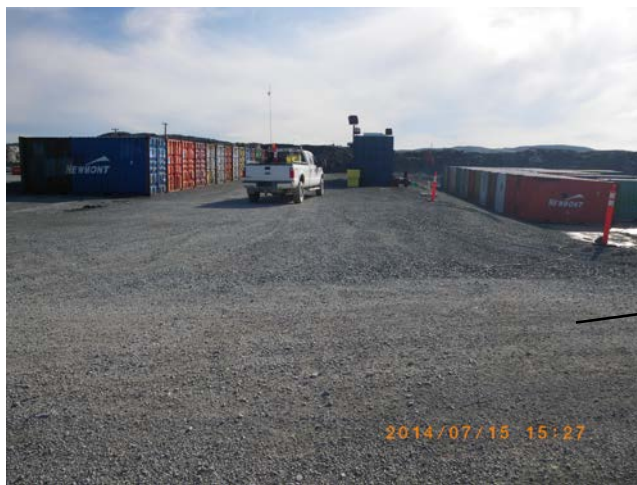
Condition of the decommissioned fuel transfer station – looking west from the access ramp into Quarry #1

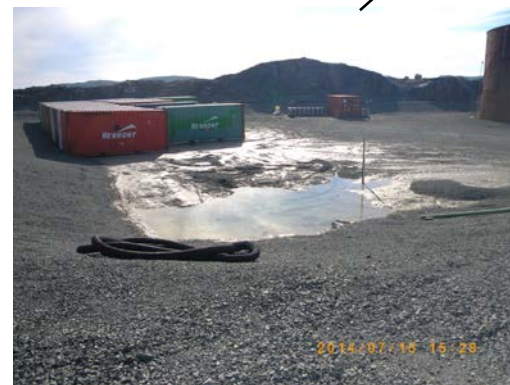
Water ponding at the sump next to the access ramp into Quarry #1 Tank Farm – looking west

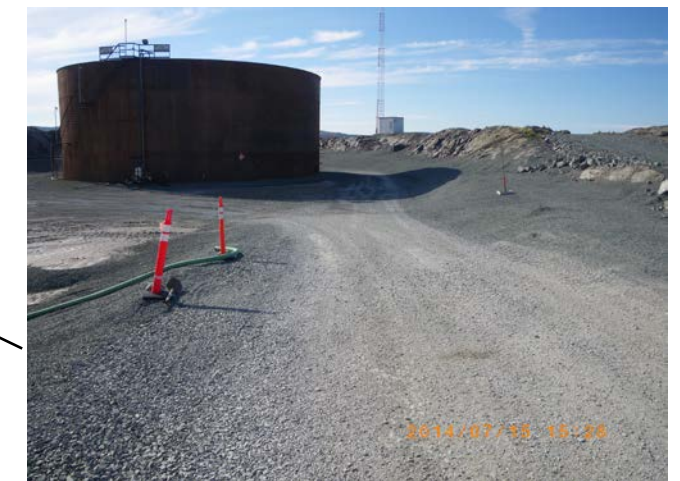
Southeast corner of Quarry #1 Tank Farm access ramp – looking northwest at the radio tower

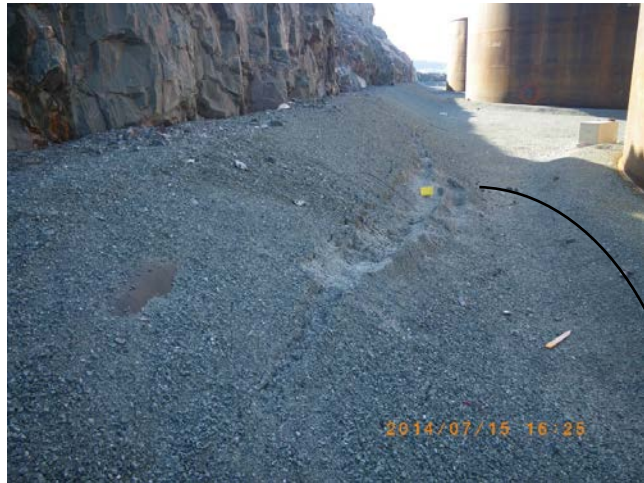
Exposed liner and grounding cable along the containment berm behind Tank #1 – looking northwest

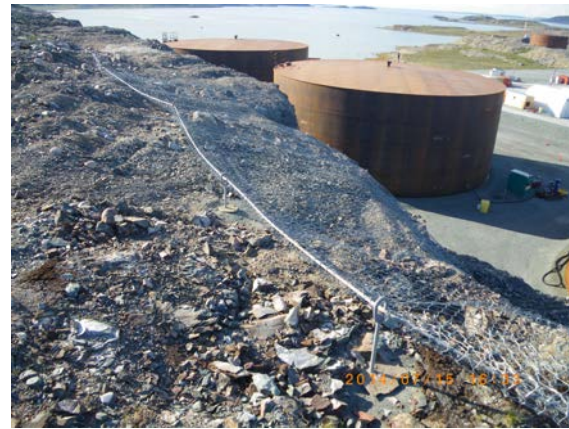
Condition of the rock bolts securing the mesh on high wall – looking down from above Tank #1

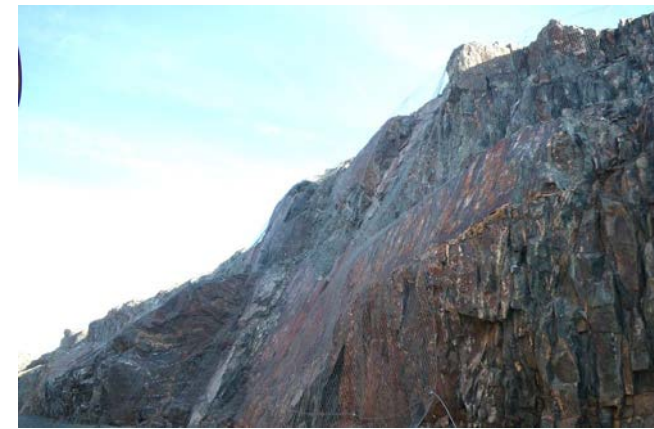
Mesh on high wall protecting the fuel tanks from falling rock – looking up from Tank #2

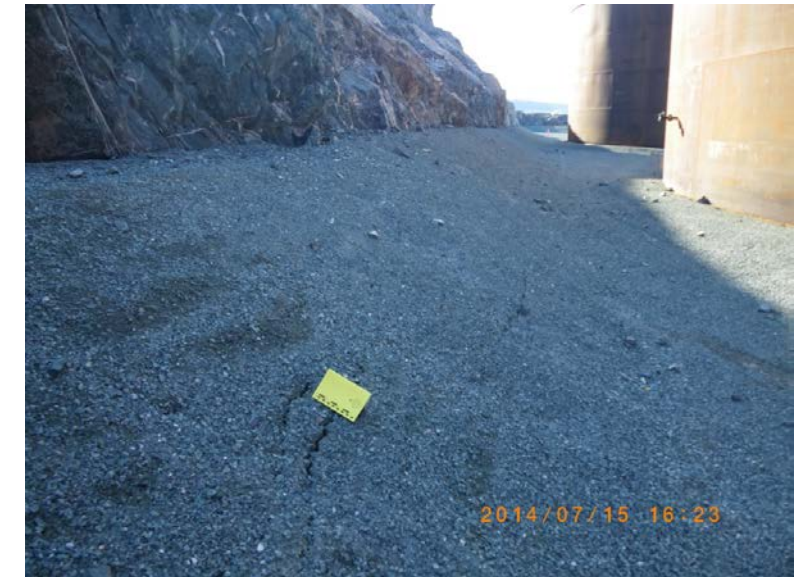
Tension cracks along the berm below the highwall – looking north from Tank #2

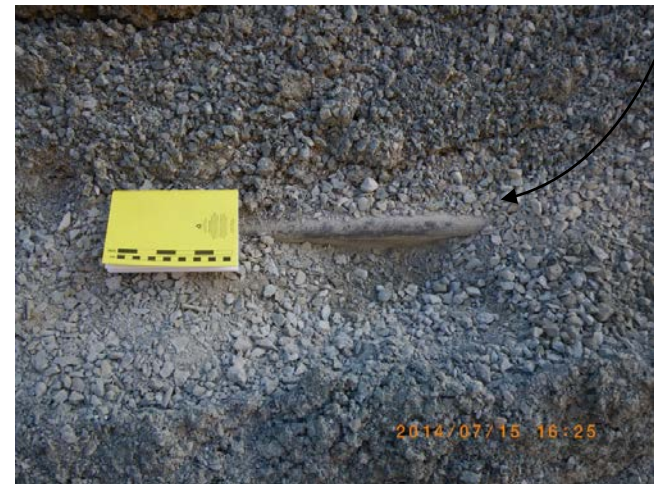
Exposed liner along the containment berm behind Tank #1

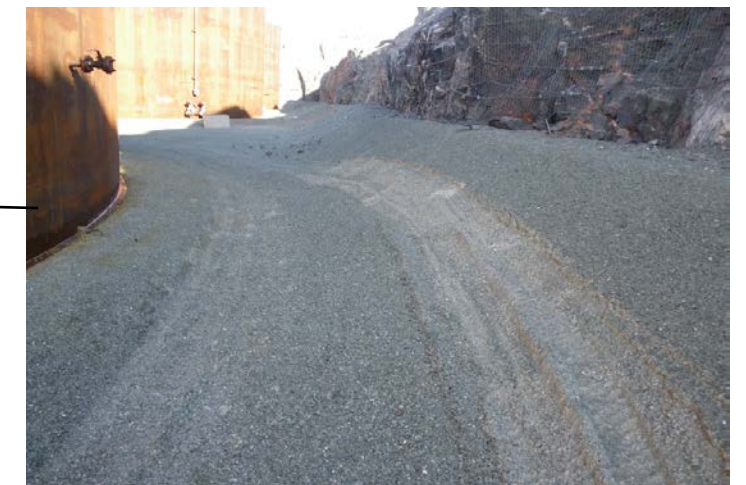
There has been vehicle traffic behind Tank #3. The condition of the liner is unknown – looking southeast

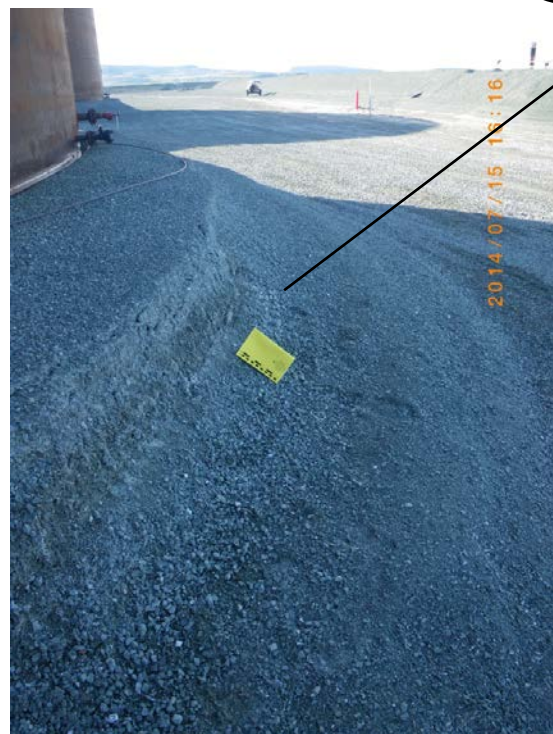
Erosion of Tank #1 pedestal due to snow and water

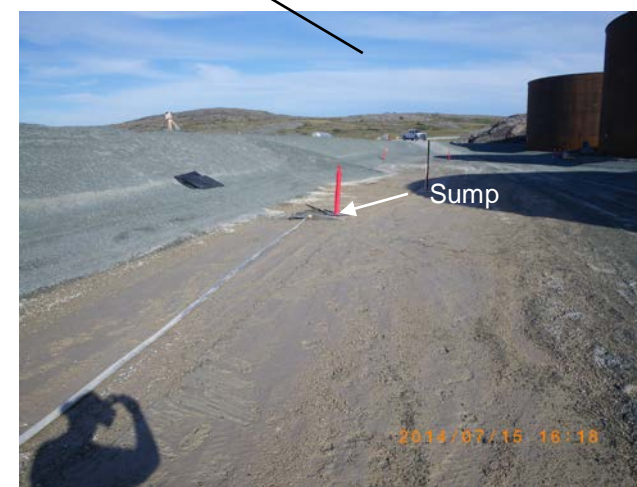
The sump east of the fuel tanks. The area surrounding the sump is covered with fine sediments – looking south towards the access ramp

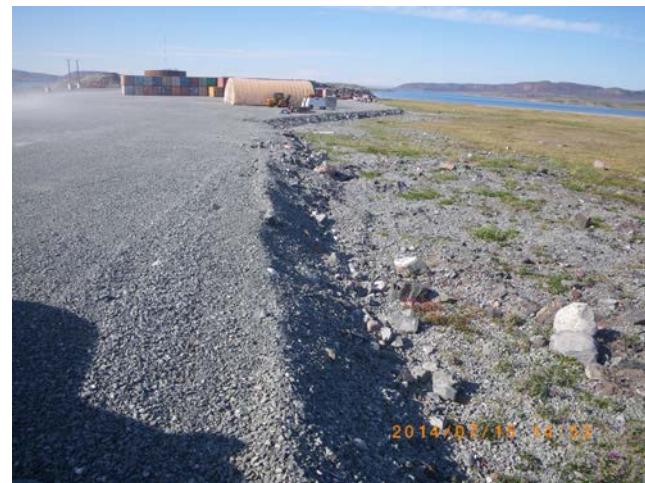
Looking along the east side of the laydown area – looking north towards Quarry #1 Fuel Tank Farm

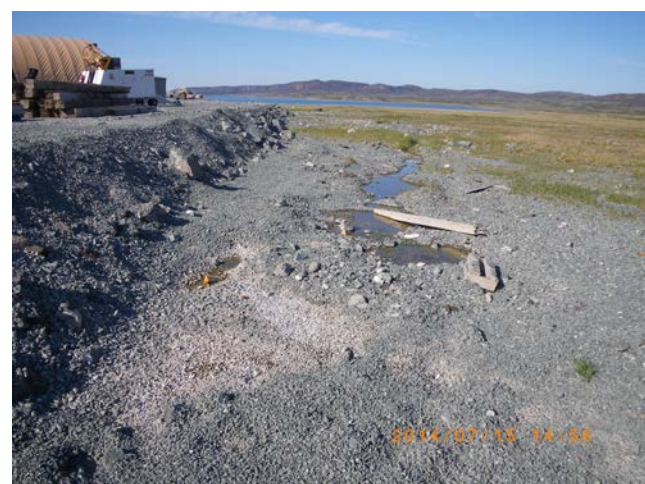
Swampy areas to the east of the laydown area – looking north

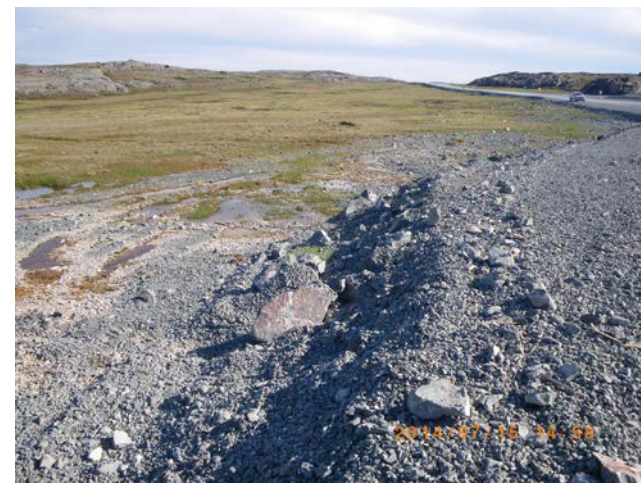
Looking along the west edge of the laydown area – looking south towards the Primary Road

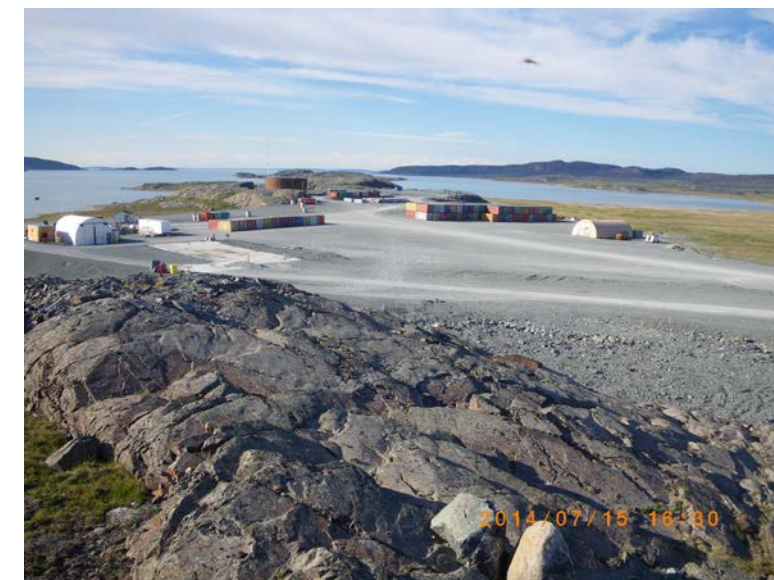
Oblique view of laydown area – looking northwest towards the Quarry #1 Fuel Tank Farm

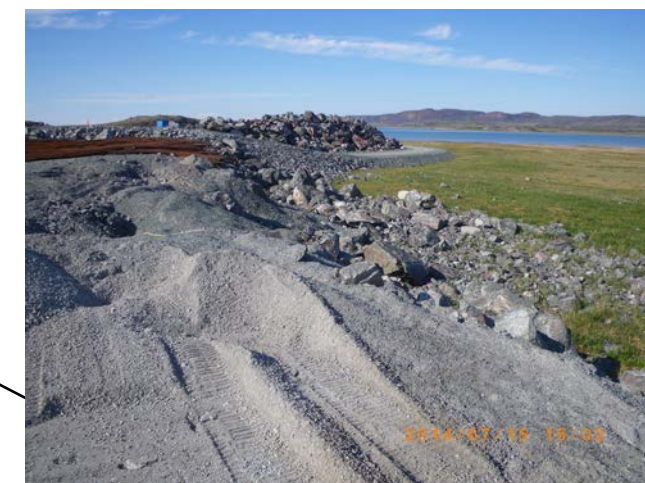
Northeast end of the laydown area with fuel transfer road in the background

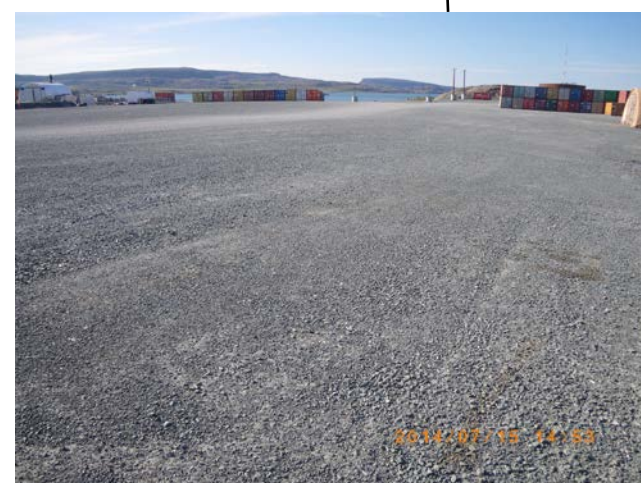
Laydown area – looking north

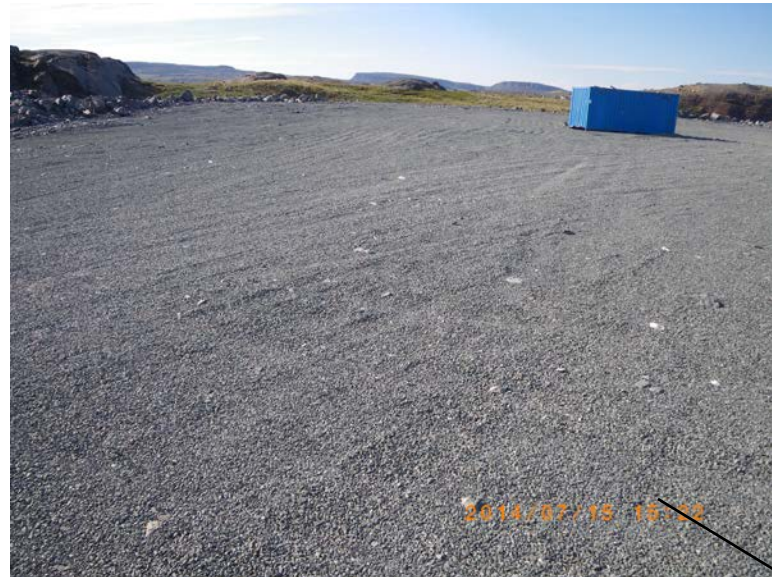
General condition of the Overburden Dump surface
- looking northwest

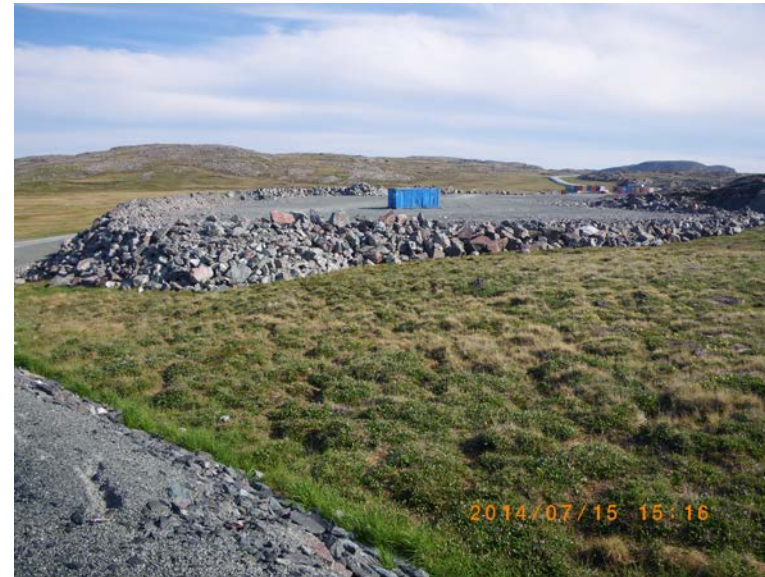
Oblique view of overburden dump – looking southeast
from the Roberts Bay Fuel Transfer Access Road

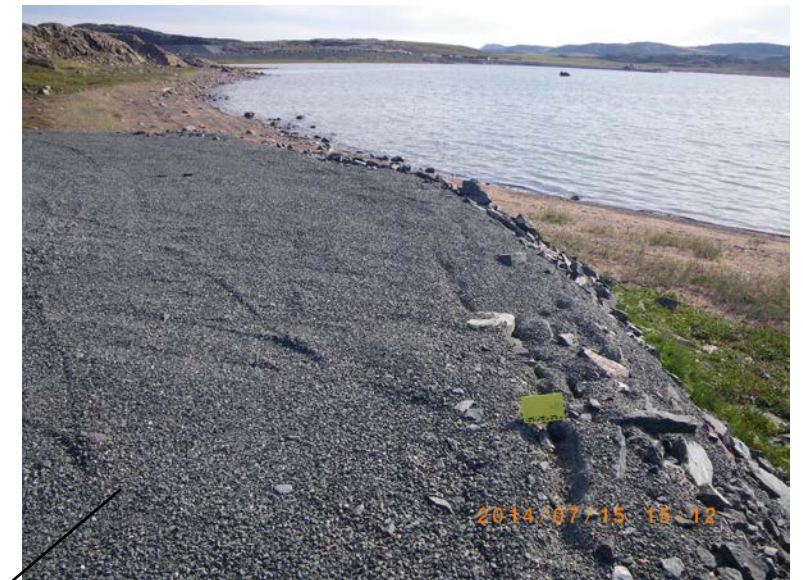
Tension cracks along the crest of the turn-a-round

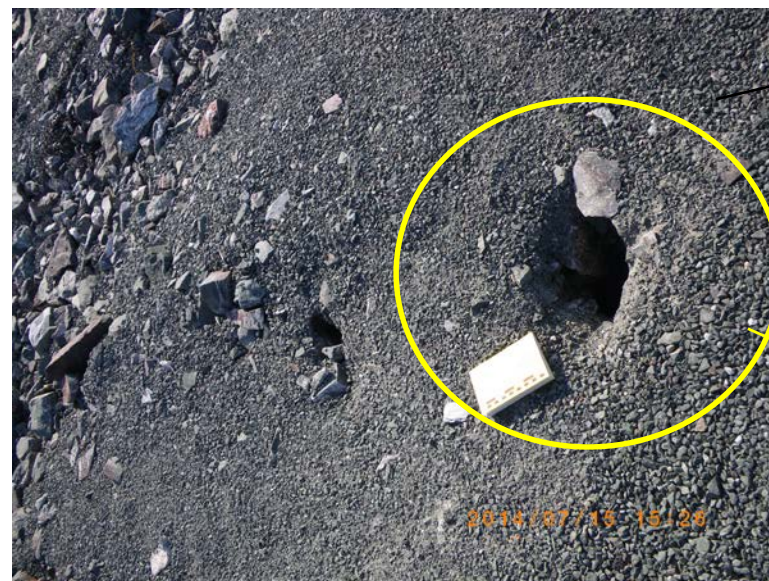
Sink holes at the entrance of the Overburden Dump

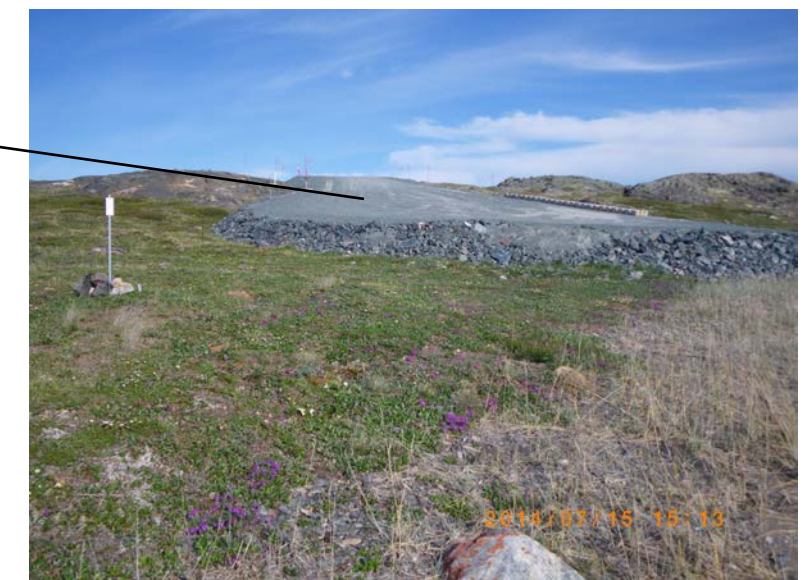
Oblique view of the Fuel Transfer Access Road –
looking east from Roberts Bay

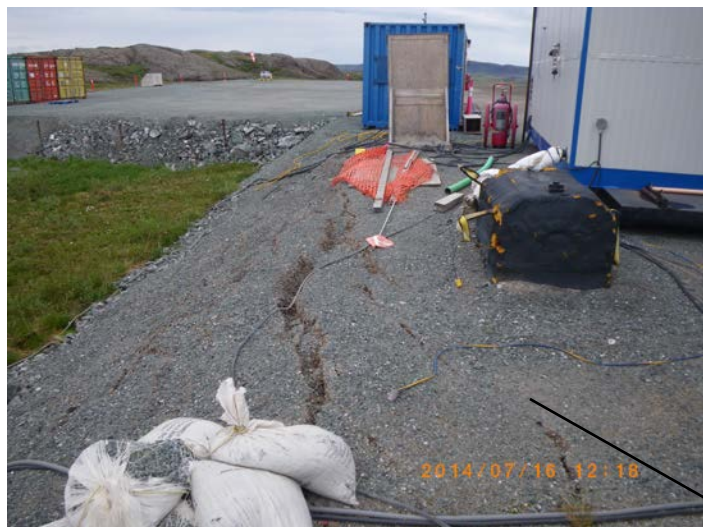
Tension cracks near south corner of the north apron behind the flight tower – looking north

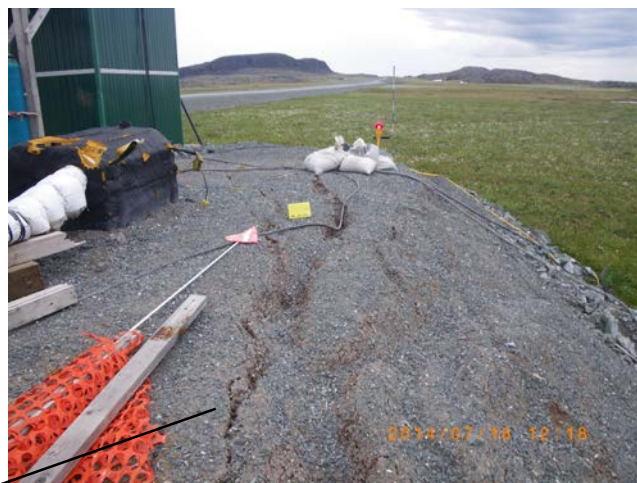
Tension cracks near south corner of the north apron behind the flight tower – looking north

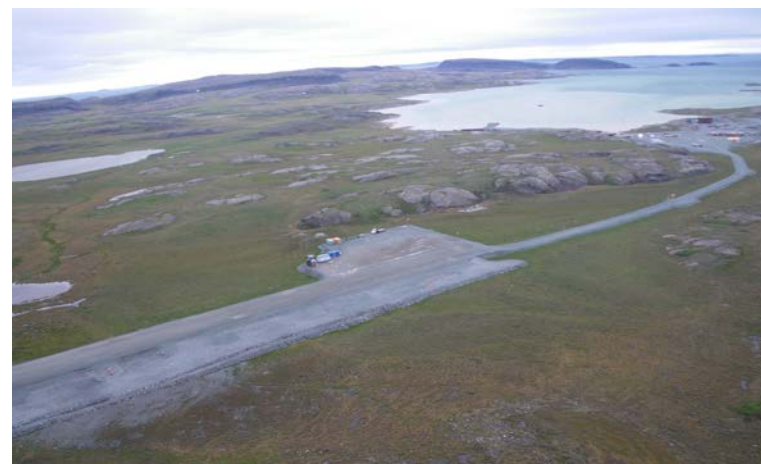
Aerial view of north apron – looking northwest

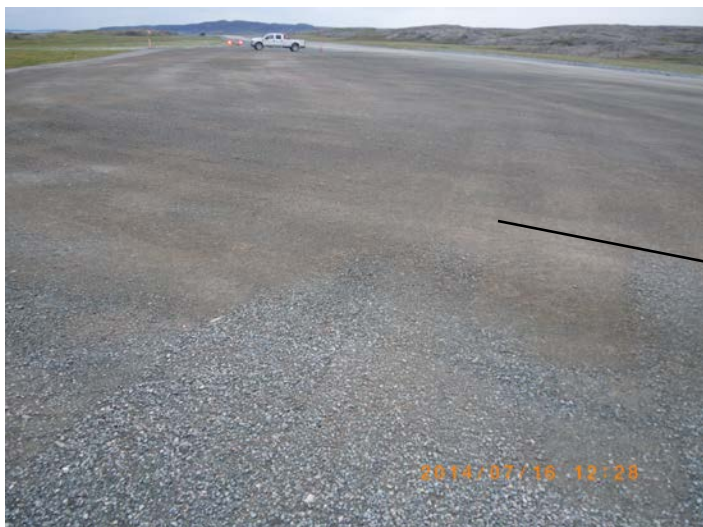
General surface condition of the South Apron – looking north

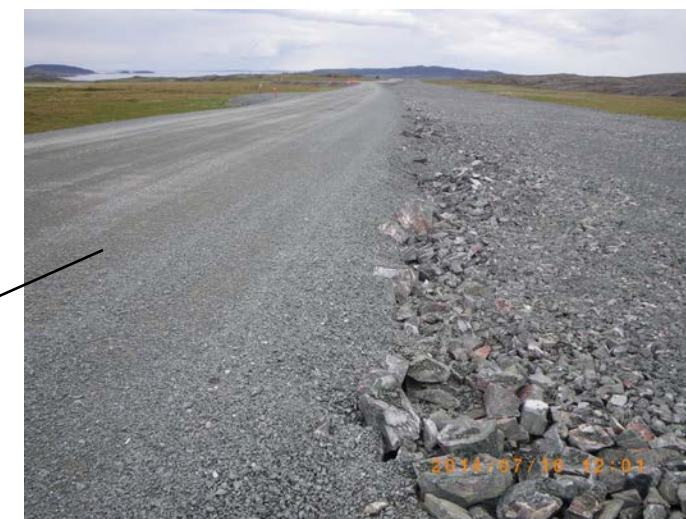
East side of airstrip – looking north

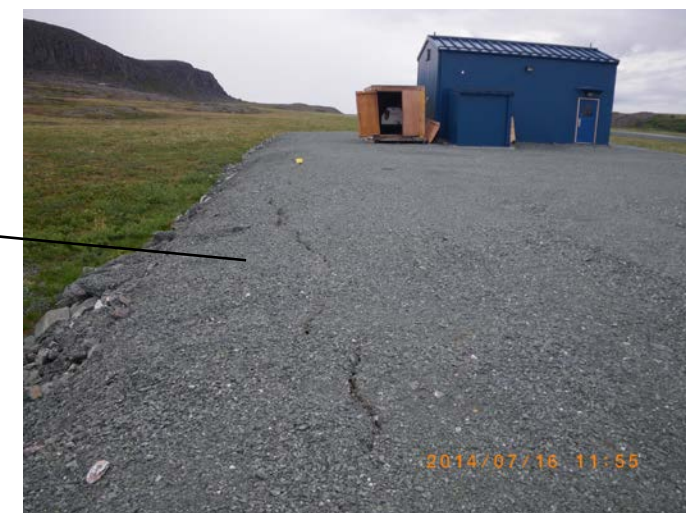
Tension cracks along the crest of the east side of the Wash Bay / Explosives Mixing Plant Pad

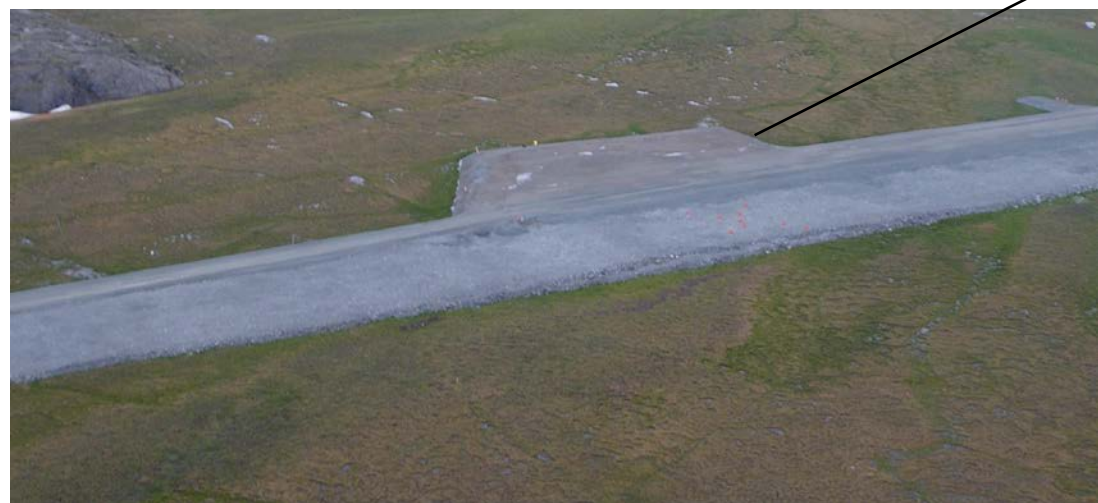
Aerial view of south apron – looking northwest

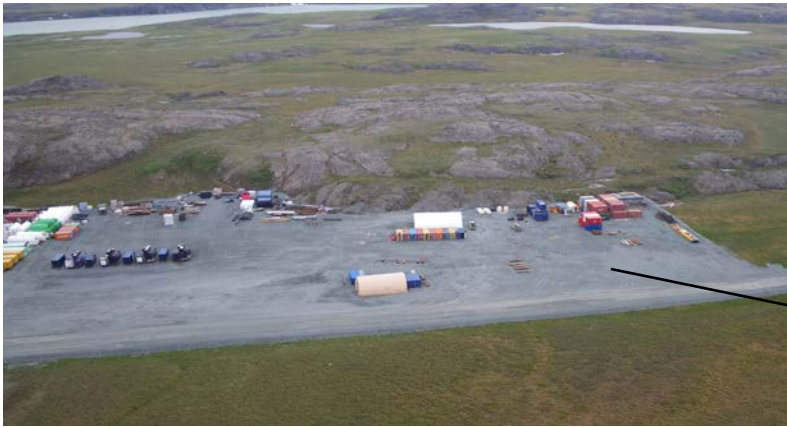
Aerial view of the Upper Reagent Pad – looking west

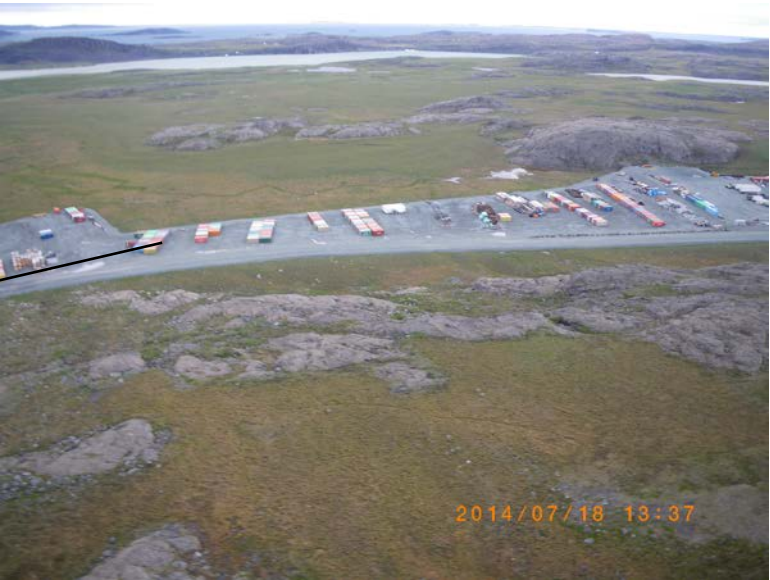
Aerial view of the Lower Reagent and Batch Plant Pads – looking west

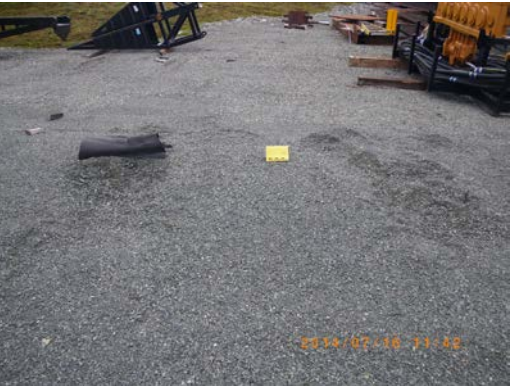
Exposed geotextile along the perimeter of the AN Storage area in the southwest corner of the Upper Reagent Pad

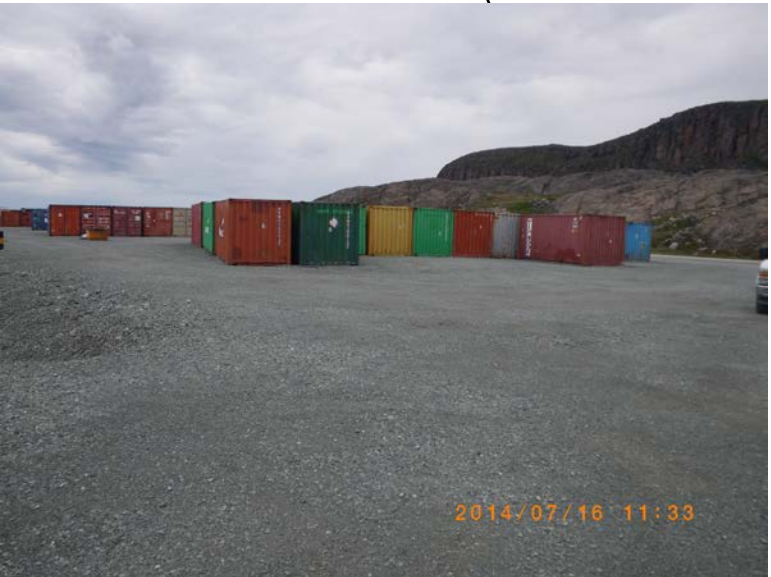
Seacans located on the Lower Reagent Pad – looking east

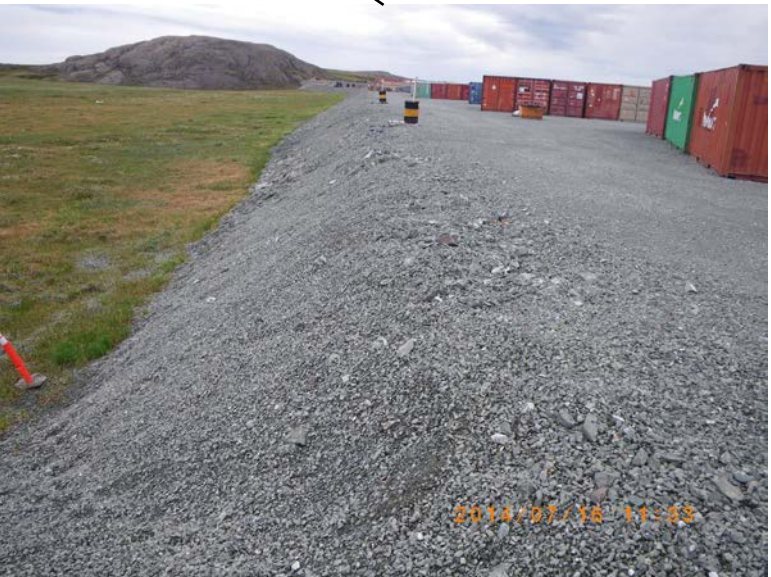
Condition of the west edge of Lower Reagent Pad – looking north
