Appendix F: Weekly Monitoring Reports

North Dam Weekly Walkover Survey Report

Date:	JUNE 7, 2014
Inspected By:	IKEY EVALIK
Conditions:	(ie. snow on ground, clear)

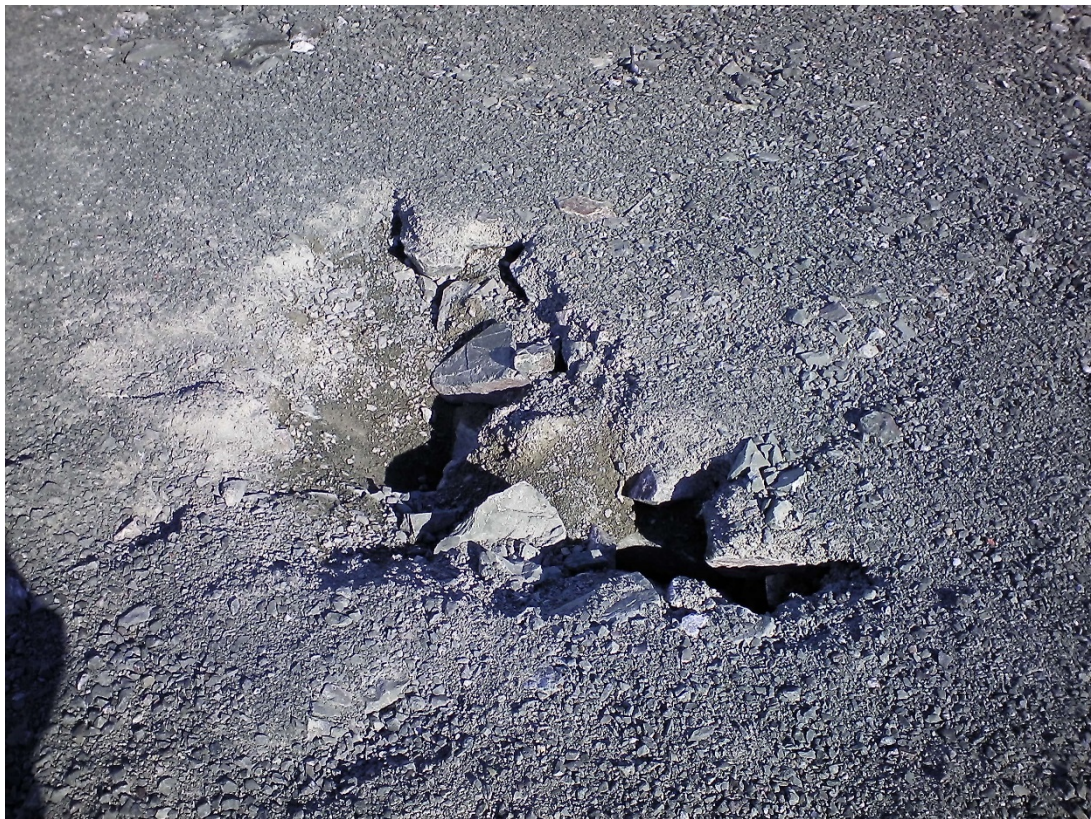
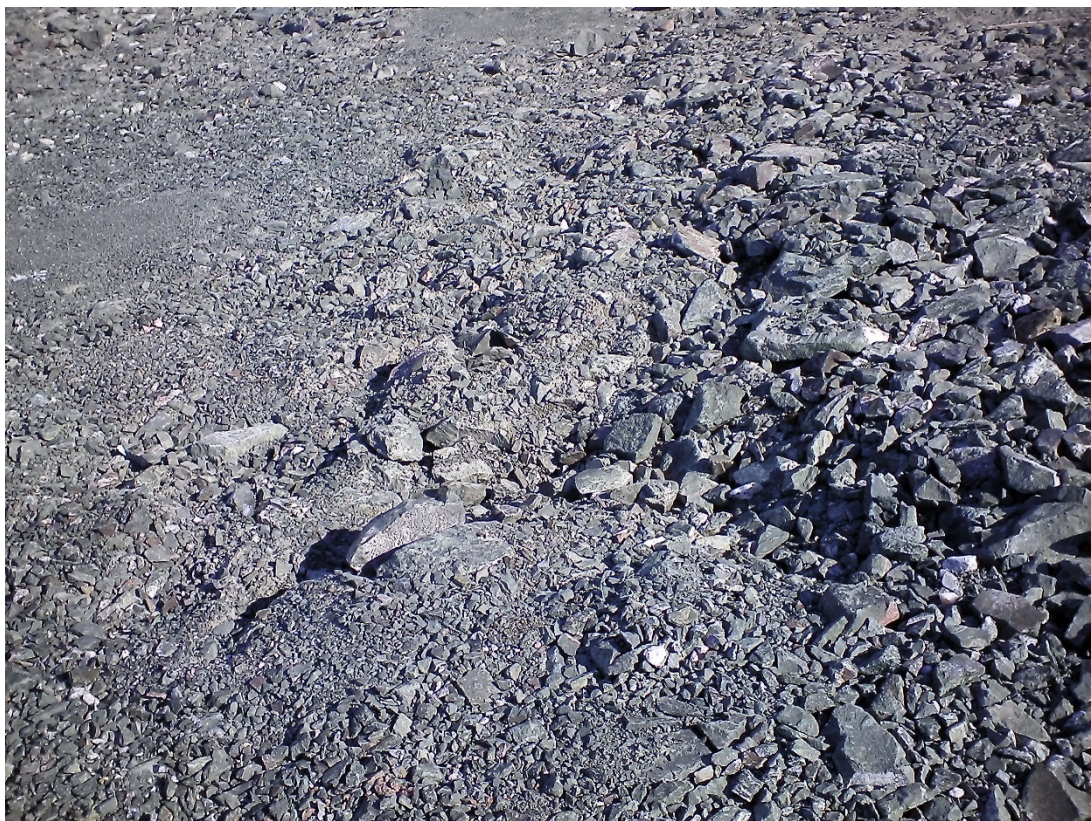
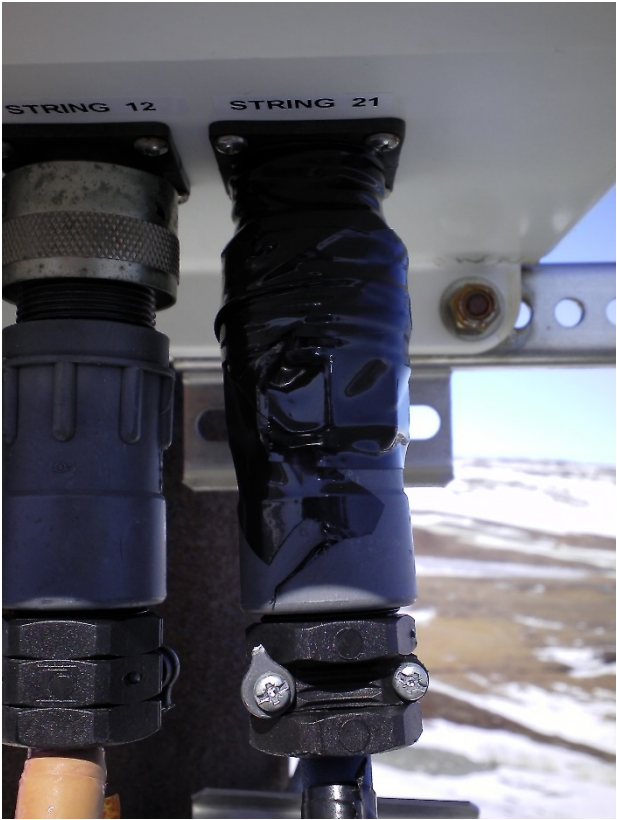
(1) Partially covered with snow		
(2) ^{small} Depression/erosion - midway - pictures taken ND-DSP-100 (WEST)		
(3) WILDLIFE PAW SCRATCH MARKS ON PAINT - FURTHEST EAST.

(4) TOOK PICTURE OF STRUG 21 ON TEMPORARY REPAIR DONE

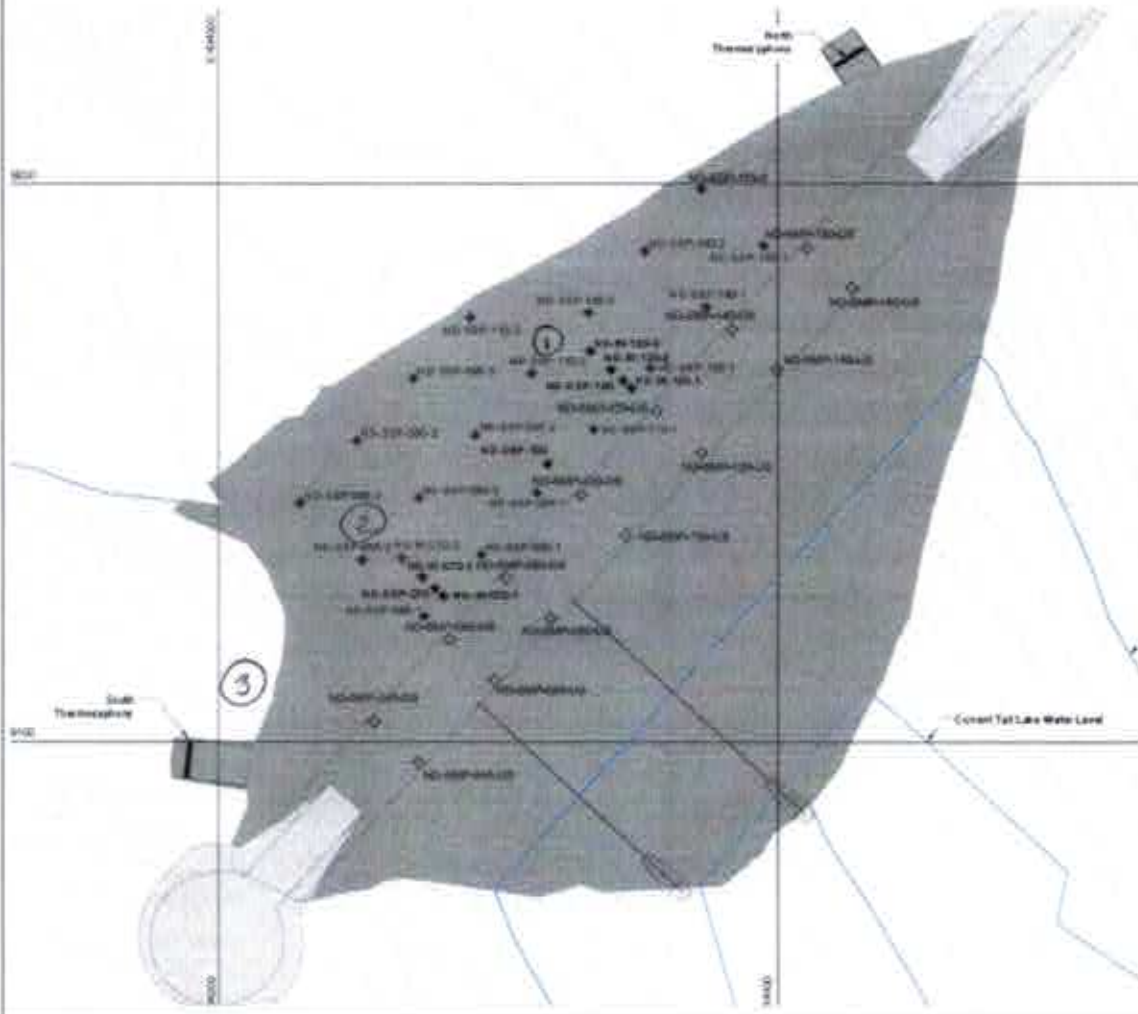
Thermistors and Dataloggers	
Any visible concerns? (frayed or cut cables, damaged boxes, etc.)	Yes <input type="radio"/> No <input type="radio"/>
<p>If you answered yes to any of the questions above please provide details and photos. Observations can be sketched on the figure provided on the next page. If seepage has been noted please estimate the flow.</p> <p>① Possible Fox den ~ 15 ft NW of ND-120-3 (see pic)</p> <p>② Several smaller depressions on DS side, one larger: 5' x 5' w ~ 1' deep. ND-SW-070-3 (see pic)</p> <p>③ Snow melt creating a small trickle of water ENE of South Thermosyphons - should disappear when snow is gone. (see pic)</p>
