## North Dam Weekly Walkover Survey Report

Date:	21 June 14
Inspected By:	Jill/Branden
Conditions:	(ie. snow on ground, clear) Clear/Small Patch snow @ downstream toe

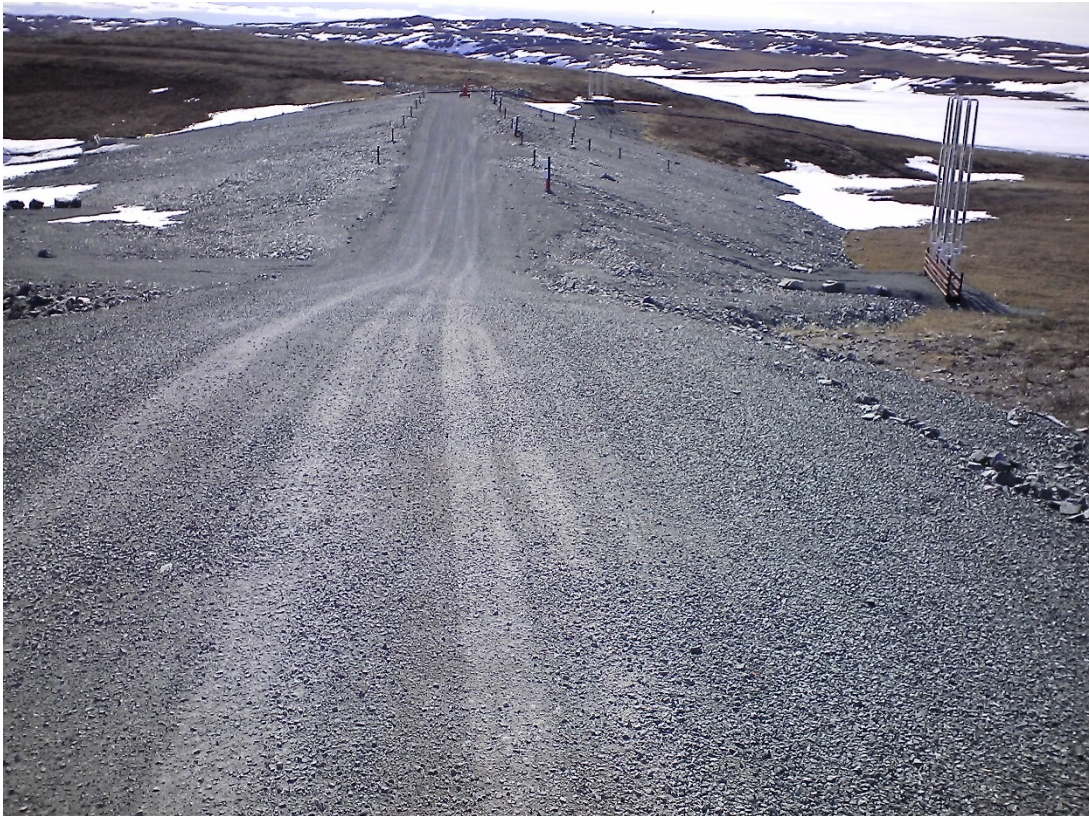
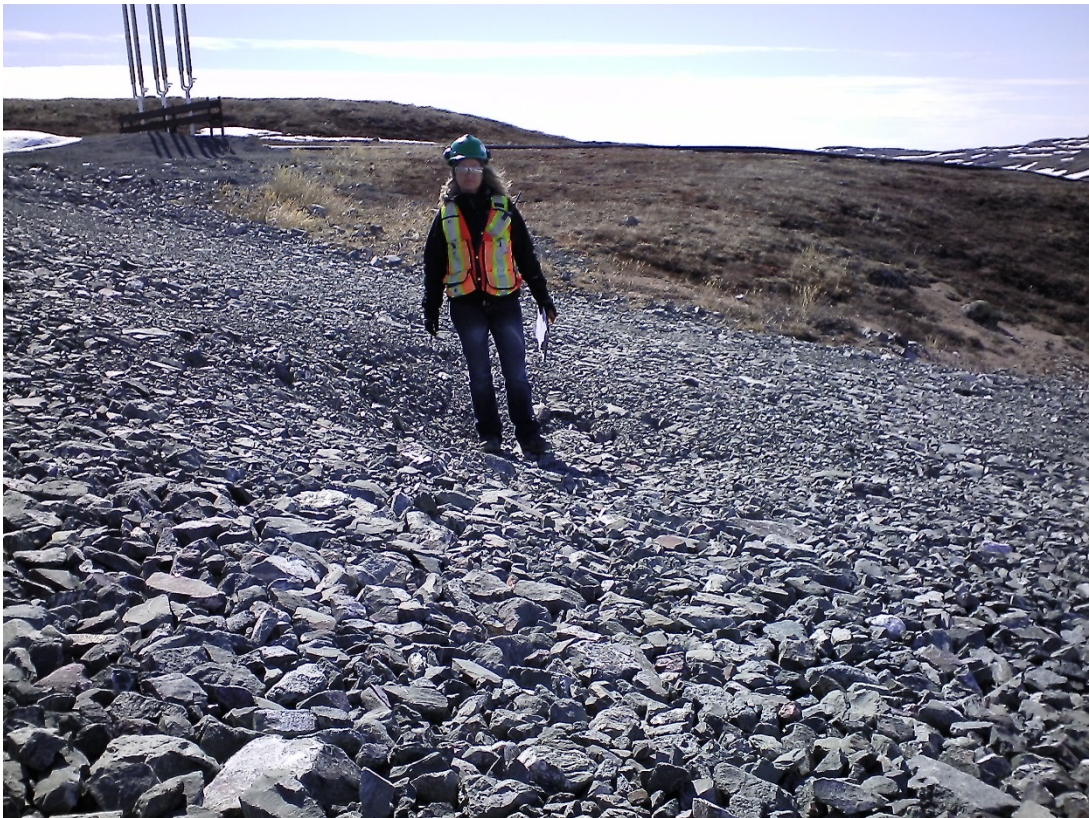
① Pretty crude rock, uneven across an area 20ft x 10ft on downstream side (see 2 pics)
